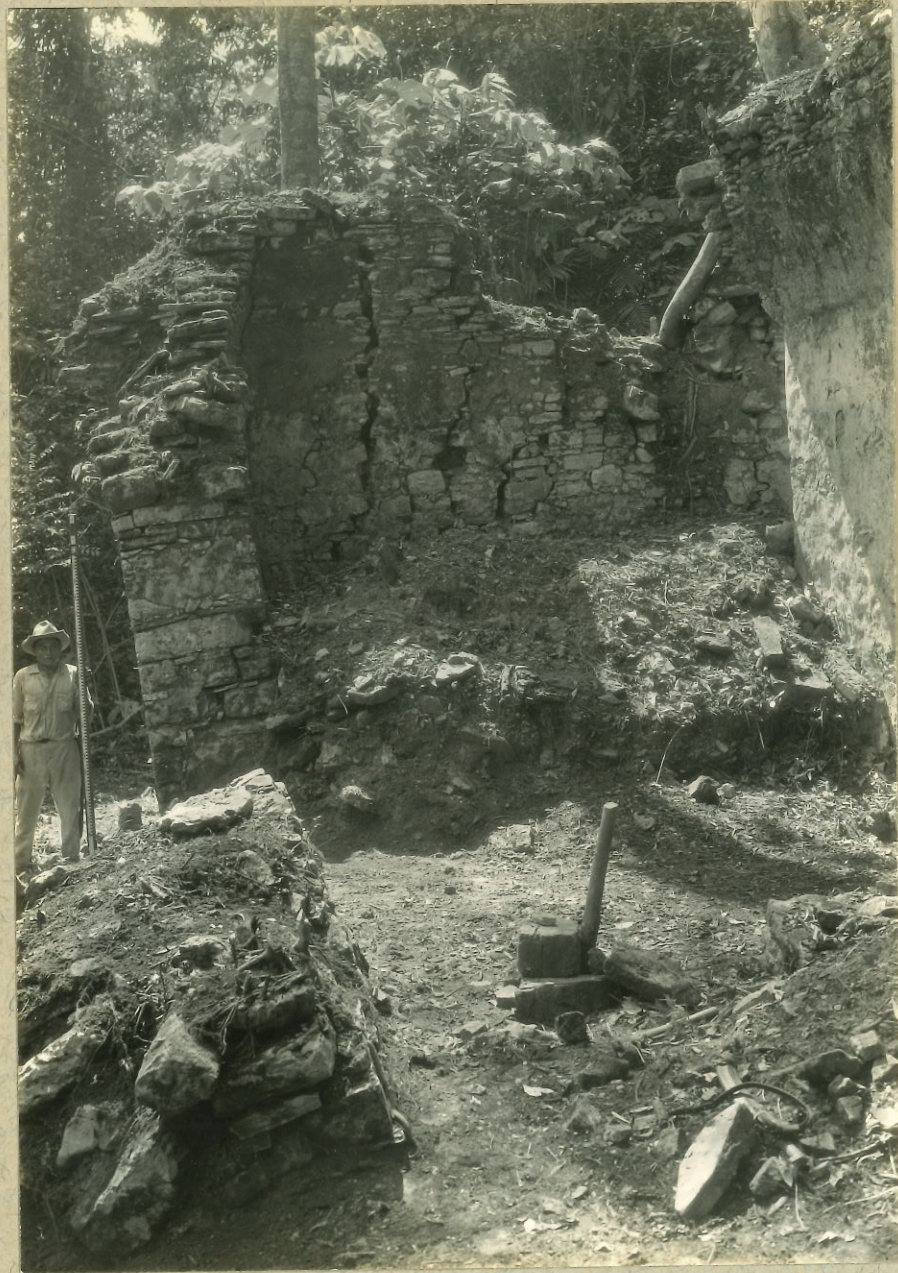
34 - 95

Right wall and anta, inside view, from debris over left end of front chamber. Right pier at left. Debris as left in 1931 (removed in foreground). The leveling rod outside rests on present plinth level there which is below zero (floor at sanctuary - i.e. rear of chamber). The jamb of the anta is intact, though leaning, to height of about 1.50; thereafter in ruins, giving a receding cross-section of anta and superimposed half-vaulting.

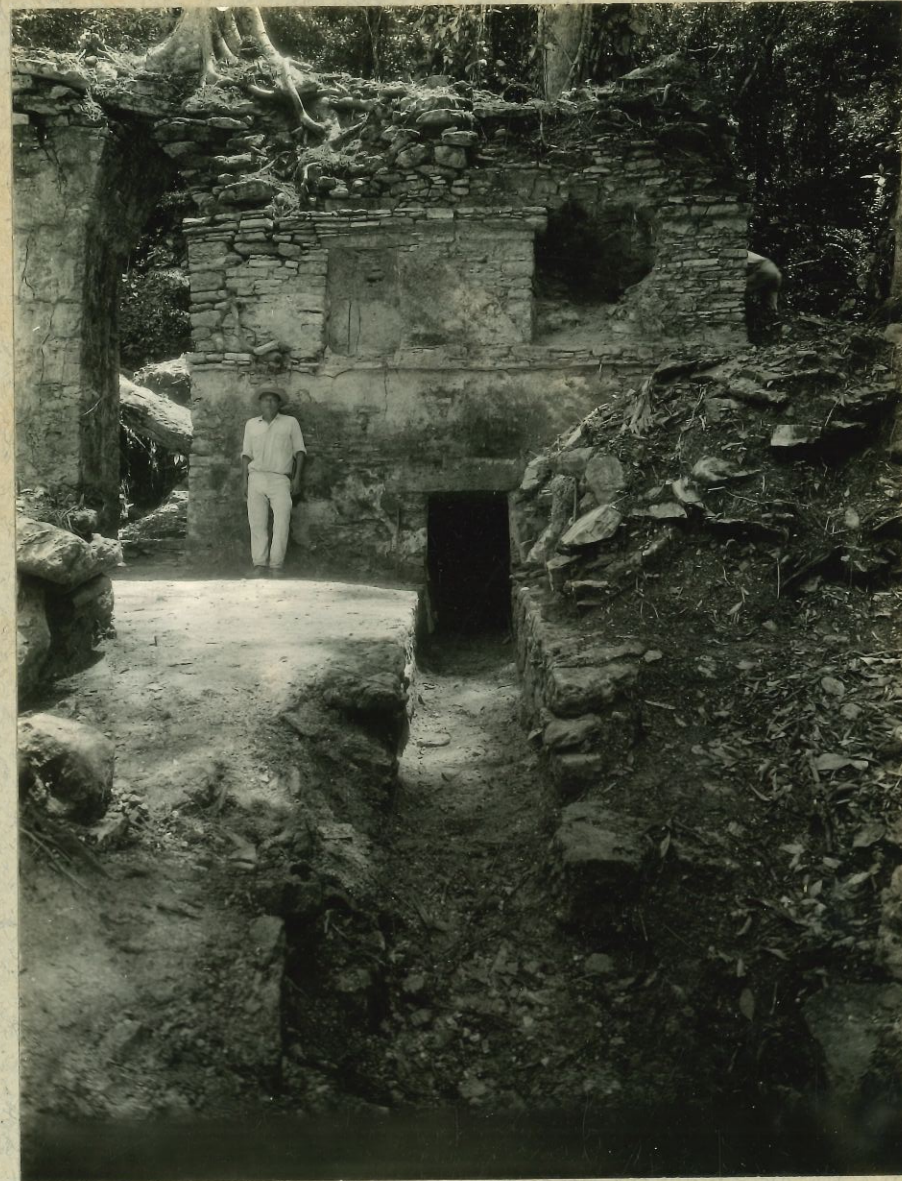
34 - 103

Close-up of Sanctuary, front elevation view, from end of depressed passage. Note heavy stone lintel in place, with plenty of over-lap at the ends. The floor where boy is standing was taken as zero level for all 1934 notes on this building. Note that it seems to slope down to edge of passage, even after allowing for loss of surface there.

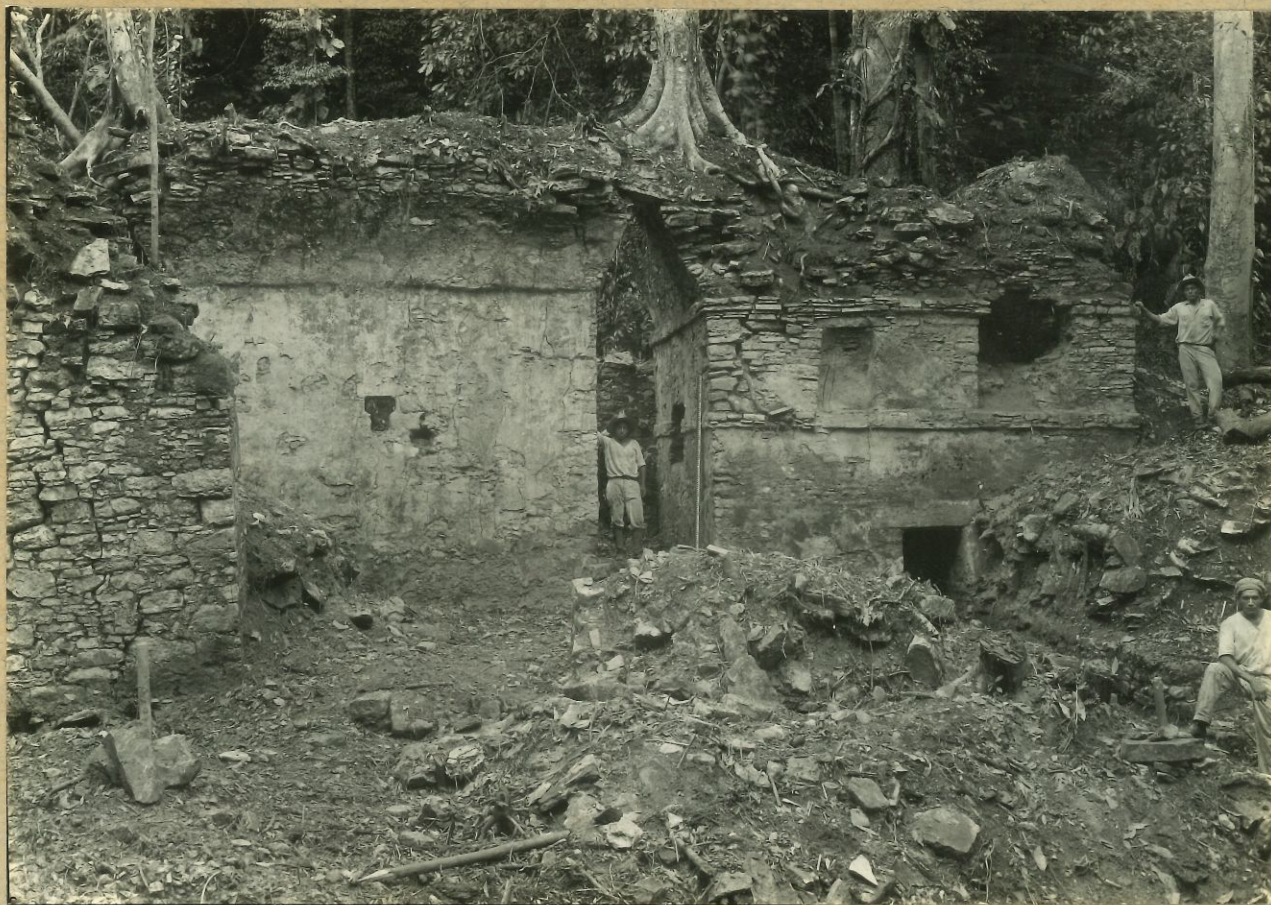
34 - 94

94 P-7 SW General view from tower in front of right doorway, front.  
Foot of boy at lower right indicate boy in front of  
exit of depressed passage to sanctuary.

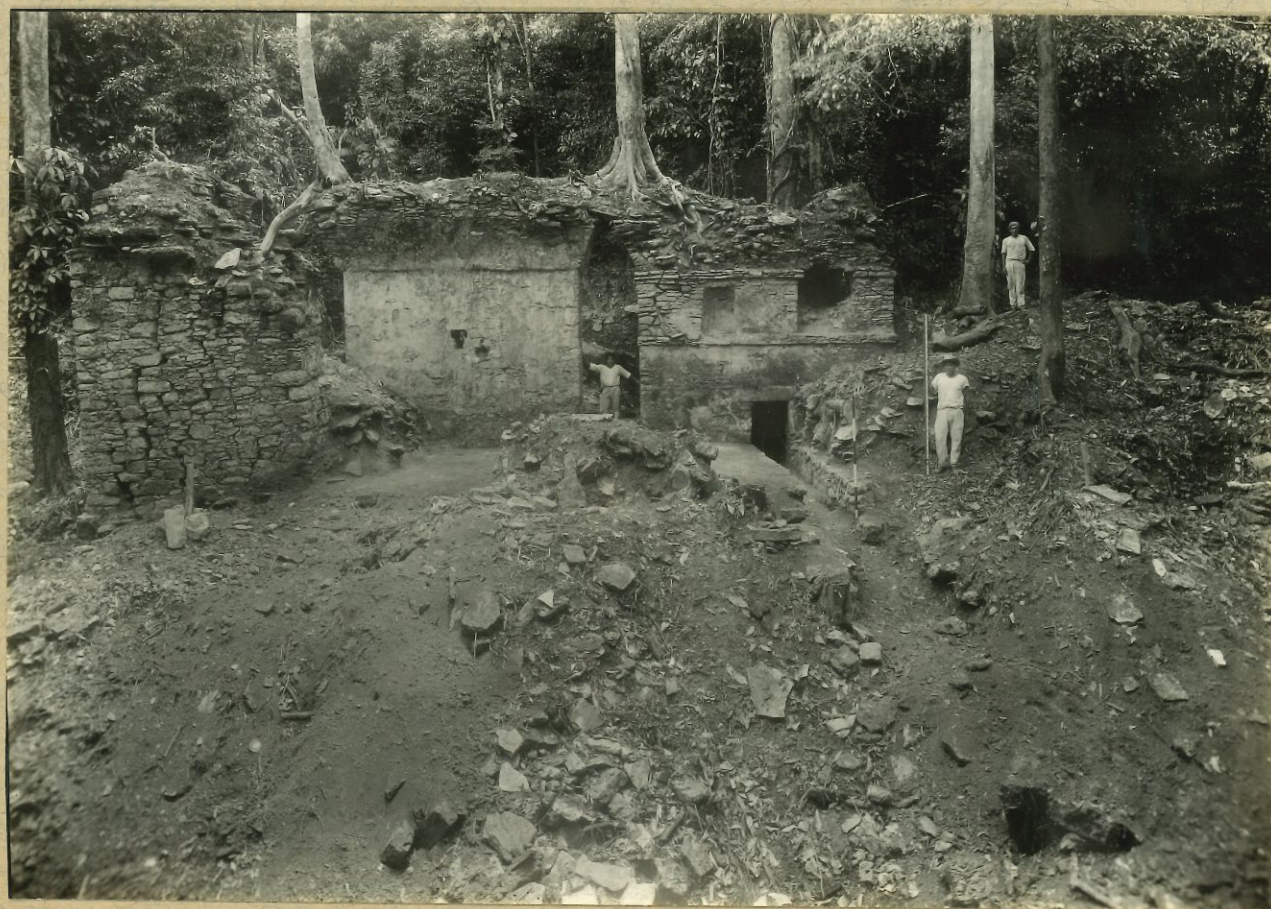
34 - 96

96 P-7 SW General front view from tower in front of right pier. Similar  
to 34-94, but from farther to front, with wide angle lens.  
Debris to left (right in picture) of depressed passage  
is undisturbed, and slopes up from it. Note dark color at  
bottom of right medial wall indicating level of debris  
before removal. Debris at right (left in picture) is undisturbed  
except that a little has been thrown on it  
from excavated area. Here it slopes up to end wall.

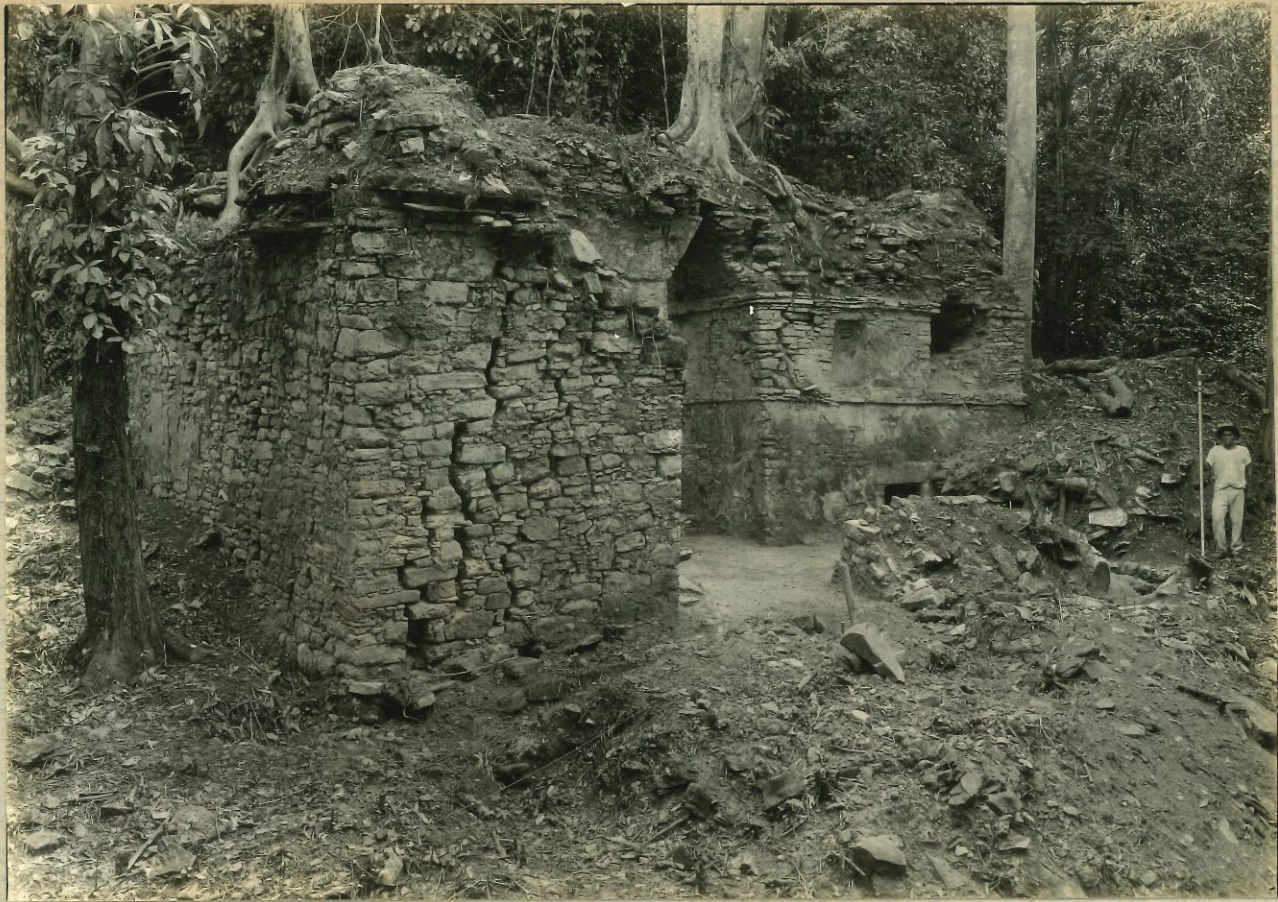
34 - 97

97 P-7 W General view from outside right (W) corner.

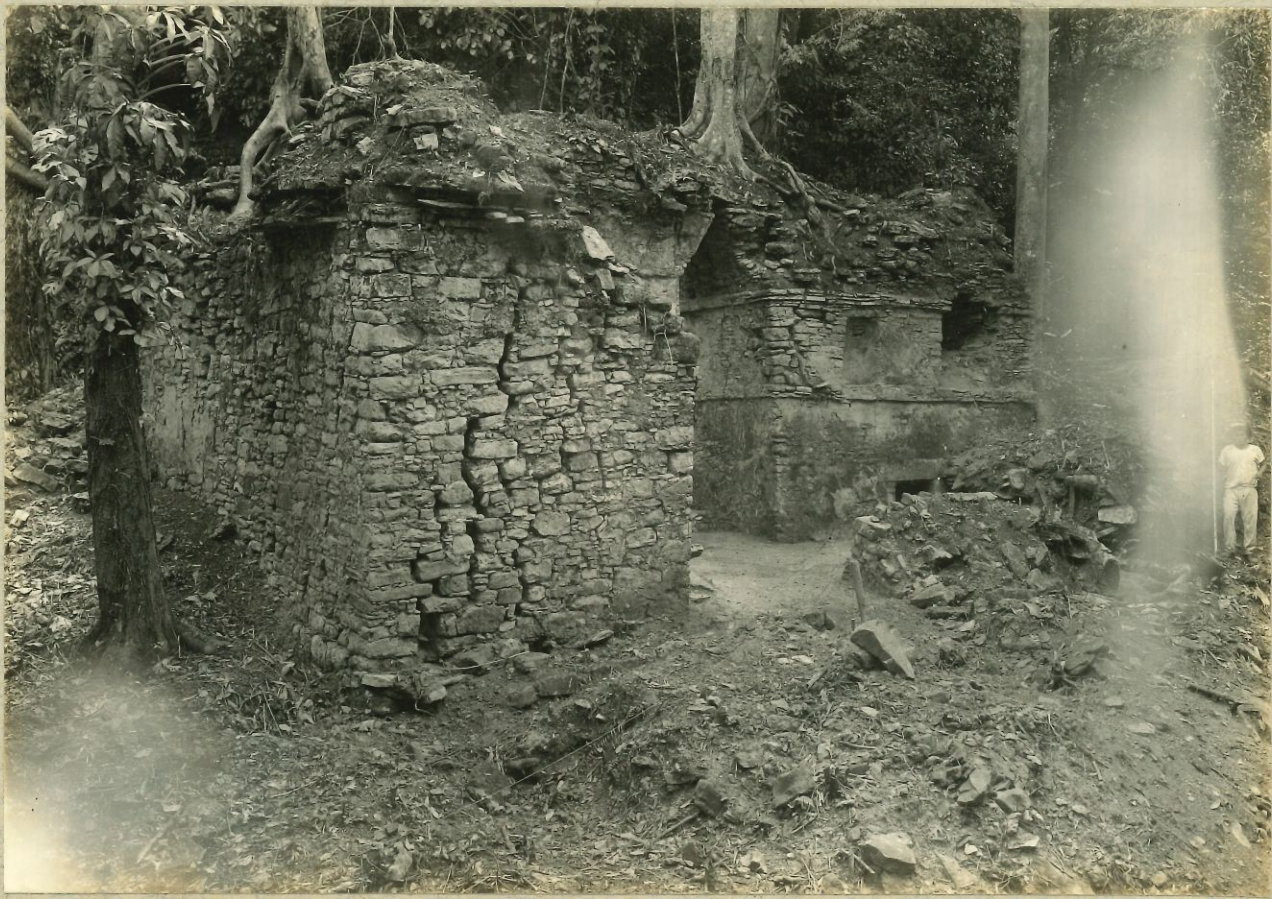
34 - 98

98 P-7 W View similar to 34-97 (light-struck at right).

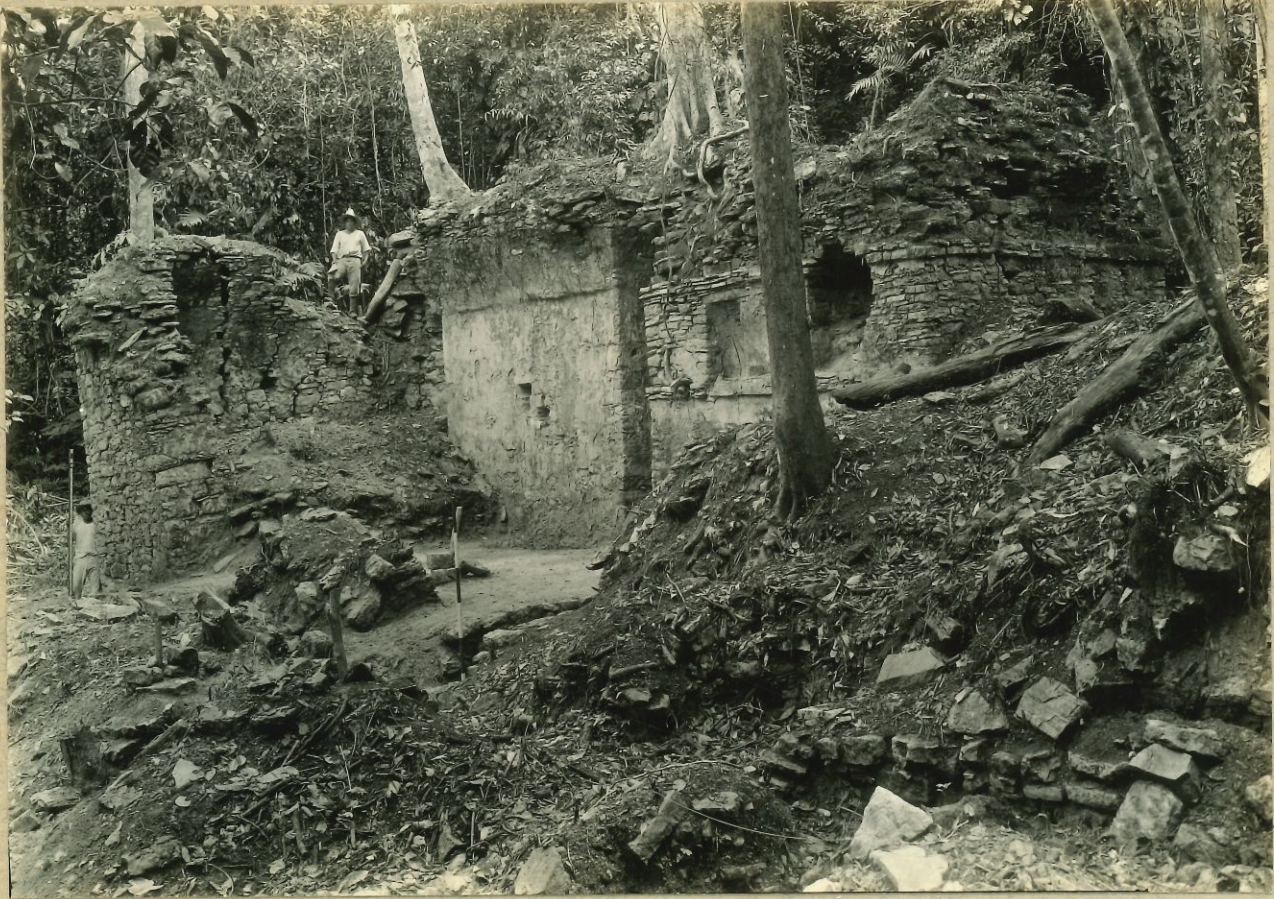
34-99

99 P-7 W General view from left front, close to left (S) corner. Range-pole marks depressed passage; boy with leveling rod is at outside right (W) corner (well below zero level).

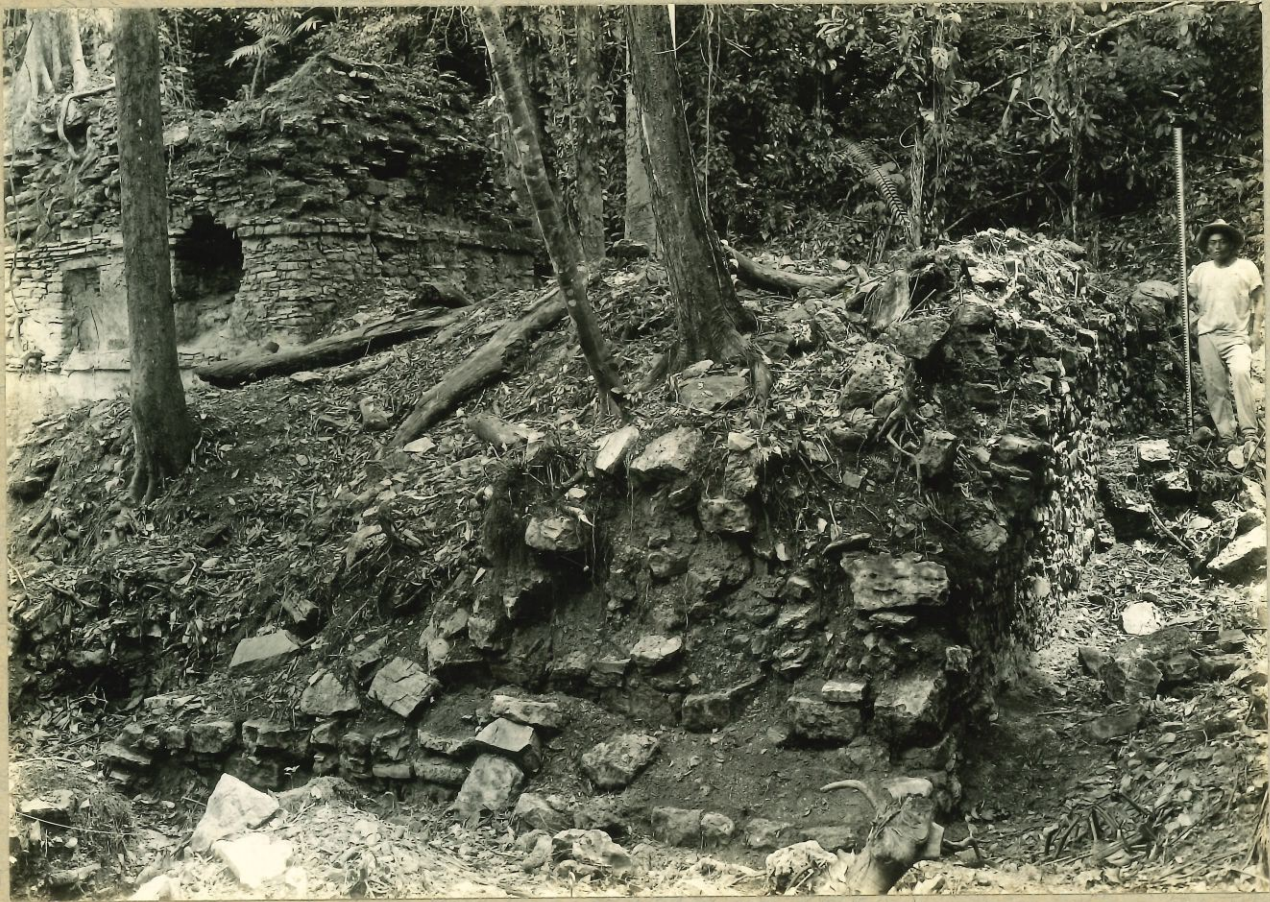
34-100

100 P-7 S Left front corner and left end wall from same point on tower as 34-99; the two pictures can be tied together by noting trees and fallen stones common to both. The left end wall is at right; note ruined front facade, plinth; boy with rod stands on debris about 1.00 m deep - there is no big deposit of debris here and it looks like all wall stone - conclusion, the end vaulting fell in and not out, as at the right end it will eventually do.

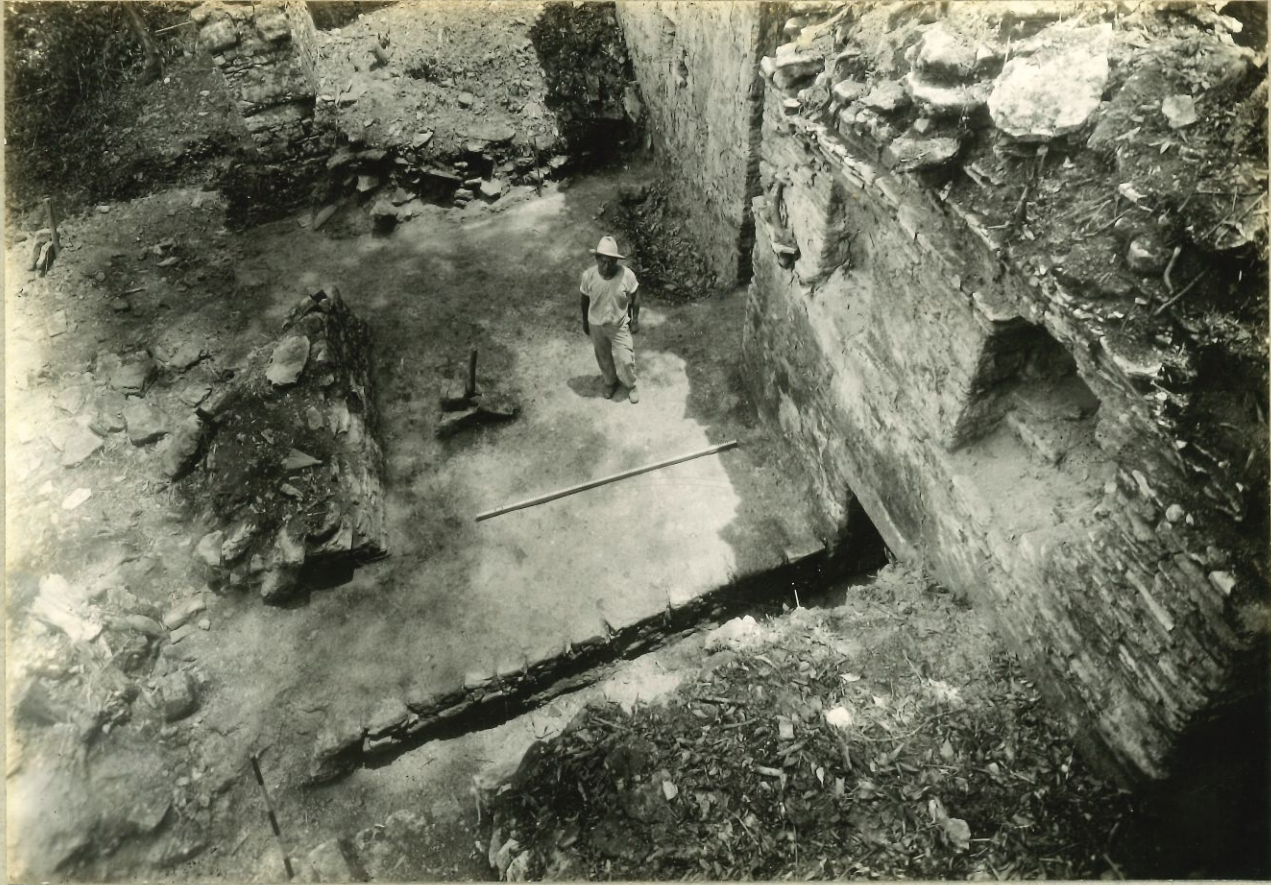
34-101

101 P-7 SE General view of right (NWly) half of front chamber, looking down on same from tower on debris over left end (camera about 4.00 m left of depressed passage, which see in foreground; Note debris left in right end, with meter stick vertical against cut section through it. Its shadow crosses large fragment of smooth surfaced river-pebble concrete believed to come from roof. There is considerable distortion in this fairly close picture made with wide-angle lens.

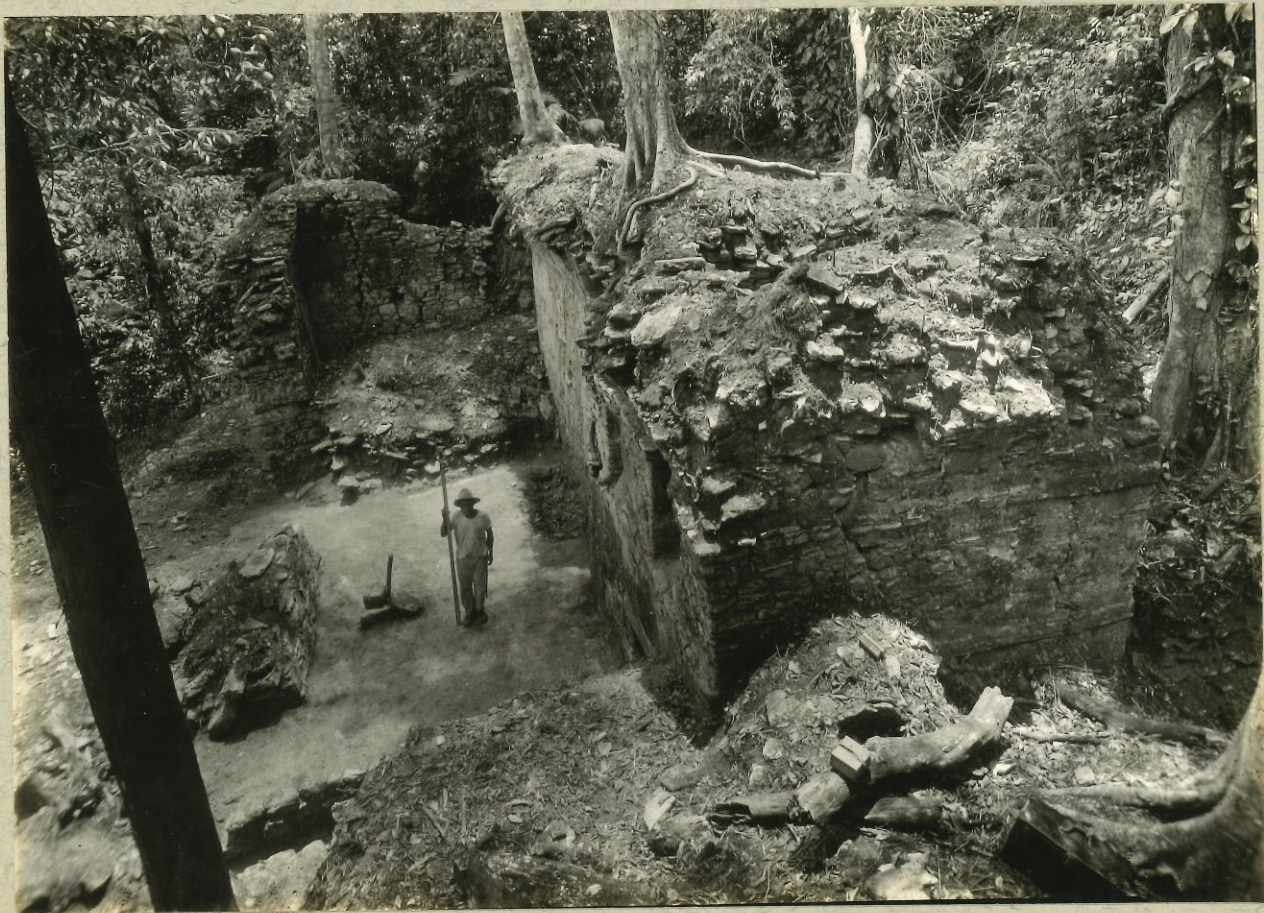
34-102

102 P-7 SE General view similar to 34-101, but from farther away, showing roof and left end wall of central sanctuary.

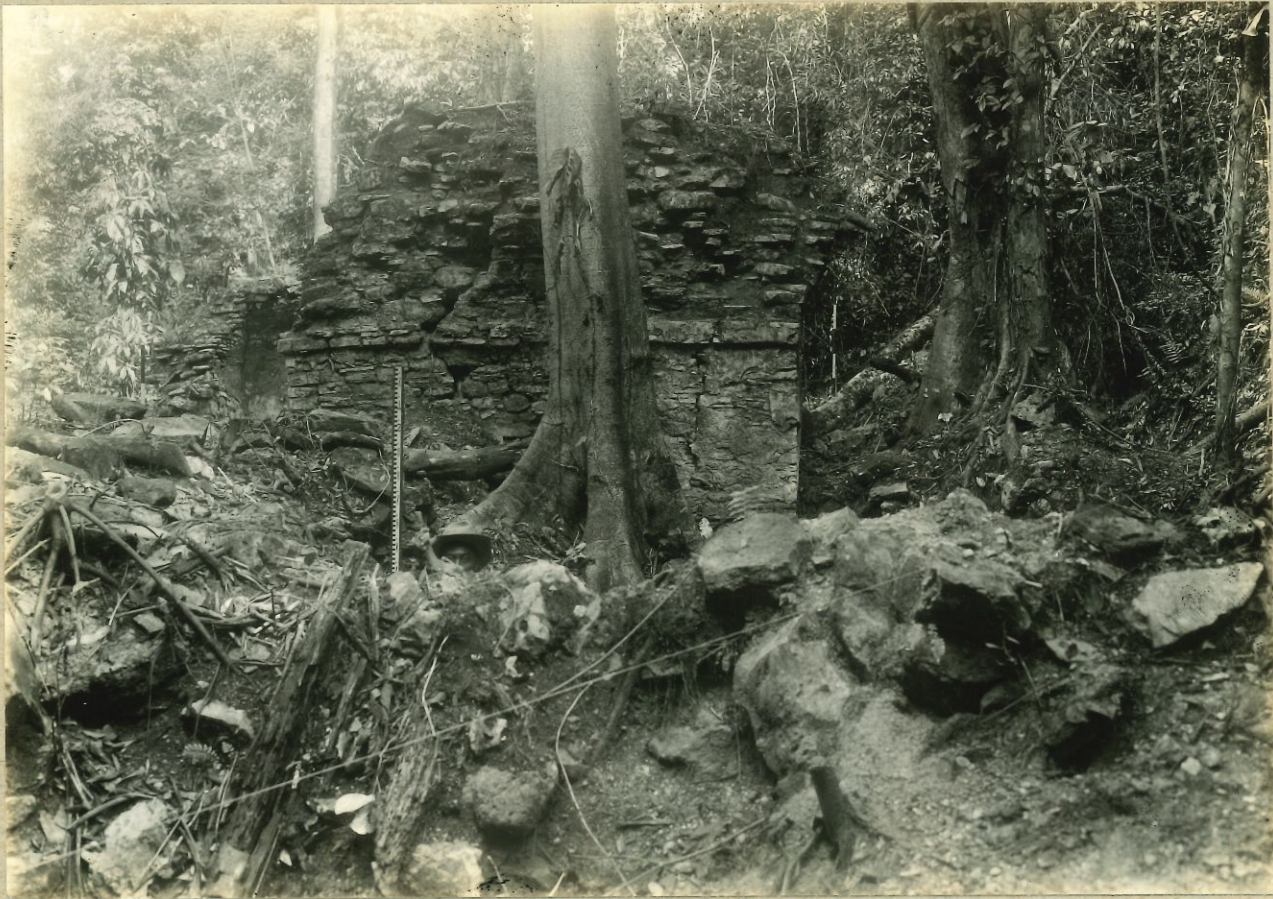
34 - 104

104 P-7 SE Left elevation (SEly side or end) of Sanctuary, in background; immediate foreground, left (SEly) end of mound. Camera about 1.00 outside left end wall, to the rear. The rod rests on approximate ~~XXXX~~ level of upper floor in left rear chamber and is closed (i.e. about 2.28 m in length). It is close to the left (SEly) end of the masonry bench or altar of the left rear room.

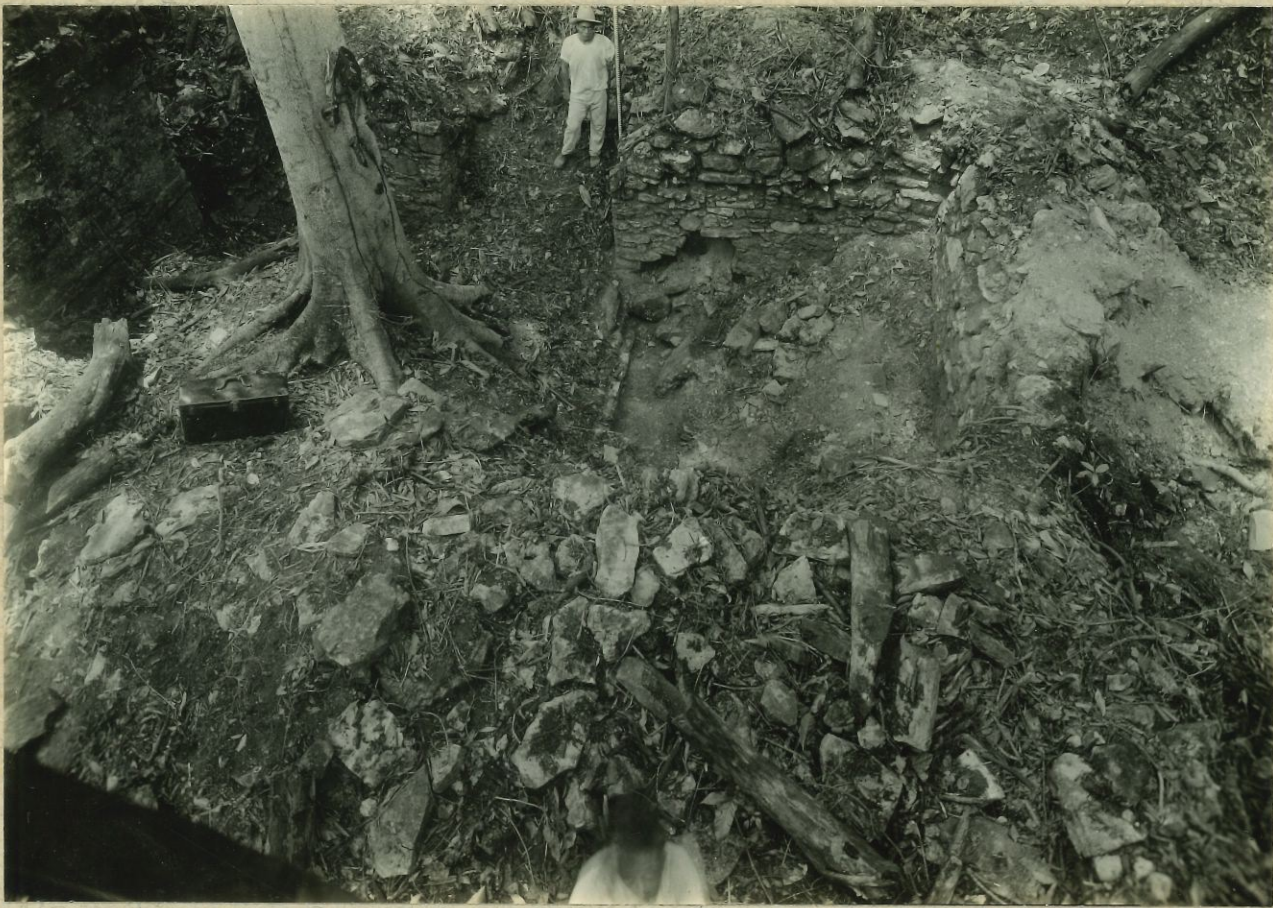
34 - 109

109 P-7 SW Left rear room from tower on debris in left front room. Upper left - sanctuary; boy stands in rear doorway, with rod at outer jamb; note sill or "drain" running from a point a little to right (in picture) of this doorway toward front. It is below floor level there; upper right, inside of left rear corner of room.

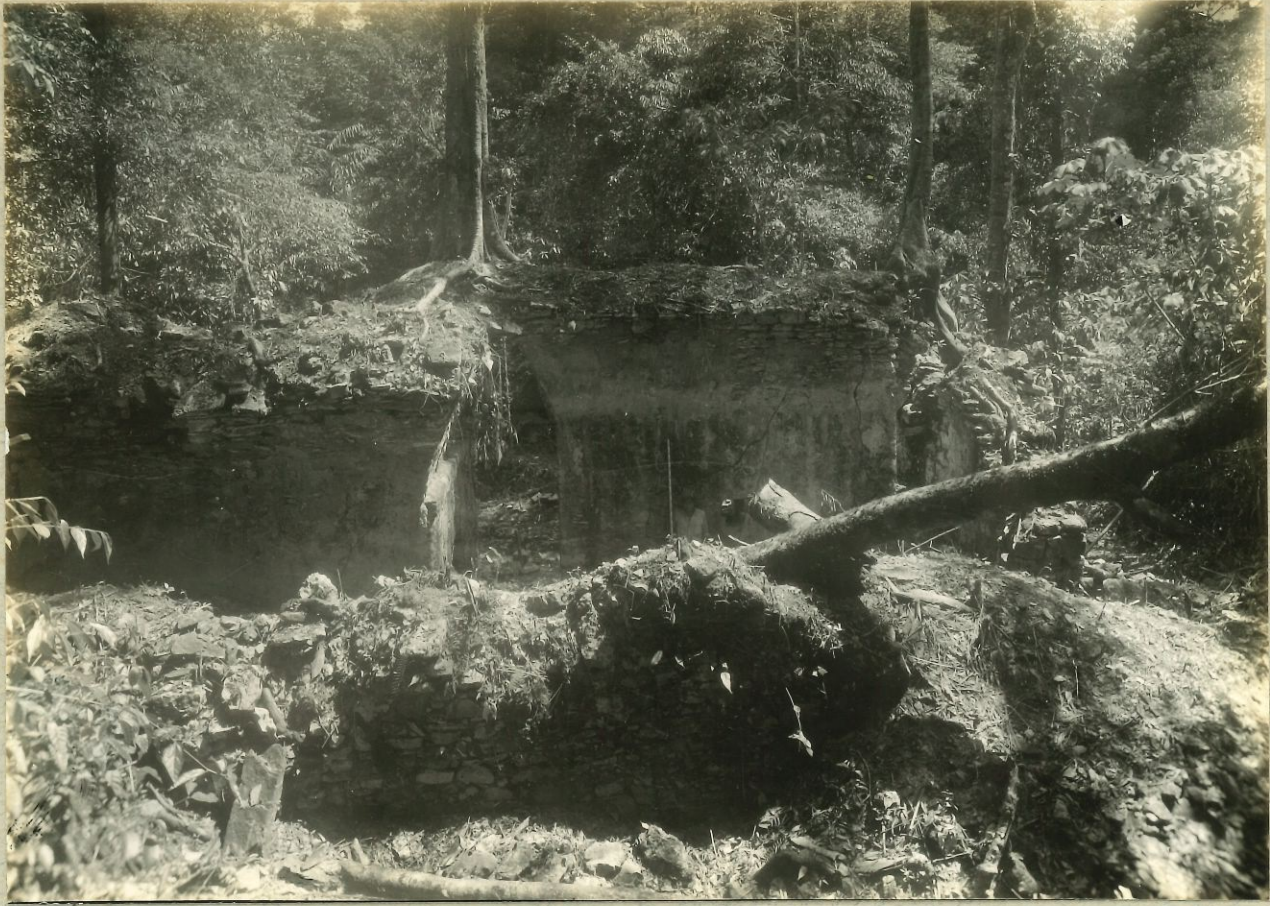
34 - 105

105 P-7 NE General view of right rear room, rear passage to left; in foreground outside of rear wall. From the terrace at the rear. Boy with rod stands on ruined (S<sup>ly</sup>) part of bench altar, the bottom of rod about .35 m above rear floor level. Note the level ruined surface of the balance medial vaulting - the irregular surface of the vaulting on Sanctuary at left. See 34-106 for a better negative of the same view.

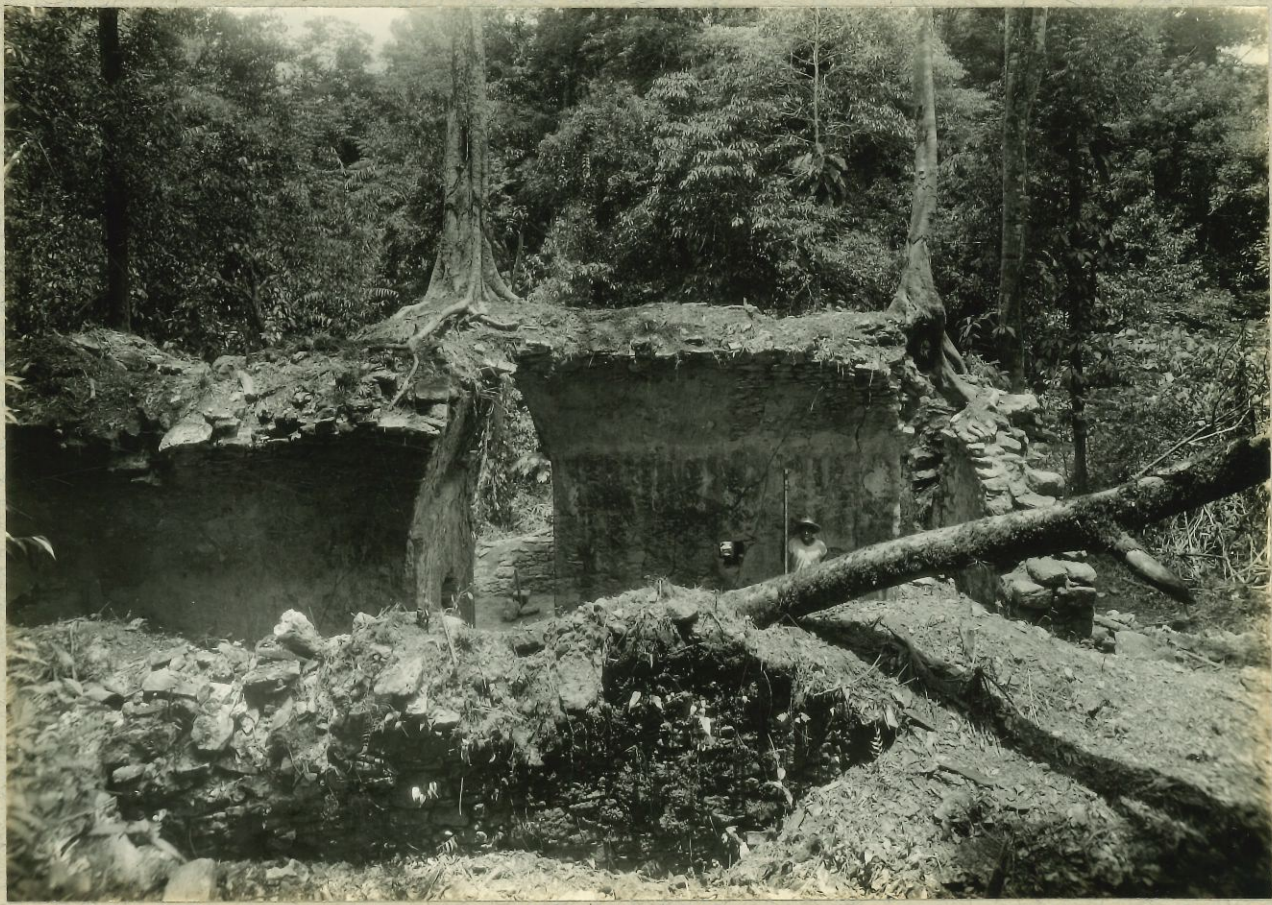
34 - 106

106 P-7 NE Same view as 34-105, which see for notes. This is the better negative.

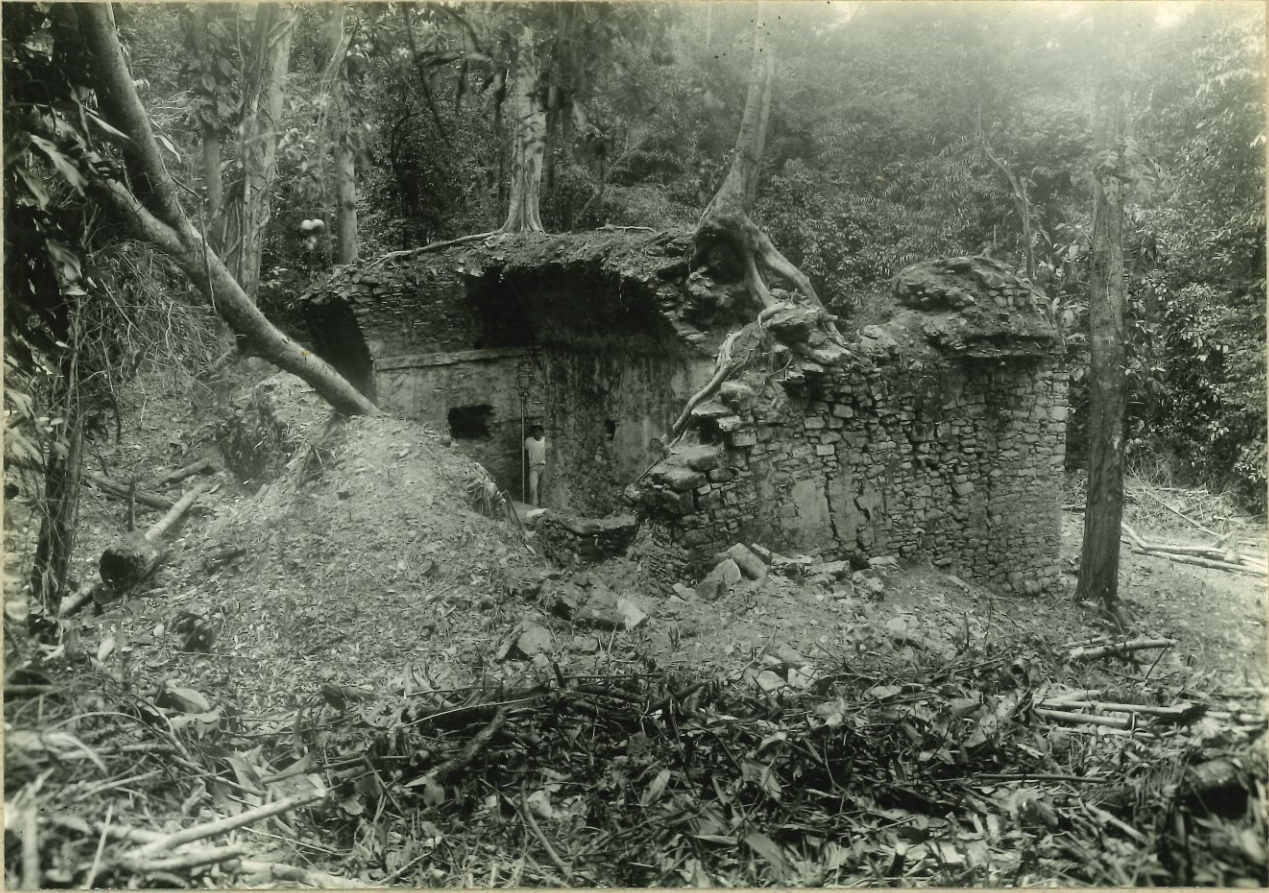
34 - 107

107 P-7 N General view from outside right rear corner, from the terrace or debris mound there; at front, note two-member apron cornice and part of vertical upper zone still in place; masonry of end wall; at left, the plain back of sanctuary (no offset, no bands).

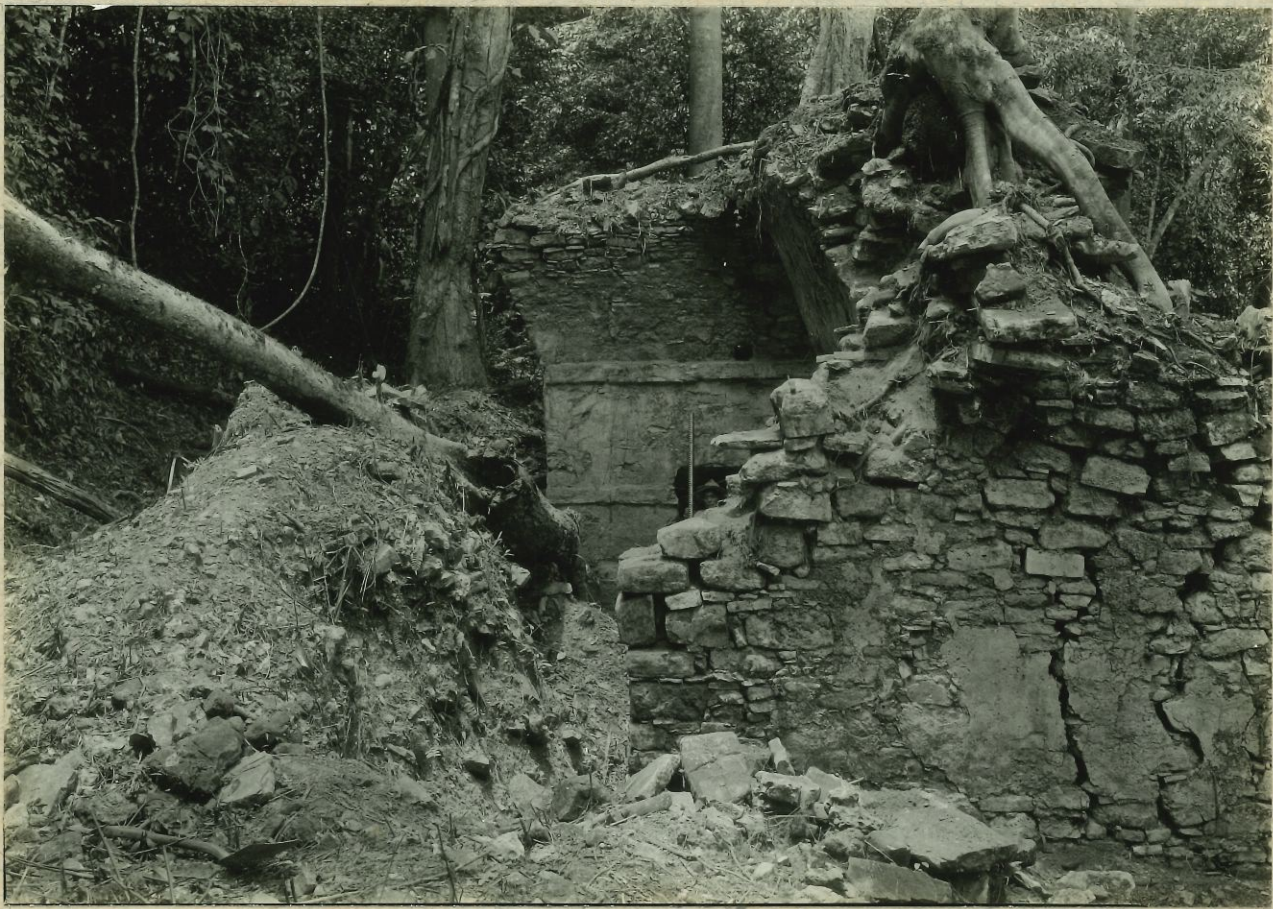
34 - 108

108 P-7 NW General view from outside right (SEly) end, at rear. Shows close-up of end wall masonry; slab construction of medial wall vaulting (in section); elevation view of rear part of right side of Sanctuary. Boy stands with rod on rear room floor. Note use of blocks near top of vaulting on sanctuary; opening of drain from otherwise closed chamber at top; remains of plaster on end wall; jamb of doorway in this wall.

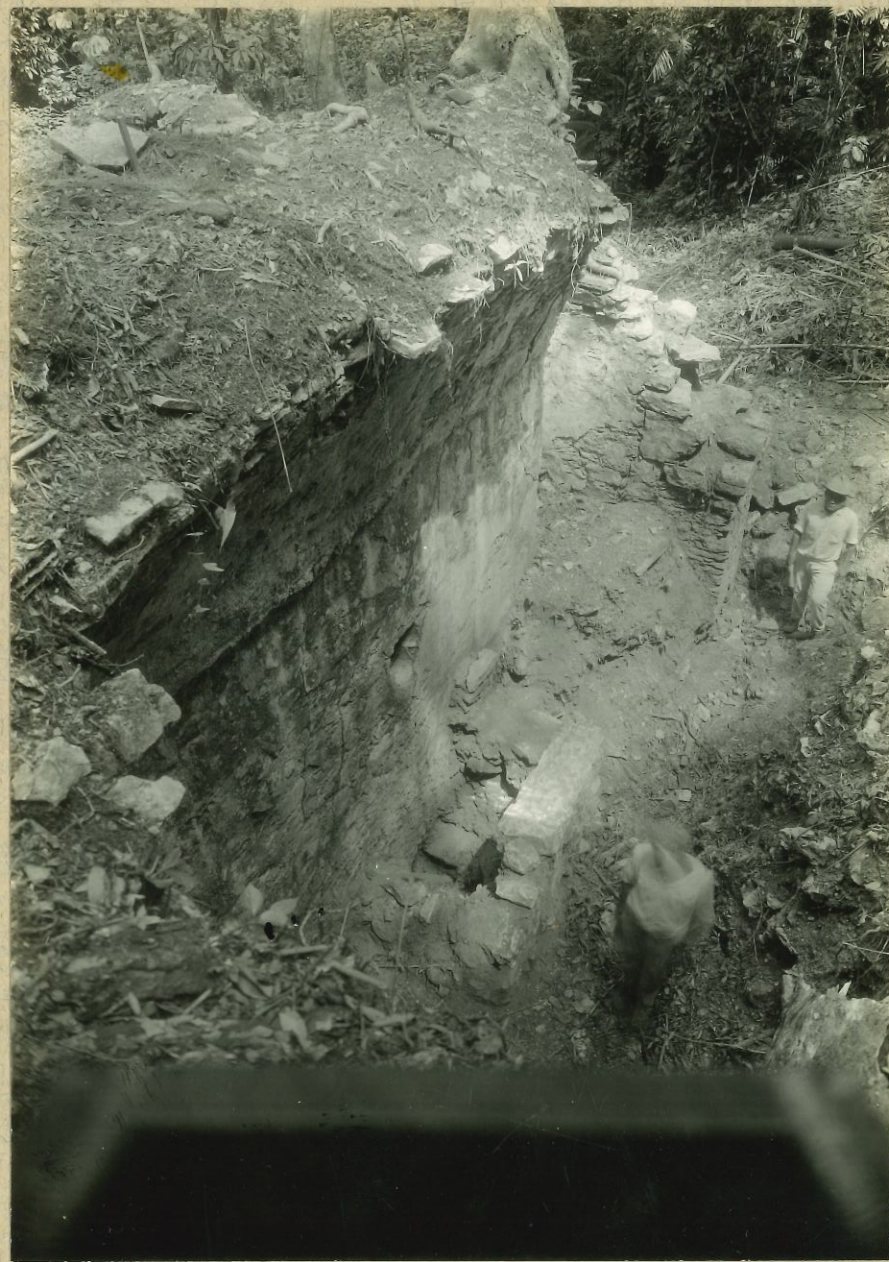
34-110

110 P-7 SE Right rear room from Sanctuary roof. Note altar, with remnant of a masonry back or screen; doorway in right end wall; surface of medial vaulting - the ruller rests on river-pebble mortar found under the small slab next it, which was more or less loose.

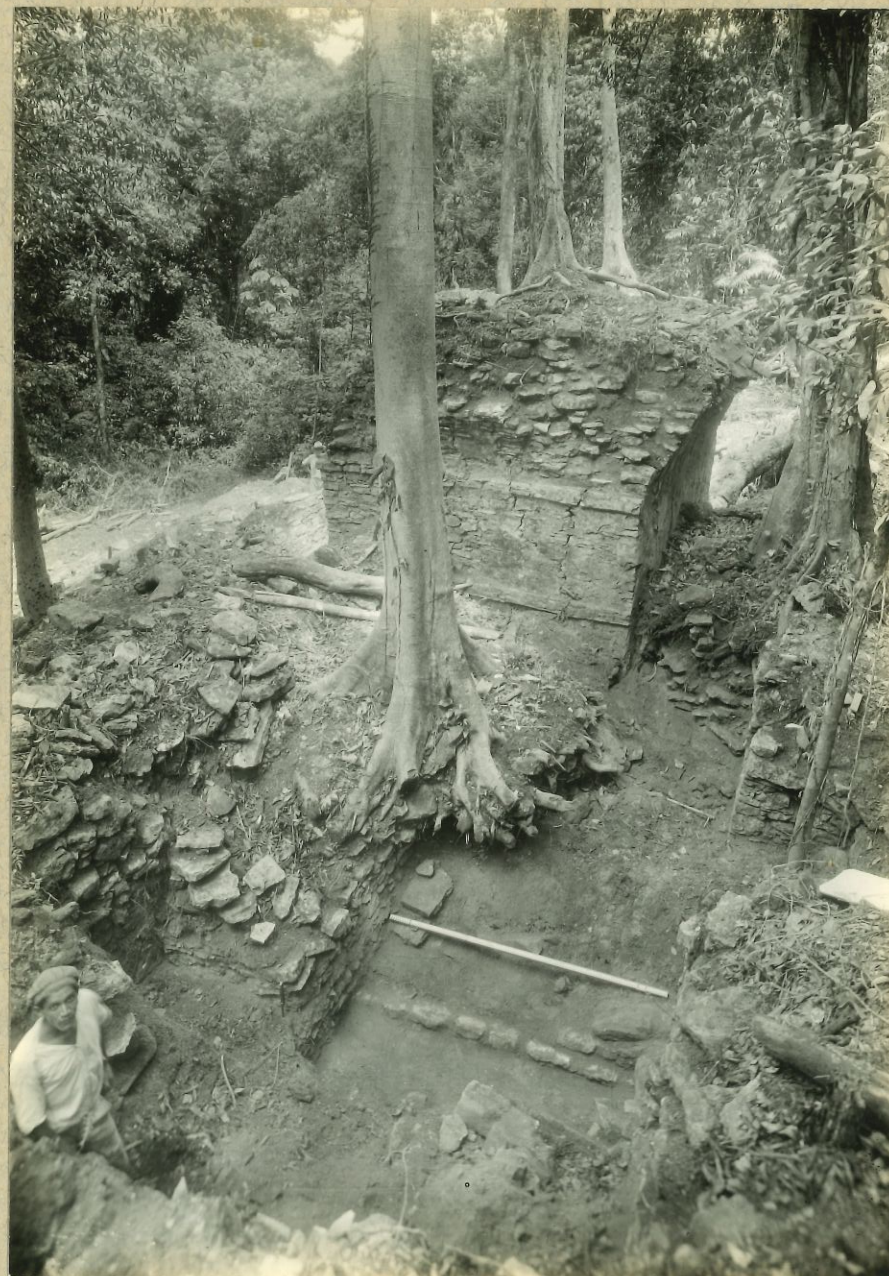
34-111

111 P-7 E Left rear room and Sanctuary from tower 3.00 m. outside left rear corner. In background, just left of sanctuary, boy stands in right front doorway of front chamber, behind section of wall which serves as a pier; Just beyond boy in lower left note exposed portion of medial wall, and the SEly end of bench-altar abutting it. The meter stick, doubled to 42 cms., rests on latest floor level, near the corner of this altar. Below this note that a rough wall, in same plain as front of altar, extends beyond altar toward lower left of picture, and overrides the sill or supposed "drain" in front of leveling rod. The latter lies horizontally at about the latest floor level. Note that at the right (in picture) the drain or flue seems to consist of two steps. Then large stone above these is fallen from above. Note slab vaulting on sanctuary - no bands or offset at rear (Cp. 54-107). Sizable slabs in the cut section of debris at near end of rear passage; NWly jamb of rear doorway.
