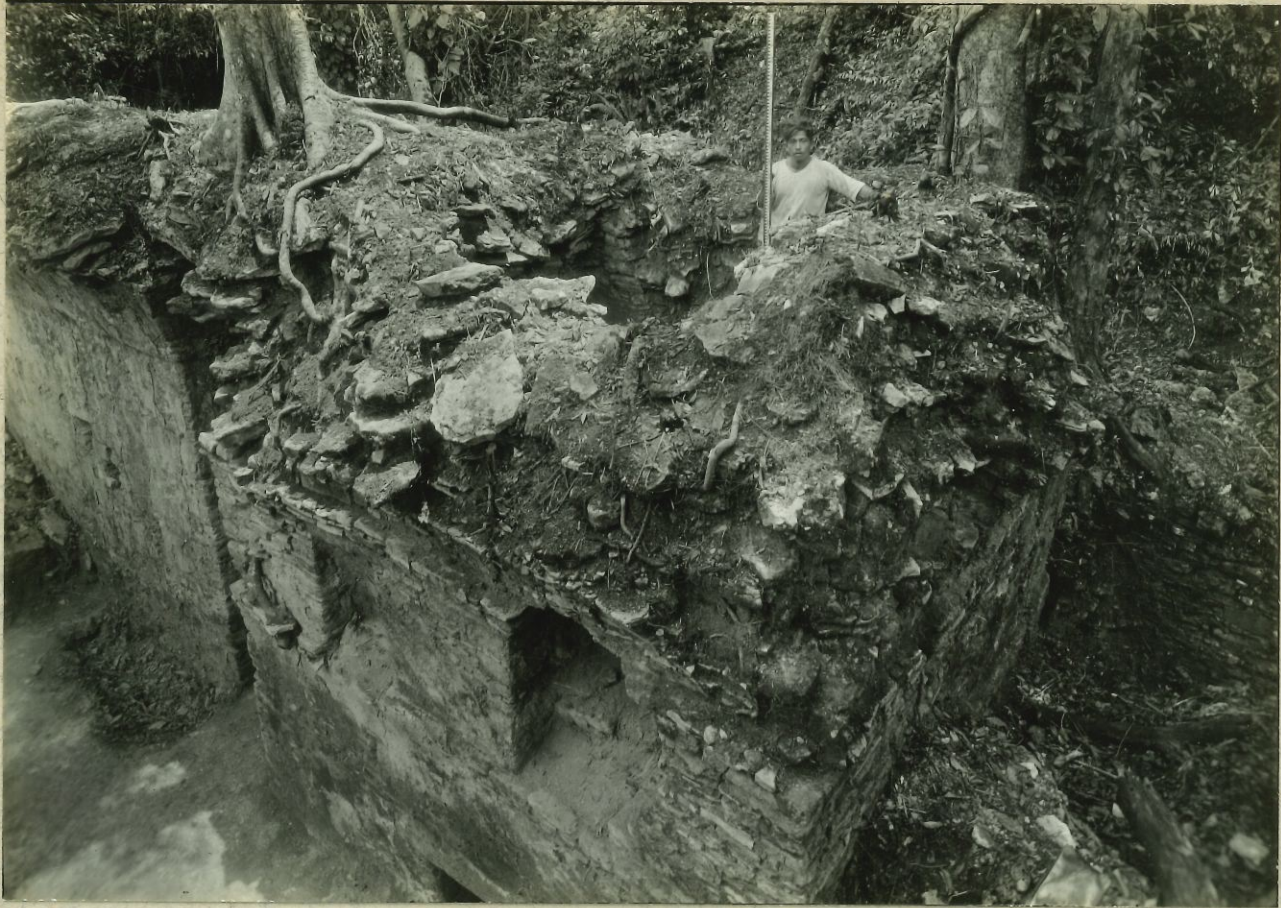
34-113

113 P-7 S Roof of Sanctuary from above and outside left front corner; Boy holds rod resting on debris a few cms. above floor of closed upper chamber, in which he stands. Shows ruined slab construction of vaulting; looks down into sanctuary niches.

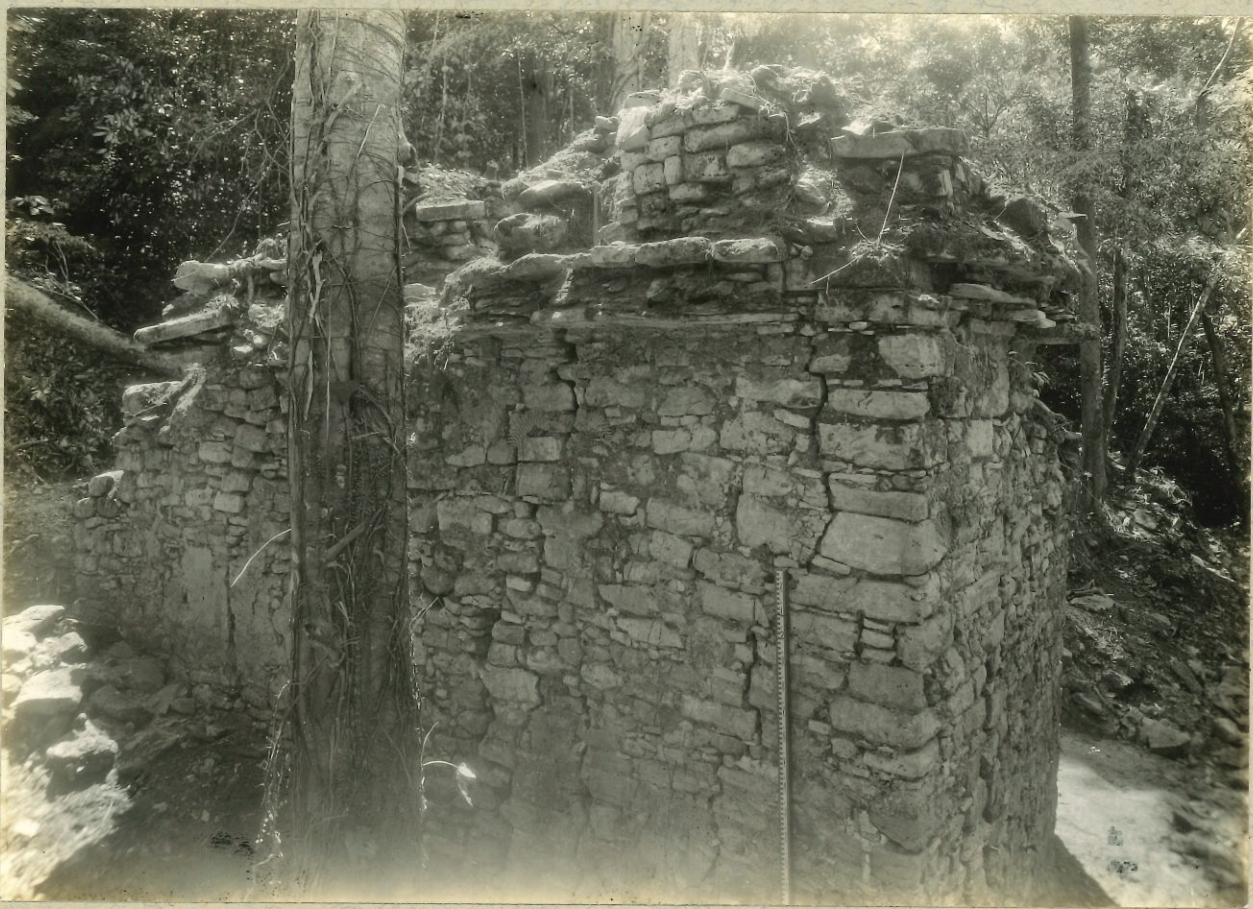
34-114.

114 P-7 W Outer right front corner, close-up from tower, camera just below cornice level. Note two-member apron cornice, the slabs of the upper member more consistently heavy than the lowest course of the apron; the set-back vertical upper zone; that the upper zone still turns the corner, though little is left at the front.

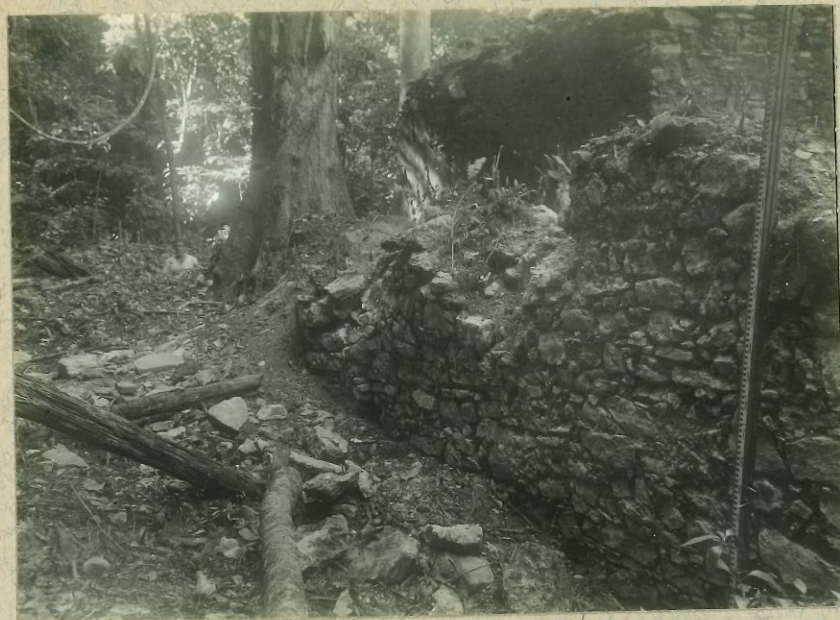
34-112

112 P-7 NW Standing portion of rear wall from outside (this is the rear wall of right rear chamber). Rod at point 75 (on sketch sheets), meter stick at NWly jamb of NWly doorway in rear wall. Rod rests on point 75 level. In distance at left, boy stands in SEly doorway leading from rear to left rear room.

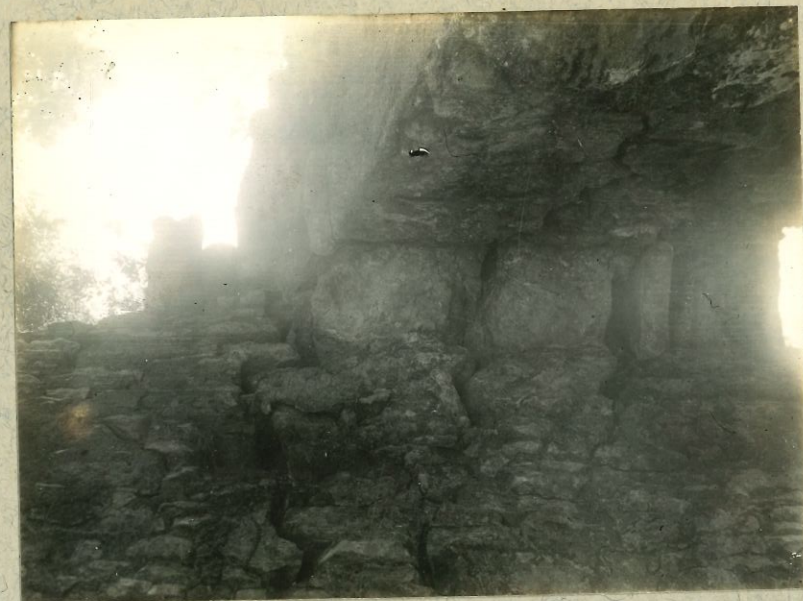
34-117

117 P-7 Looking straight up at cap-stones of vaulted doorway between front and right rear chambers. Rear chamber is at end of picture with most sky (left). Note here the overhanging slab; slab on edge instead of flat like the others next to the last remaining one at front. See drawings to understand this picture - it is clear that slabs overhung the vaulting of both sanctuary and medial wall. But roof beams were certainly not below this level - could have been at about same or above this level.

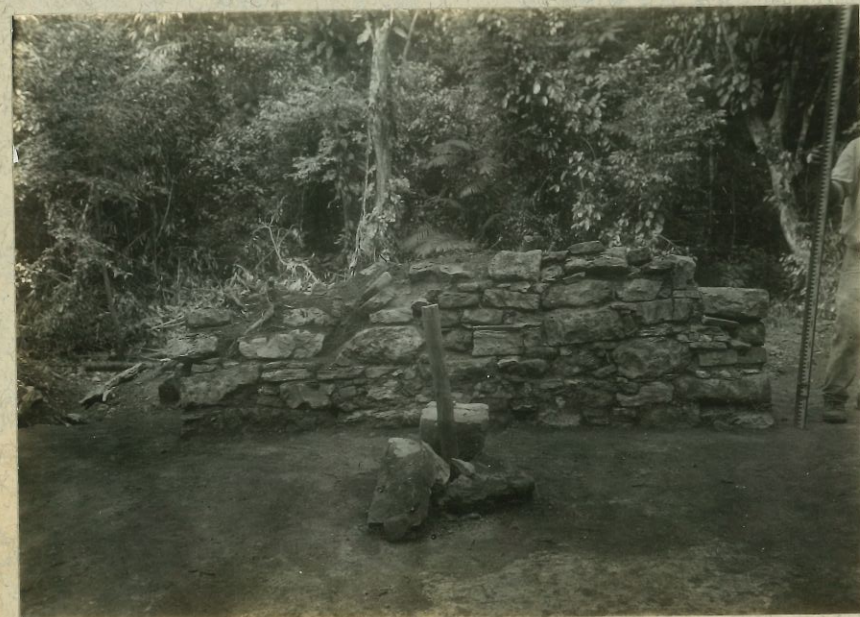
34-118

118 P-7 NE Inside of section of wall forming right "pier" of front chamber. Note that stumps indicated present top of this pier was original surface before excavation - they are good hard growth. Meter stick on wall at 22 cms.

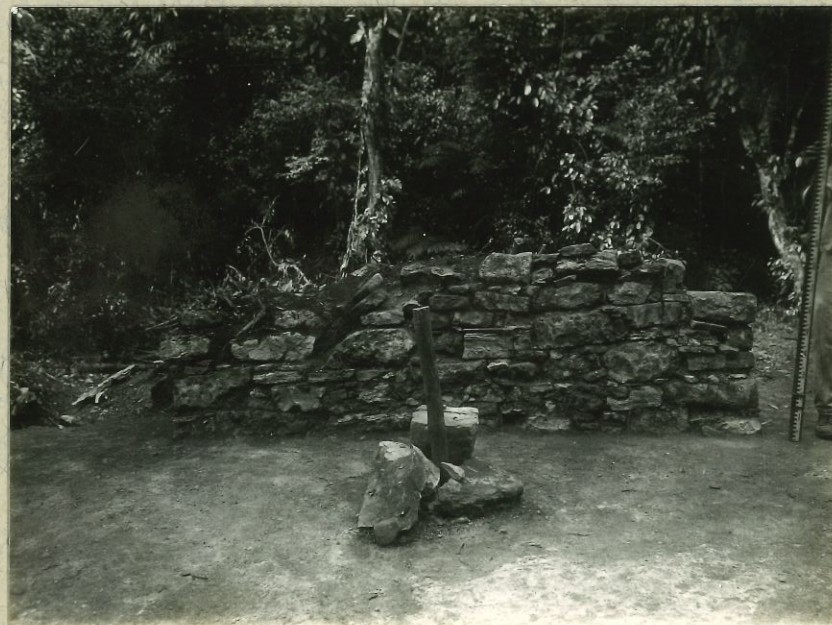
34-119

119 P-7 Same view, another negative.

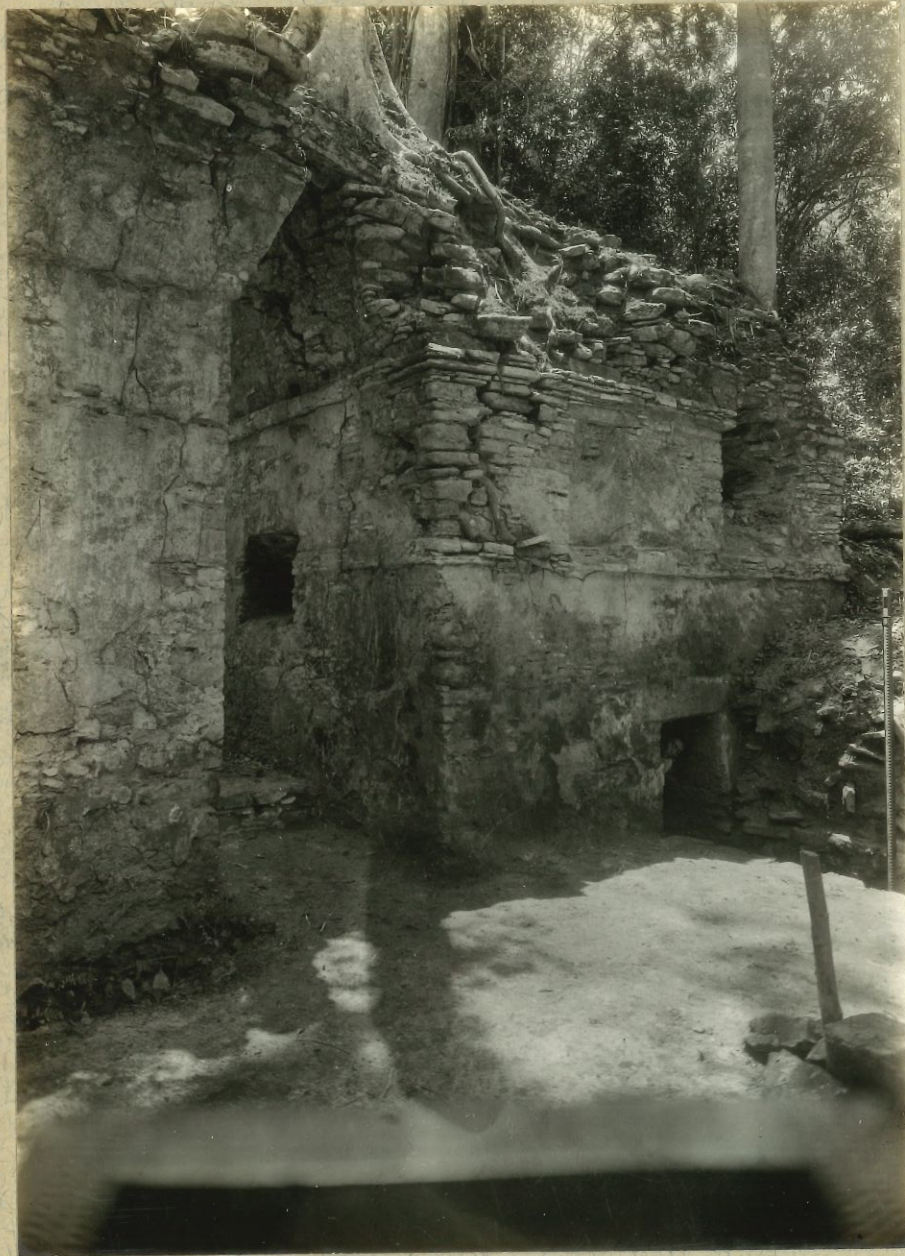
34-116

116 P-7 W Sanctuary from right front doorway of front chamber. Rod is on ~~XXXX~~ depressed passage floor and passes in front of fallen (roof?) ~~XXXX~~ concrete of river pebbles, with smooth surface, with vault slabs above (surely from the sanctuary vaulting (~~XXXXXX~~) the front half of which has fallen.

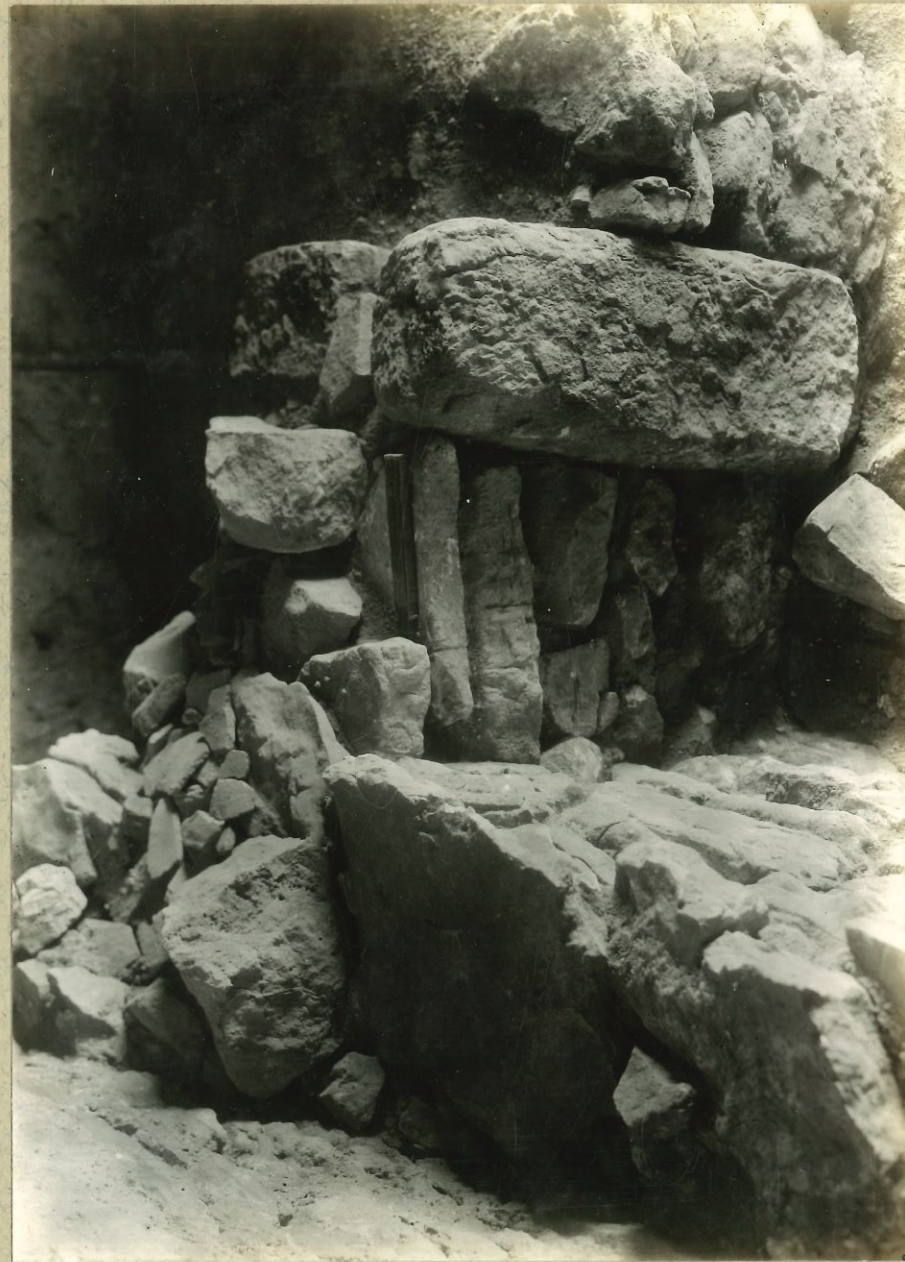
34-120

120 P-7 NW Sanctuary Altar, seen from hole in left wall made by predecessors of Maler. This view shows the inside of the altar. Note that top slab at rear has left the rear wall (wall falling forward; monolithic jamb (the right jamb is fallen, which makes this view possible). This is after excavation in 1931.
