G 3010

Serdab.

Is debris filled, rubble with stepped facing. Original offering room had included the latter ~~had included the last~~ ~~last~~ shaft B., the division wall of which blocked up the niche. This division wall rested on rough rubble filling in building the northern end of the offering room. The south end of 3012 was used as one jamb of the door. The mortar used is pink. This mastaba is built against the mud brick mastaba 3021.

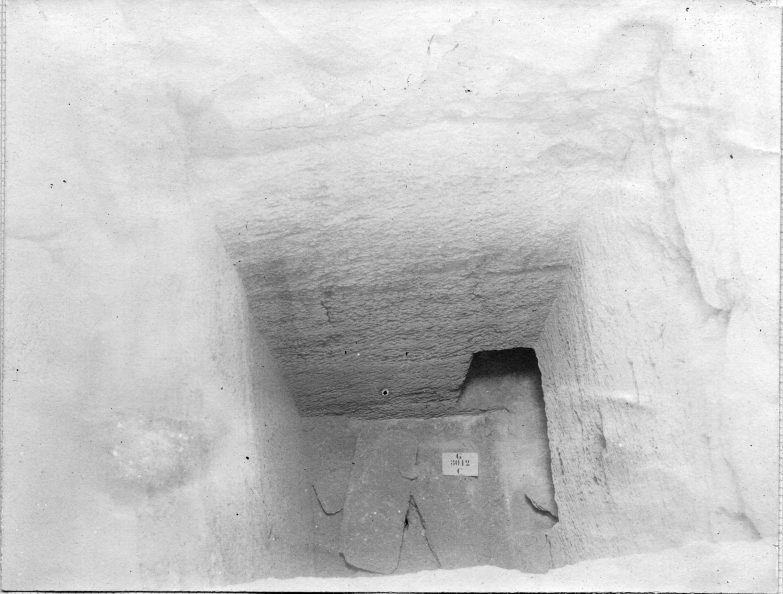
G
3012
C

A black and white photograph of an archaeological site. In the center-left, there is a pile of skeletal remains, including a large, rounded skull and several long, thin bones. To the right of the pile is a small, rectangular label with the text "G 3012 C" printed on it. The background is a rough, textured surface, possibly a rock wall or a dirt floor.
