J-3

PIEDRAS NEGRAS  
STRUCTURE J-3  
MAY 1931

Memo re J-4 (Piedras Negras)

Stn. XII  
Burial # 5  
Plans, Sections &c.

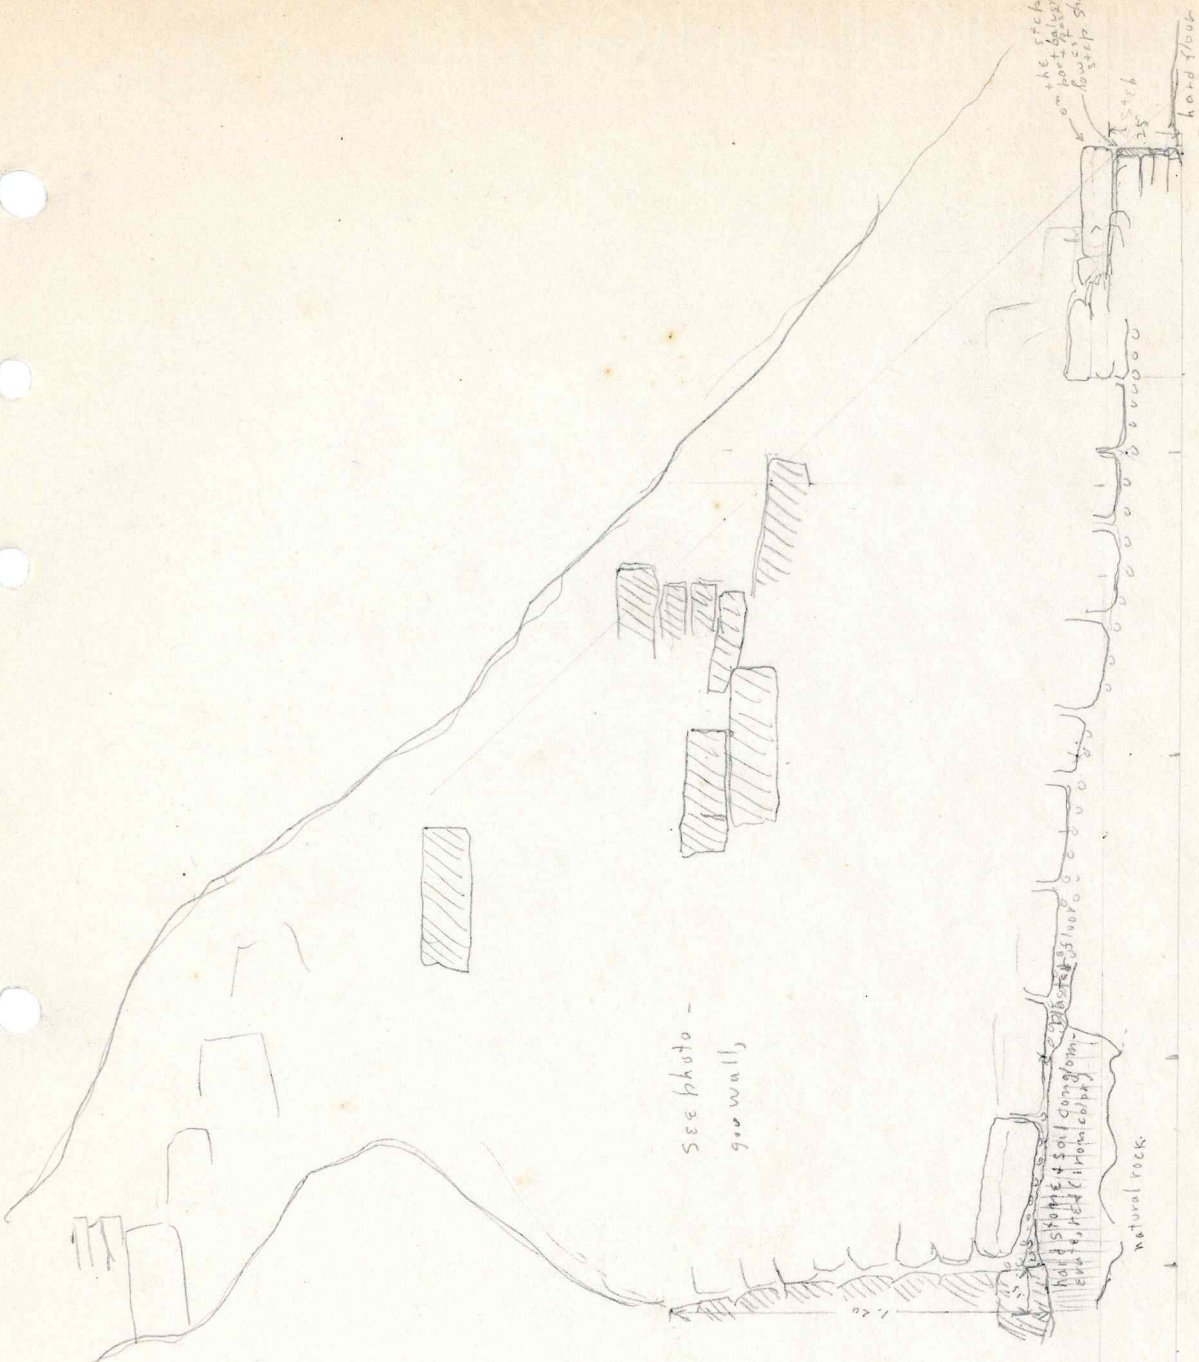
5/12/31 Ste 19 main Terrace  
"W" side of main stairway  
; 04 = 1.70'

SEE photo -  
geo walls

The steps are  
probably 25 x 25  
- measurements  
vary -  
• wall leans in .28 in 2.00

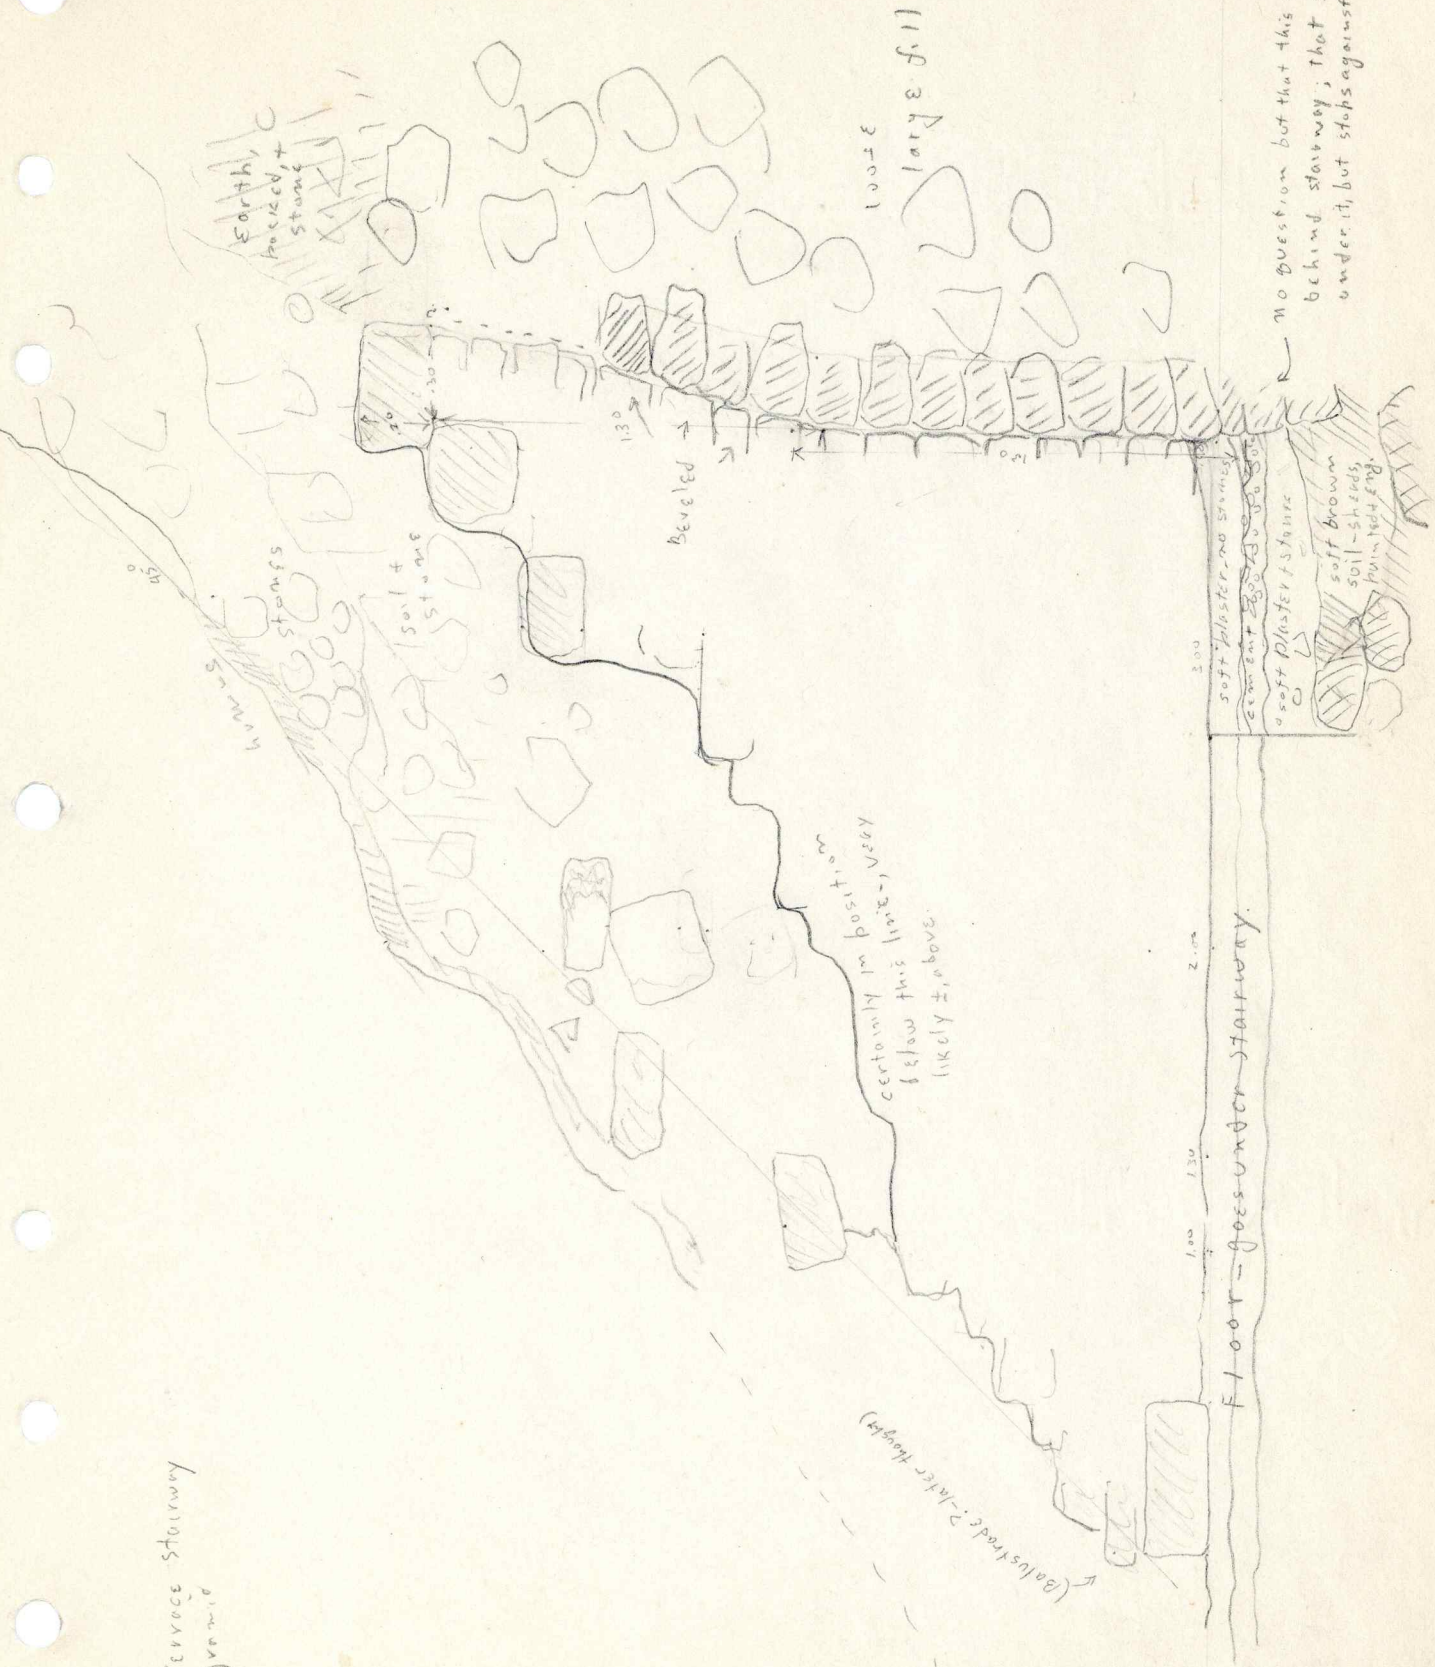
"E" end of Terrace Stairway

No question but that this wall runs behind stairway; that floor runs under it, but steps against this wall

certainly in position below this here, very likely ± above.

Floor - goes under stairway.

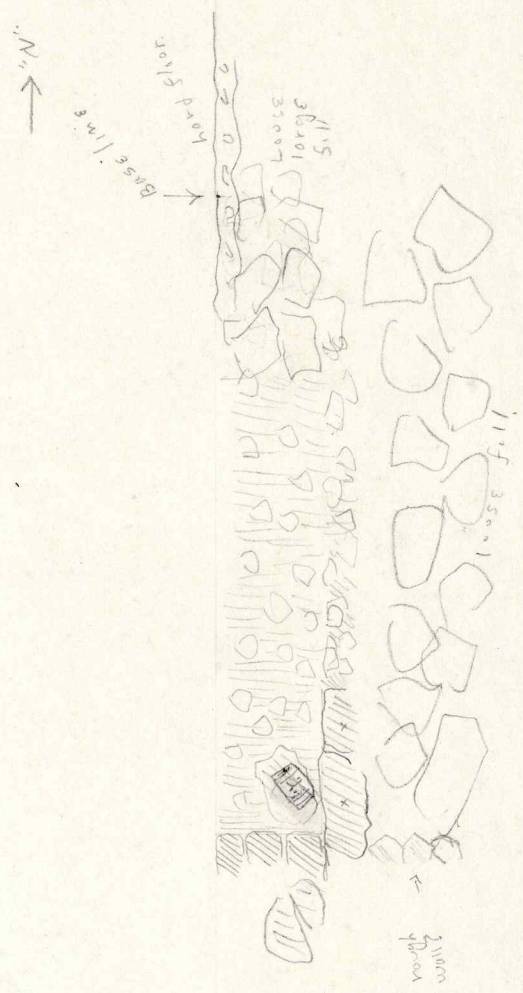
5/9/31 - Stela # Cist.  
 Section through center.  
 .01" = 1.7m

x-clear across front - a roughly paved floor or "step".  
 Ya cylindrical stone 23 x 21, 20 x 19, 6 x 13 - definitely conoidal - the large  
 stones were of sides + in front of it  
 The front wall very doubtful - stela left a big surface break in falling.

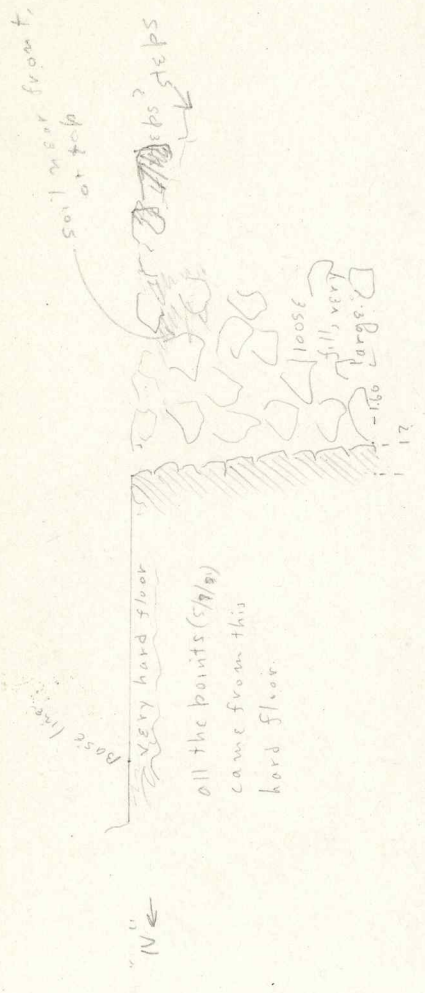
Section through old retaining wall, 3.00" E of Base center 1:50 (2020.100)

all the points (S/g/g) came from this hard floor.

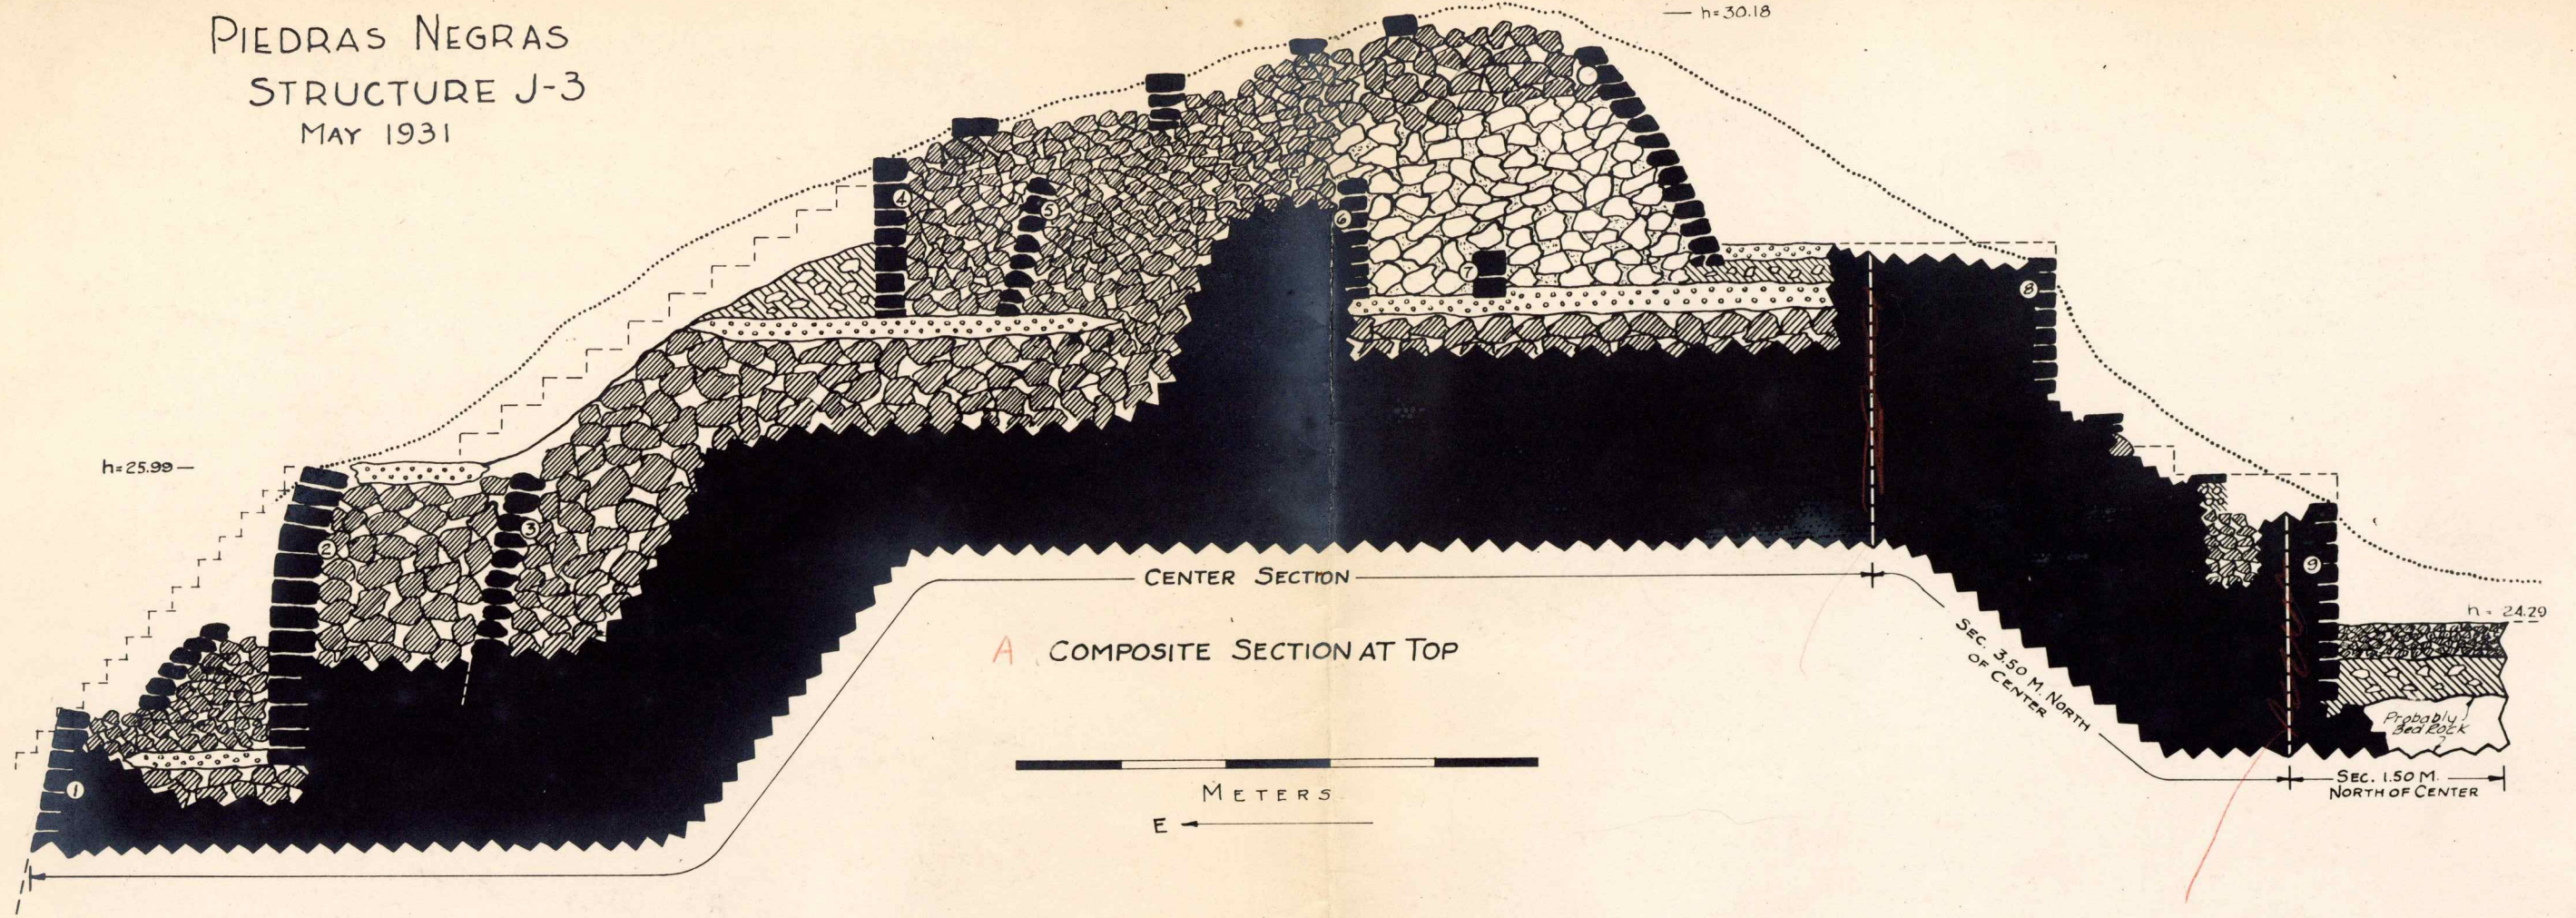
A. COMPOSITE SECTION AT TOP

- Hypothetical:  
--- Fallen - Restored
- In Position:
- Concrete Floors
  - Debris line
  - Walls, stairs, &c.
  - Fill - mixed earth & broken rock
  - Fill - broken rock & some disintegrated plaster
  - Pure broken rock fill

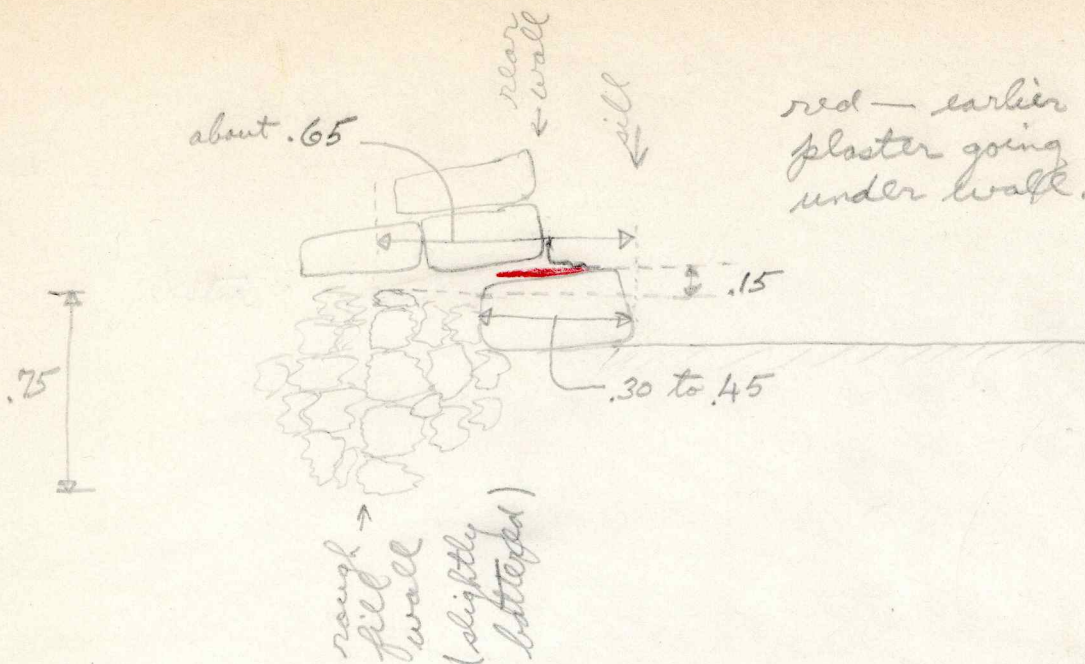
section thru  
rear wall to  
left of niche

Top of rough fill wall .65 behind front of sill + .15 below top of sill. ~~small area with gray finishing plaster between lowest wall stone + sill stone. .45 from left side secondary wall, .05 to .10 behind front of rear wall.~~

Gray finishing plaster <sup>(in red)</sup> with bits of charcoal, between lowest wall stone + top of sill. .35 to .65 from left side of central room. .05 to .35 behind front of sill. .01 thick. Irregular + broken. Does not go out to fill wall.

Floor of central room in front of wall to right of niche has light gray finishing plaster 2 to 3 cm. thick with smooth surface, above very small fill (chicos)

Fill under floor of central room is made up of large rocks as well as small ones. Small ones only for leveling up. In places large rocks come almost up to floor surface.

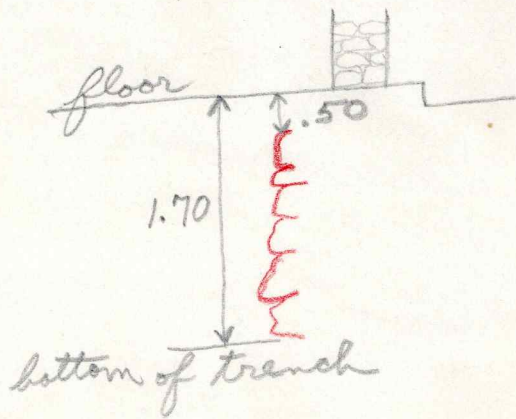
J-4.  
4/18/36

Fill wall of large irregular stones  
Practically vertical.

Top of wall is about 2.00  
below top of sill.

.85 below top of wall is  
a rough earth floor  
with chicos.
