Court 2

COURT 2  
J-9, J-11  
+ COURT 2  
1936  
LS

Court 1  
 Stn J-11 + J-12  
 "Junction"  
 1932  
 LS

PIEDRAS NEGRAS 193.6 STR. J-11

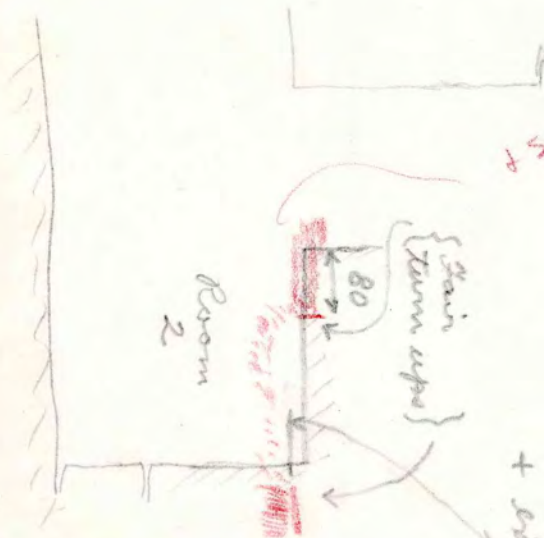
Floor 2 in center + on side do not connect but are on same level, both about .01 below floor 1.

Floor 2 is dark gray or blackish.

wall stone below floor 2 level .07 outside latest wall + extending under corner.

Floor 2 runs under all six secondary walls except wall 1, where it was not found — only chicos. Floor 2 turns up to both main walls — outside + medial.

Floor 2 is about .01 below floor 1. In front of wall 3 is another floor, .02 below floor 2 but without good surface, — probably only a foundation level. Plaster between walls found only at ends of wall 5.

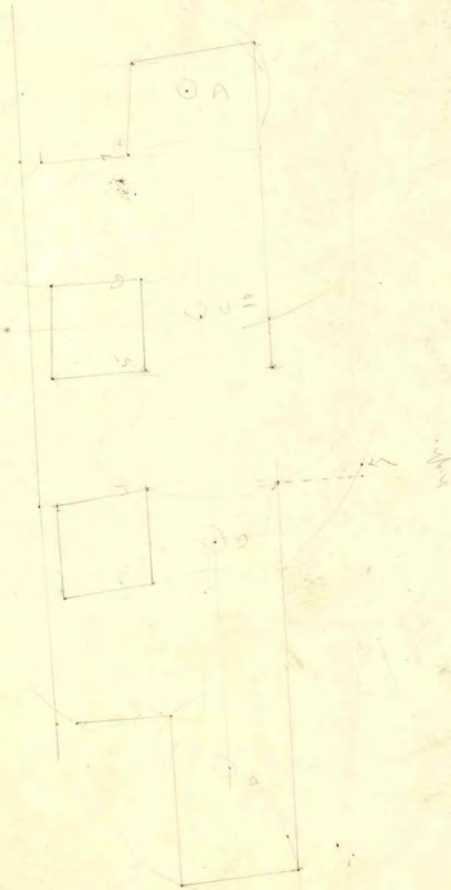
Pier average th. 1.20  
 Room width av. 1.67  
 Pier av. width - 1.20  
 Pys av width. 1.65

1.67 } 1.200 } 71 = 72.5%  
 1169  
 310  
 167  
 143

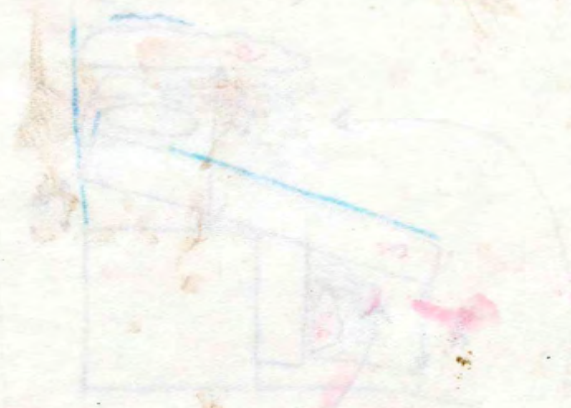
Piece of yellow mortar with finishing plaster directly in front of it, about .15 above floor.

Floor 2 - dark  
reddish brown  
color under walls.

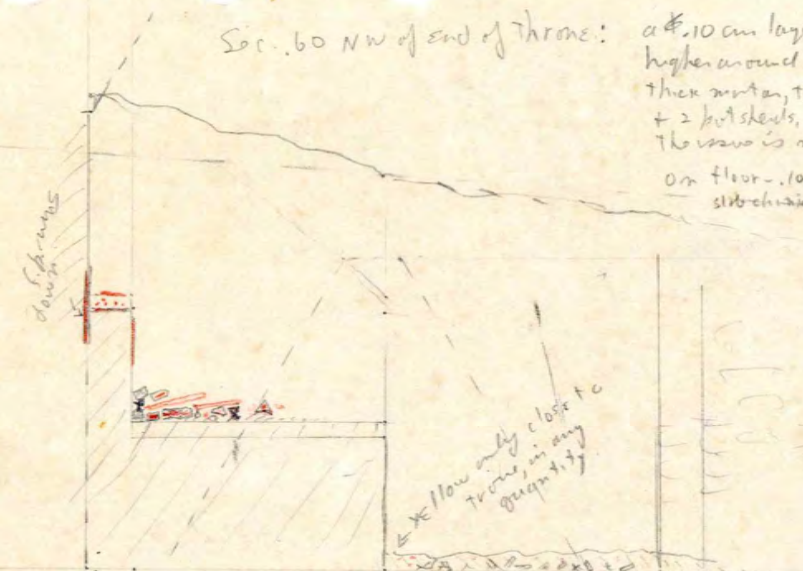
Same gray, fewer slabs.

3 of these thin upper edge of throne - obvious vaulting

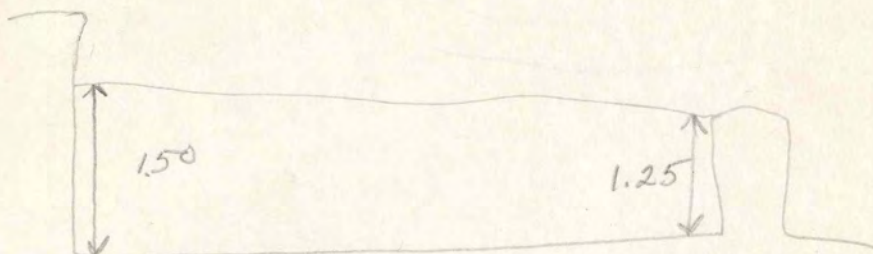
Cross section of debris thru pier on left (N.E.) side of central doorway. Central room on S.E. side of building. Looking N.E.
