5-29 - Nov 1956

Dating 2 caches w. the  
Mid. Phases.

PIEDRAS NEGRAS May - June 1936 STR. 3-29

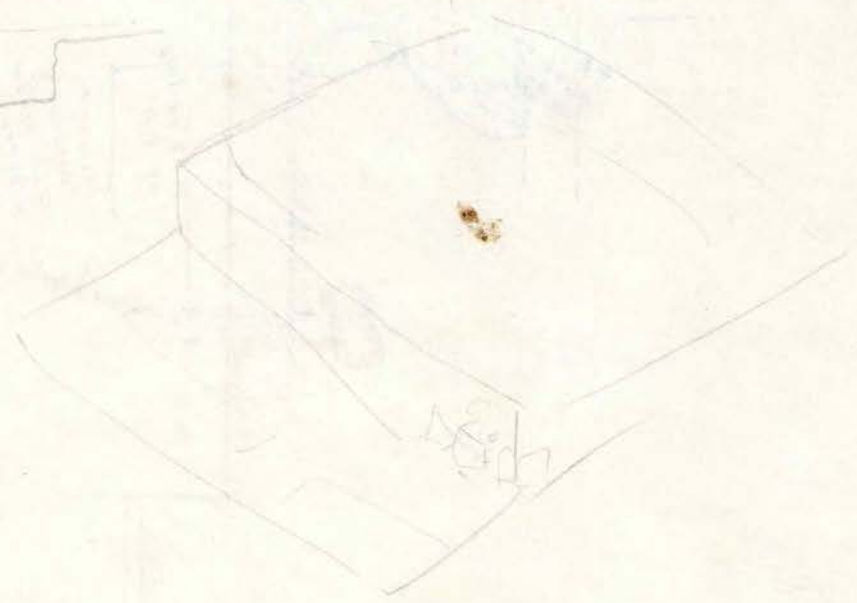
REMARKS Overlap of rt end wall with butt  
end of earlier.

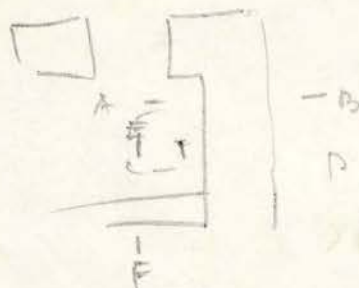
Sec A B - and wall leans out .11 in 1.53, which is total height here.

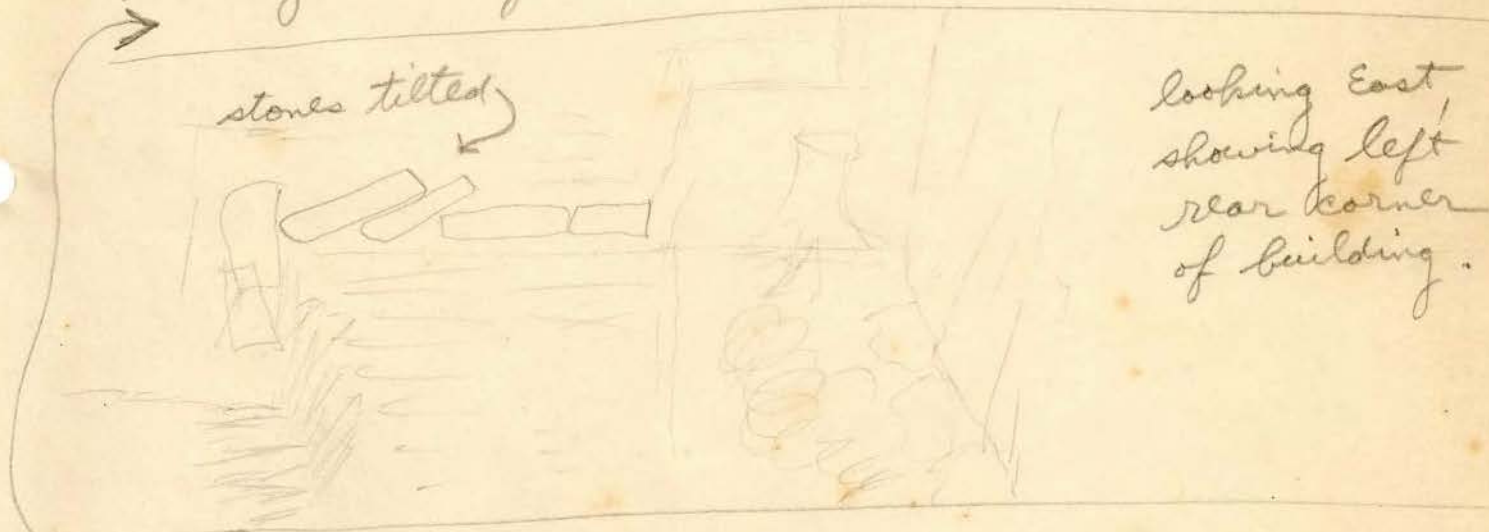
Right side of building. Piece of metate found in surface debris outside of secondary wall.

Between outer + inner house walls, above plinth of inner wall, were both rough fill stones + well-faced stones evidently once used as wall stones.

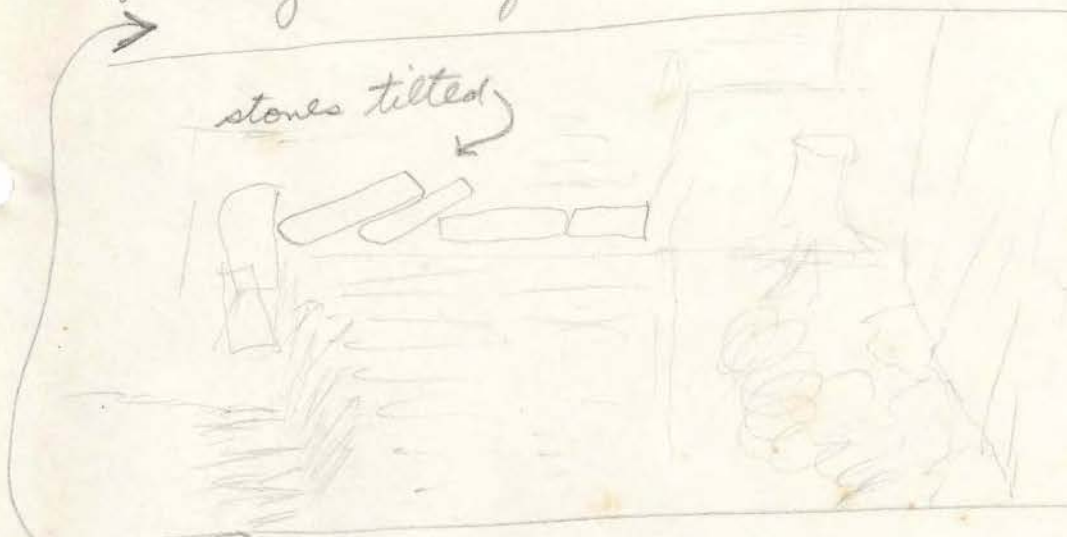
looking East,  
showing left  
rear corner  
of building.

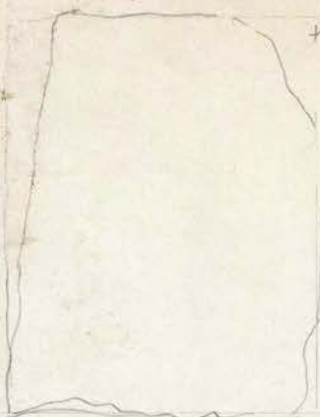
41  
Probably vaneet slab,  
one fair edge.  
1 flat face  
(vaneet face  
clearing, planar)

thick: .07.  
vaneet all over.  
except vaneet (a. th. .08) & then the top.  
gray mortar all over. Not  
back - possibly clear face  
front. It has been  
been exposed a month  
as has (vaneet) face  
- cop-stone. clearing  
planar

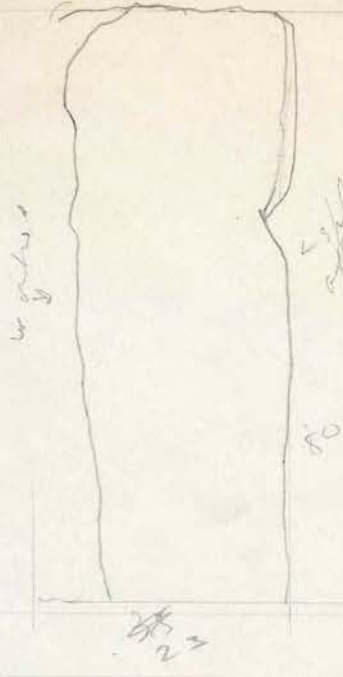
No 7

th 30  
th 90 all-ages  
rough worked.  
Flintbedded  
very smooth faces.  
- cop stone.  
Most fine, but both  
clear, plane, and  
weather

Reverse side  
Very rough  
as if broken down  
from thicker  
slab  
th. 10 to 14  
- only on face in  
clearing plane.  
- cop stone

th 06  
This face smooth  
than reverse -  
but both in  
clearing plane  
cop stone or  
rough working

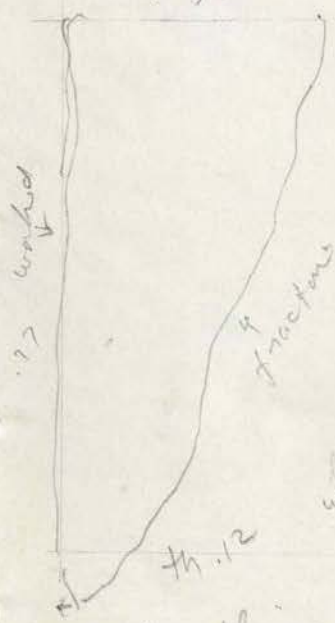
face clear, plain  
never very rough -  
now left over

clear, plane &  
never very rough -  
weathered  
Heating Paho

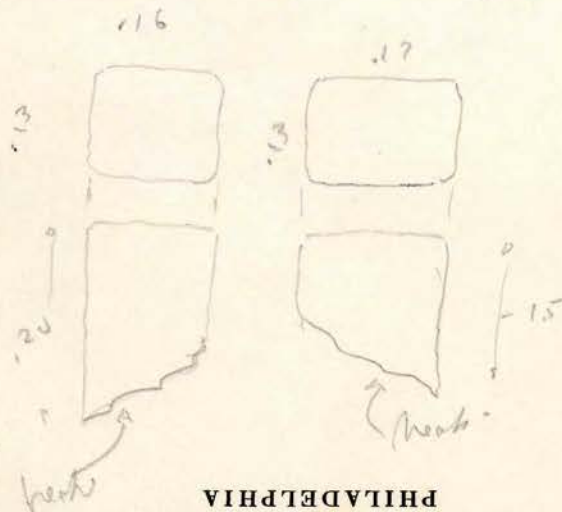
Misc. 7 or 8 well tooled fragments from debris behind left pier, ± center of room, about 1.0 or 1.50 above floor.

top & 4 sides well tooled.  
- yellow soap stone.
