B-12

0-12  
From 1936 notes  
Scale 1:100  
Rectified

B-12  
Moss's benches

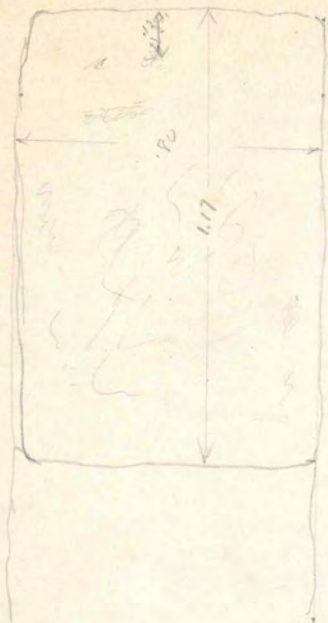
Fully exposed on surface, top edge about 1.25 below highest point of pyramid, facing Sly toward ravine

Big thin slab half its side had to be moved to left, it's gone loose DEbris + rubble underneath.

lay lengthwise on slope, if you go any higher there is room for only one doorway.

Cross section of debris thru right (S.E.) side  
of left (N.W.) doorway. Looking to S.E.

Did not contain typical large flat vault slabs but smaller stones + slabs as from walls. Loose dark humous soil goes all the way to floor level + there is no light tan colored disintegrated mortar. all this indicates a non-vaulted building, especially the shallowness of debris.

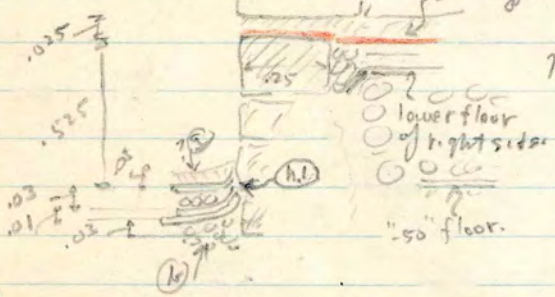
Note: the upper sub-chamber floor is contemp. with passage wall in chamber. (kinds of secondary with ~~red~~ cooling. The 2 below preceded it and ~~are~~ broken at edge, near passage wall all four run under chamber wall, the upper ~~only~~, two over passage wall.
