R-4 Field Notes  
to folder -  
next "Unit  
Reports" on R-3

R-5 Jemois

PIEDRAS NEGRAS June 21 1937 STR. R-9

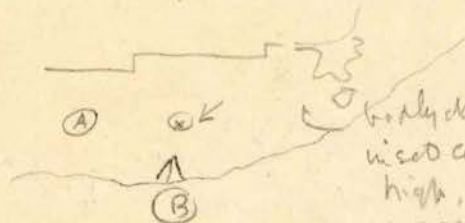
behind first used, inside, within p.v. terrace,  
acc. to Cannon; a week after investigation  
he had found it at (B).

badly destroyed  
in set corner, base  
high, unlikely that  
a cornice slab  
would have  
remained ~~there~~ on  
terrace.

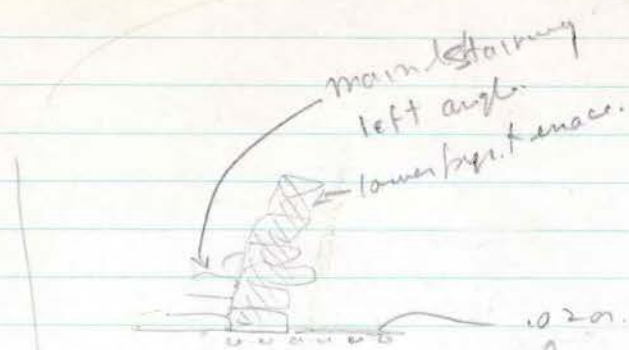
Str R-9  
Sun 10, 1937

R-9 Ald. Plot  
is a small (low)  
terraces.  
Looks as if it  
reduced an  
earthen one.  
Bld Sep 37-8  
Sketch [5]  
bricks  
floor

0.2 or 0.3 cm of yellow mortar on  
lime whitened crushed stone unquestionably  
a plastered floor.

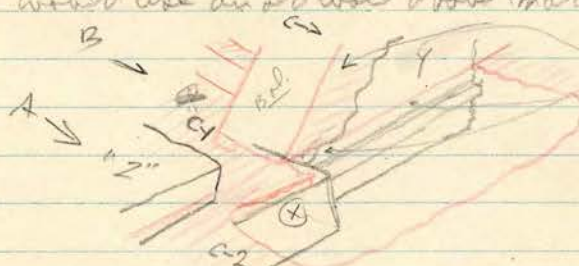
- Being so near edge, floor F would extend to Stela 25 Plat. 1 = C-2

- Bal. would use an old wall above molding at rear.

allows for diff in Pos. (30.3)  
mas. seen in 300 (116 + 18 W)  
+ plaster below to top  
+ wall base.

- Requires a leaning on (X) surface built - or inside

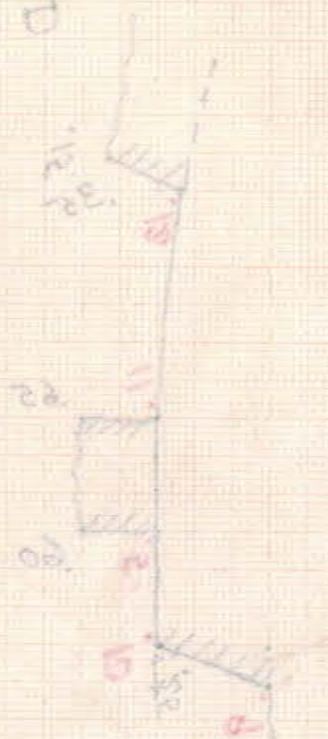
11 - height above top of substructure  
in front of vertical bearing  
line on point 10

substructure wall  
battered on side  
but vertical in  
front.

substructure wall  
battered in front  
but vertical on  
side.
