Stela 30. March 1942

Reconstructed from
Mailey photo of his L.S.
measurements

PIEDRAS NEGRAS 5/22 1936 STR. R-4

Section at base of pyramid, right side, near front corner, looking to rear.

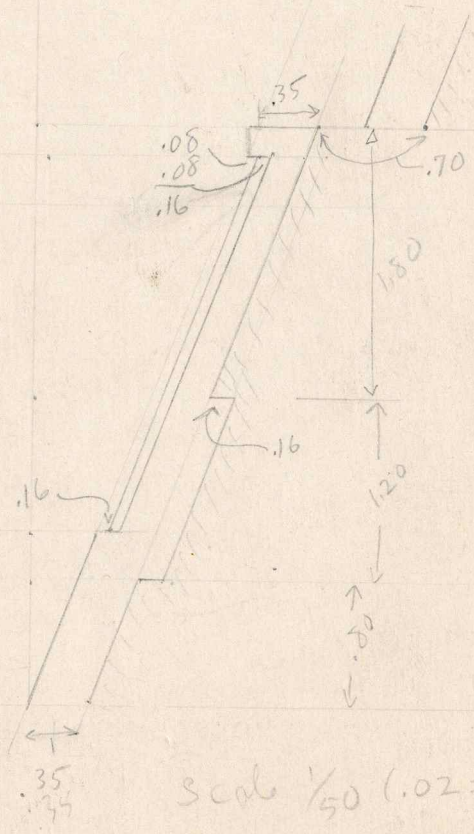
Scale 1/50 (0.02 = 1.00)

282 x 77 x 34 thick

89 x 17 to 18 x 34 "

The design lay-out suggests considerable, a moderate, exhaustion of plain butt, and is, plus probations, hardly allow for a broken off & missing piece of the butt.

Probably base has been damaged by falling tree; or when it was faced up by a fall backward.

Plenty of room for standing figure without supposing missing piece of butt.

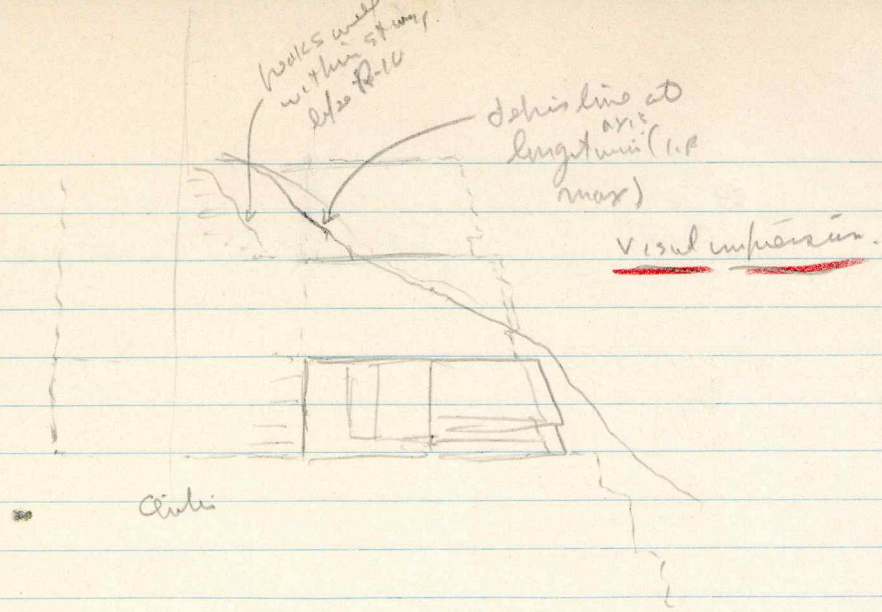
R-4

Level + draw section at top - levels

Lower tenac - Inset Corner -

Large stone - heavy deep tailing tubular, occasionally blocks.

Coursing - very bad condition, but noticeably good just above + below bottom of arch - 3 above, 2 below.

Thinner tablets set in arch overhang (except one block).

Mosaic panel - much the same -

Stair side wall - ditto - 5 small areas shown 4 med to large block faces, in detail -

All of above: bearing horizontally in mortar; occasionally thick slab sh held for bearing - gaps plugged.

Surviving plaster traces on stairway side wall are gray.

Tenace runs behind stairway.

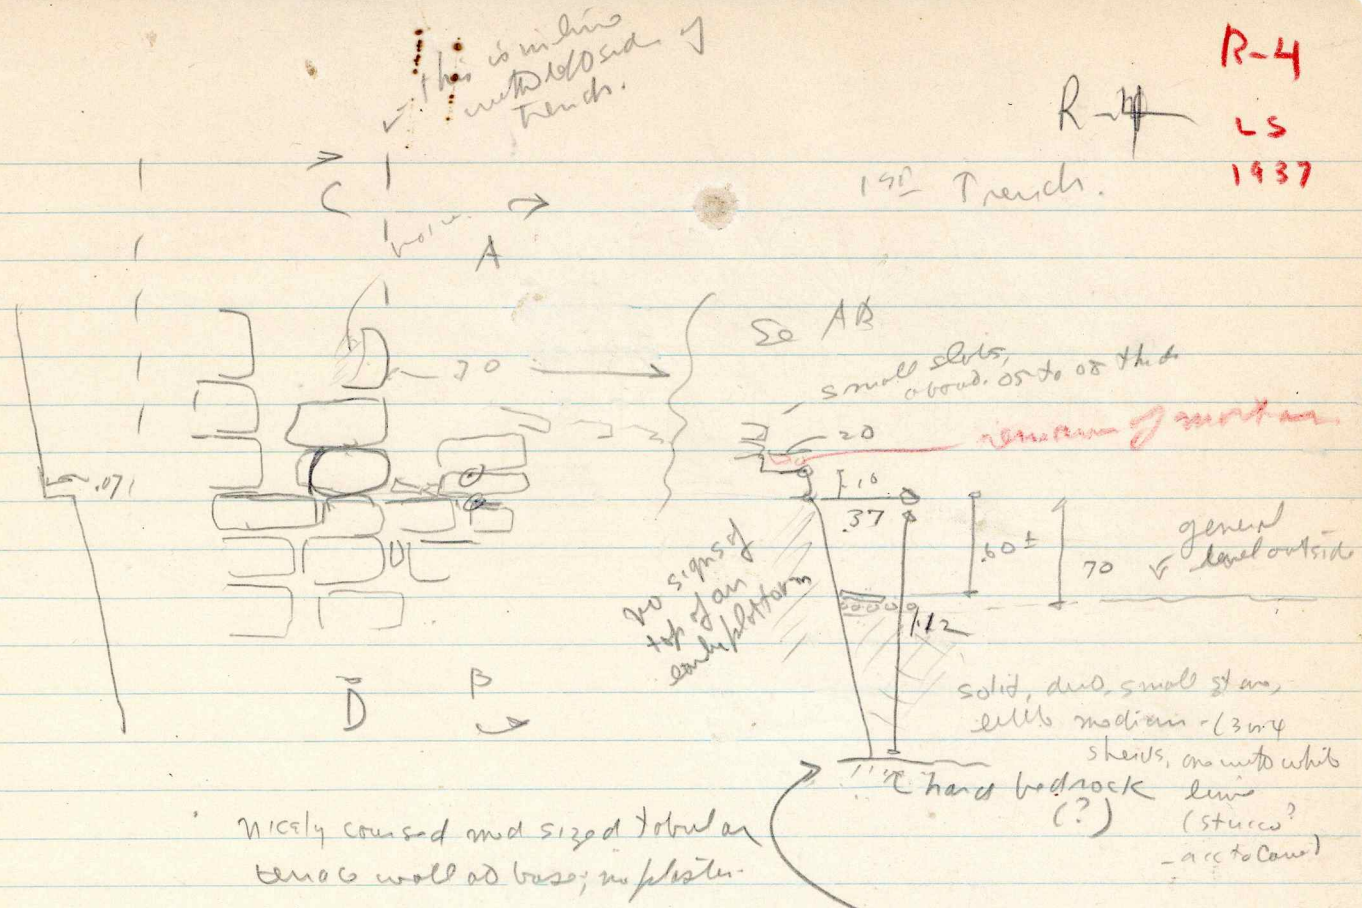
Probably like R-1

Floor?

looks like
bed rock.
Some indistinct
signs of floor in it.

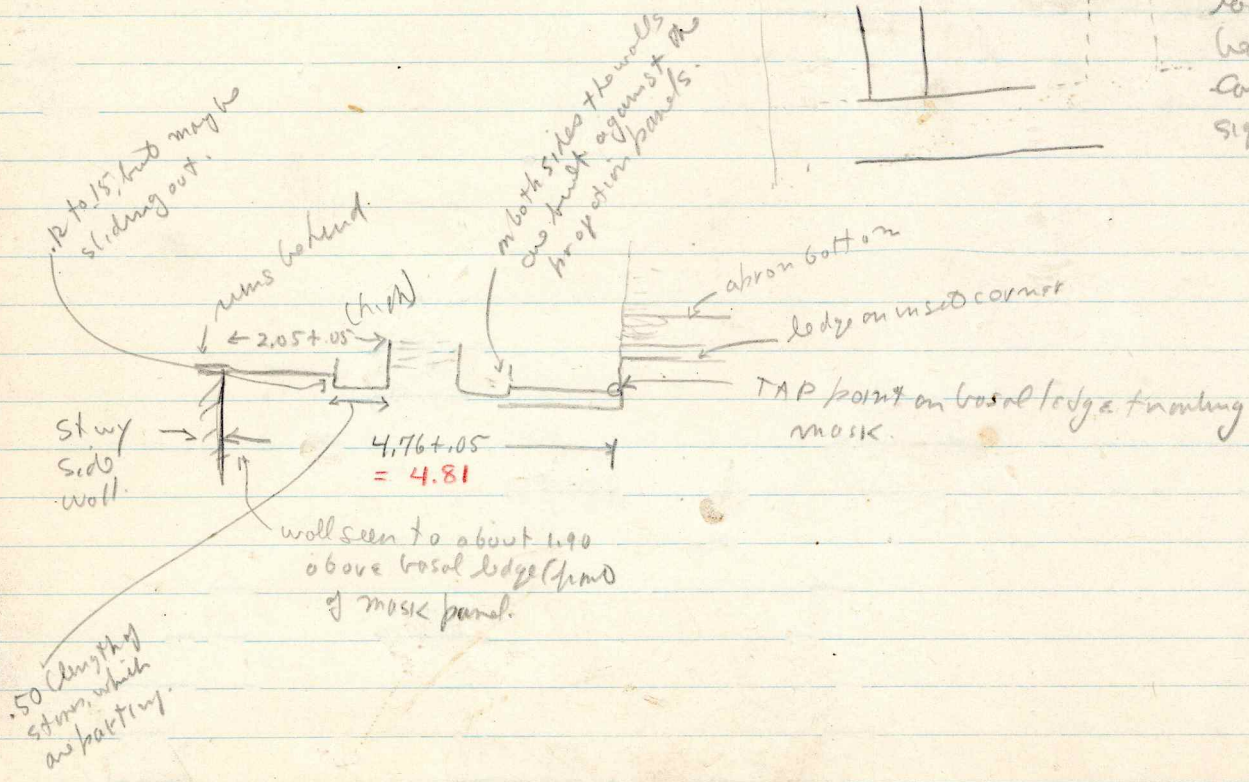
Plan

A + B - Stairway from corners (located on plan). Note: A is almost surely broken-off end of step, corner further on (no side wall, good step. B is same corner.

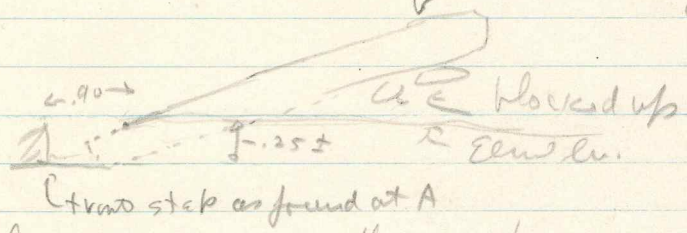
Section

Stela is about in middle now (hanging over sticics), - a bit to left, probably
 Basic is plain for 40 or 50 cm at top. (P. 2. the under side of stela could be lined over as it's face, after stairway built, & no board in center - this would hold both close to steps.

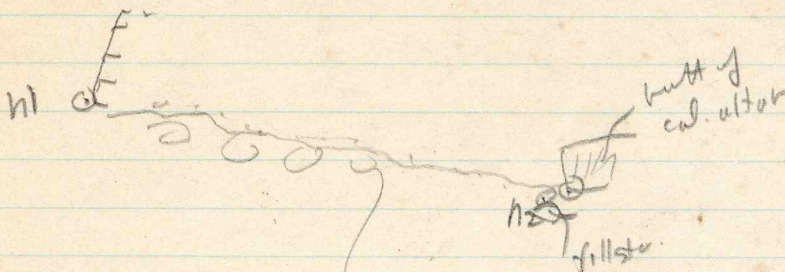
Section through Bld. Platform
at top of Pyramid.

h1 = 1.43 above h1

h2 read. 2.34

Support fill, with loose crushed stone on top, followed by a
terrace base, which rested on it.

apparently altar was buried.

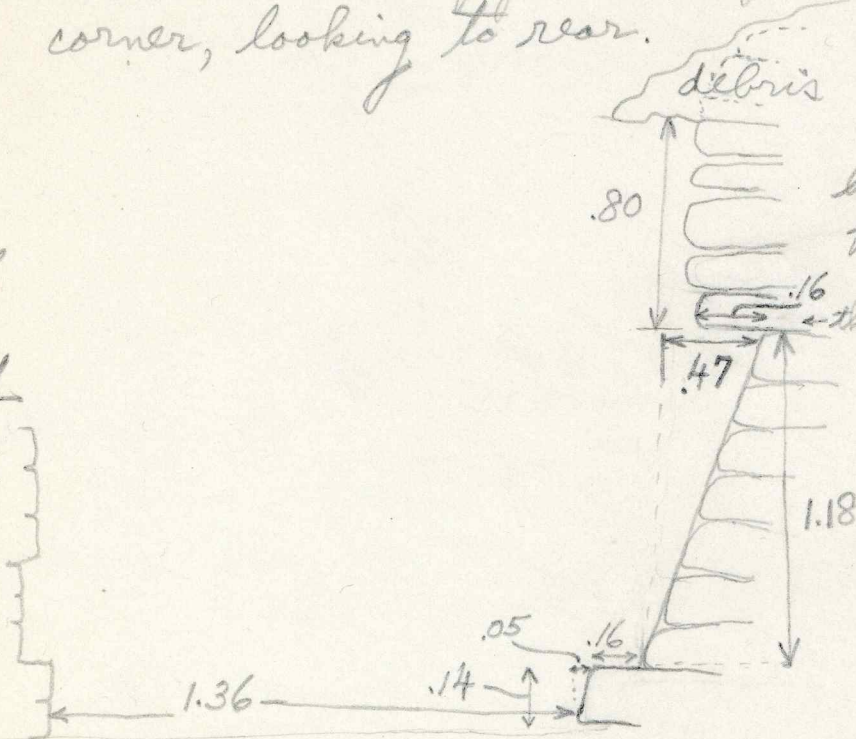
base of R-3 pyramid

R-4 pyramid
bulges out a little from original position; is practically vertical.
