R-10. LSSJ
NOTES

R-10 1937
 Second Plan Sheet
 Secondary Platform

PIEDRAS NEGRAS *Cla-May* 1937 STR. R-10 R-10 1937

SCALE 1:100 (rough) SEE PHOTO Nos. _____ P 37-2
Plan Sheet 2

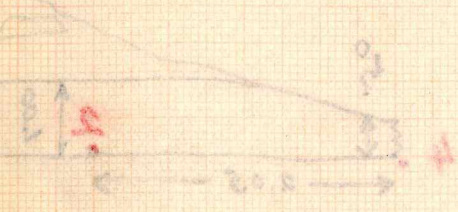
on this side of wall
wall displaced
at corner is
falling down
to the side.
upper part of wall has
fallen over in
front of lower part
causing break.

face of part - top is covered with
hand
smooth in above in
front of part - hand

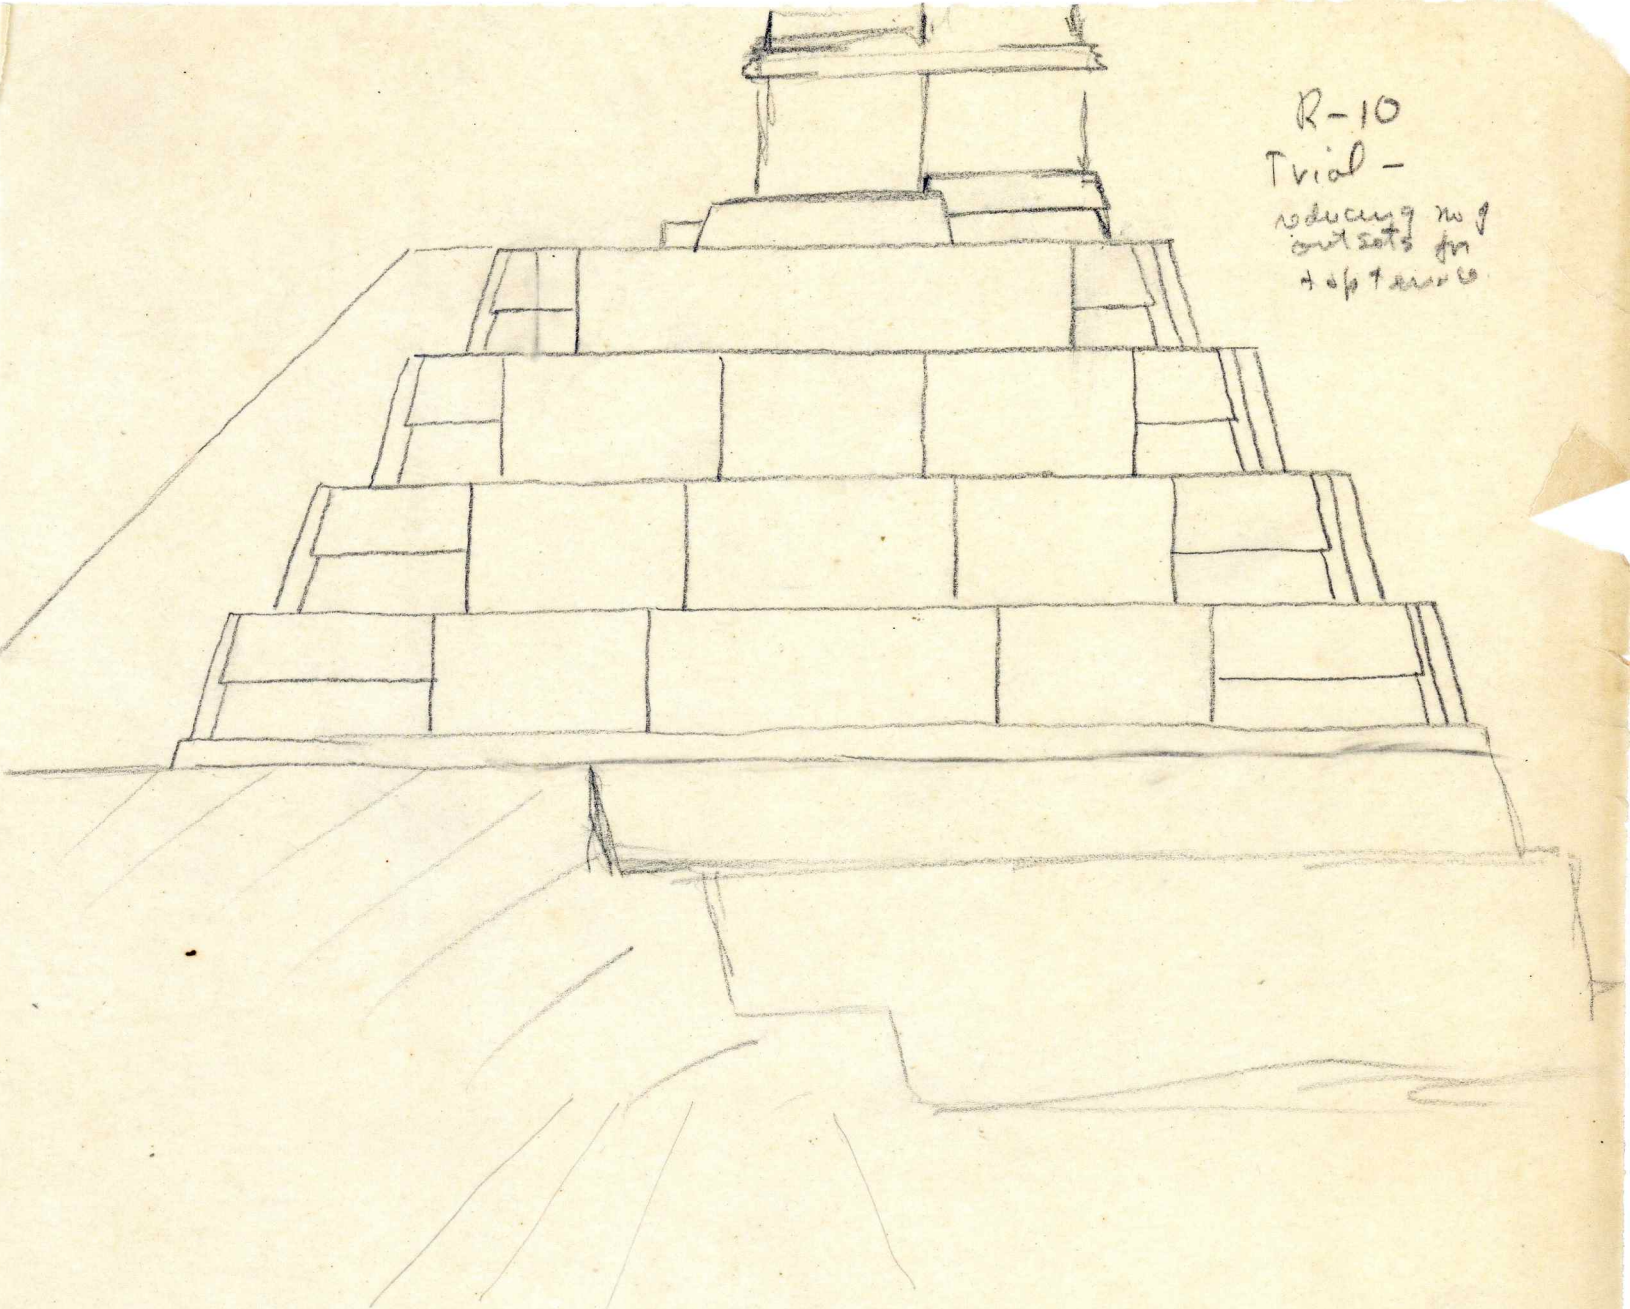
R-10
Trial -
reducing no of
cut sets for
top 7 rows
