Measurement of Lines and Angles.

Appendix —

Linear measurement and estimated angles.

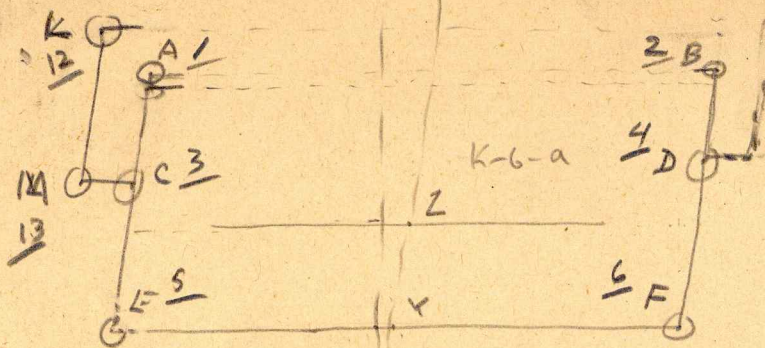
Fig 1

K-6

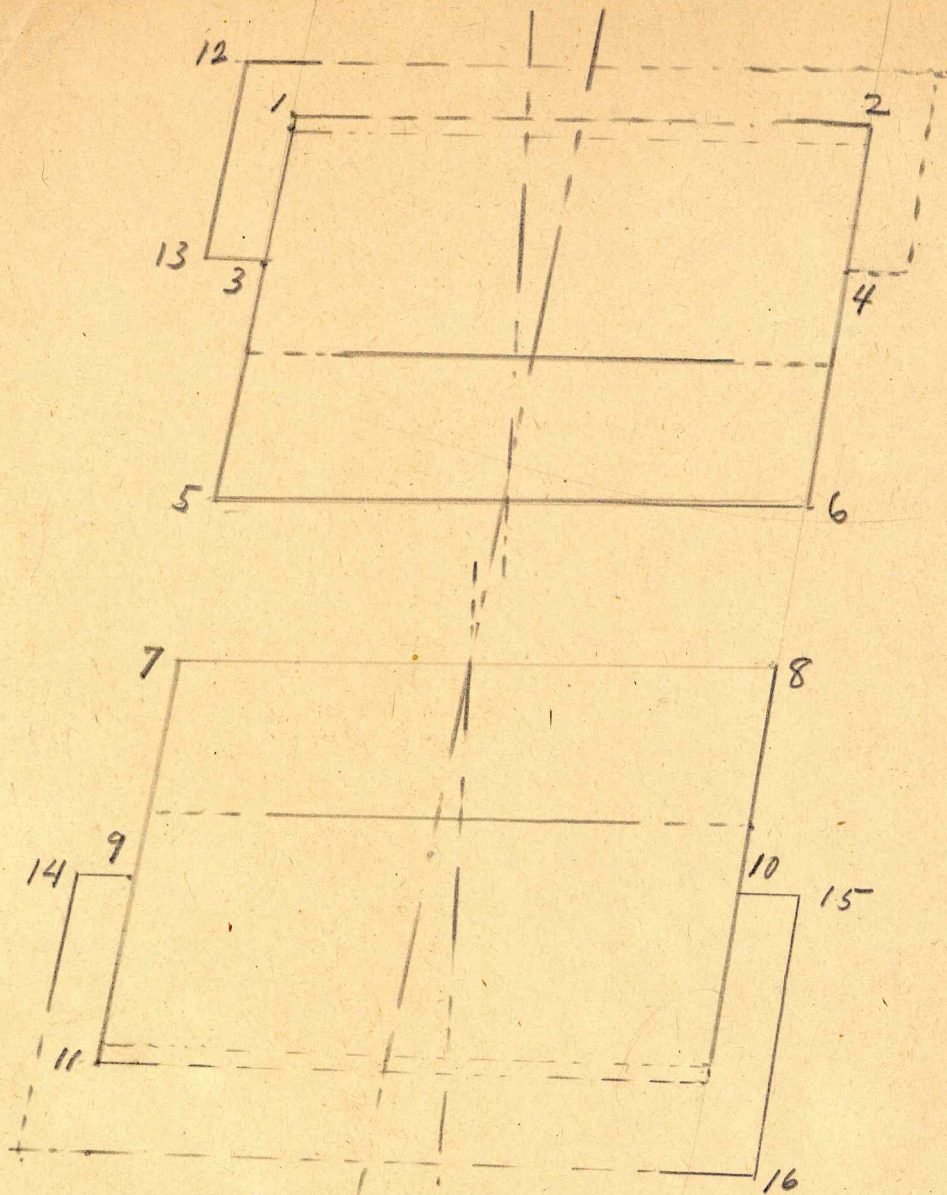
Fig. 1. Structure K-6 (West Group Ball Court).

1-2	21.15	1-5	8.95	3-5	6.60	12-13	3.70	13-3	1.25	5-7	6.60
3-4	21.25	2-6	8.96	4-6	6.55	15-16	3.25	14-9	1.25	6-8	6.70
5-6	21.26	7-11	8.97	7-9	6.56			10-15	1.23		
7-8	21.50			8-10	6.50						
9-10	21.55										
A	(.35)	B	(.02)	C	(.10)	D	(.45)	E	(.02)	F	(.10)

Further evidence is that sometimes the acute angle of a parallelogram outline is on the left, sometimes the right of an observer facing the front or rear. (Cf. Fig 1 with Fig 8).

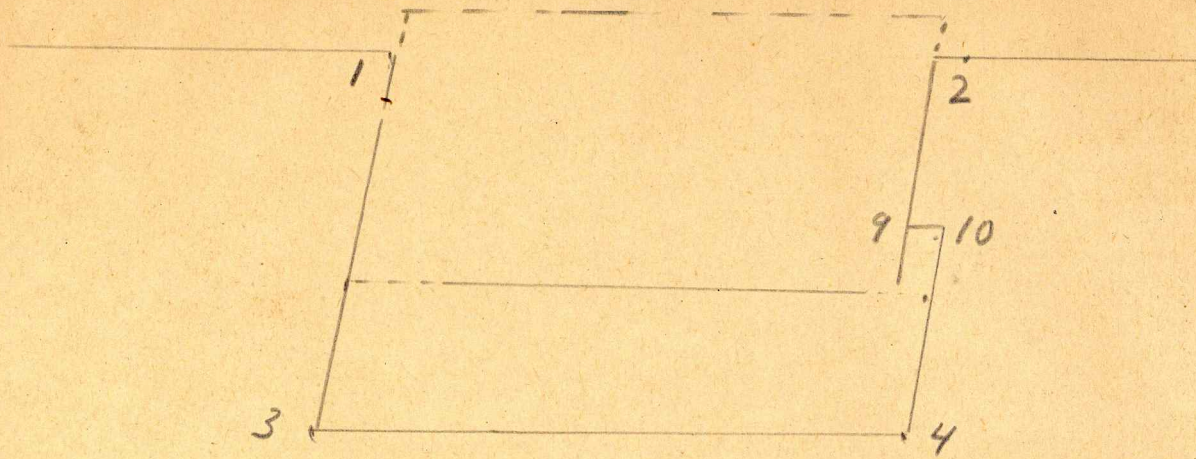
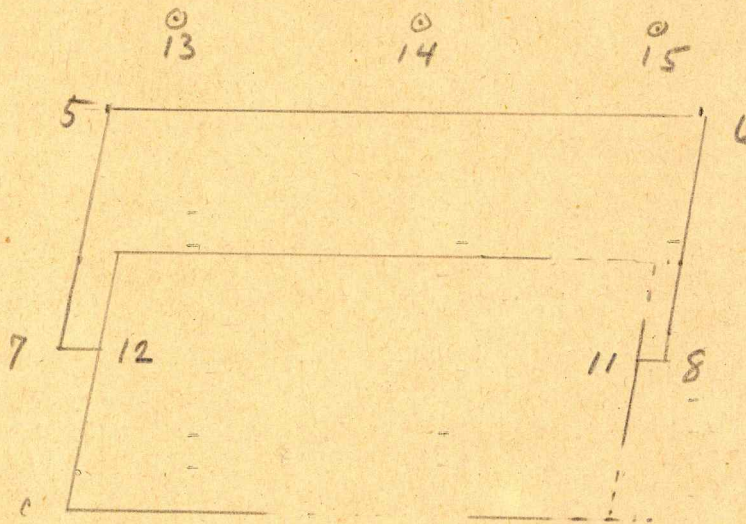
Fig 2

Str. R-11

1-2	17.55	2-9	4.35	10-4	6.90	9-10	.53	3-5	4.35	13-14	7.85
9-10	<u>+ .52</u>	10-4	<u>+ 6.90</u>	6-8	6.82	11-8	.52	4-6	4.35	14-15	8.02
	18007		11.25	5-7	8.83	7-12	.38				
3-4	18.00	1-3	11.34								
5-6	18.15										
7-8	18.28										
A	(.28)	B	(.09)	C	(.08)	D	(.15)	E	(.00)	F	(.17)

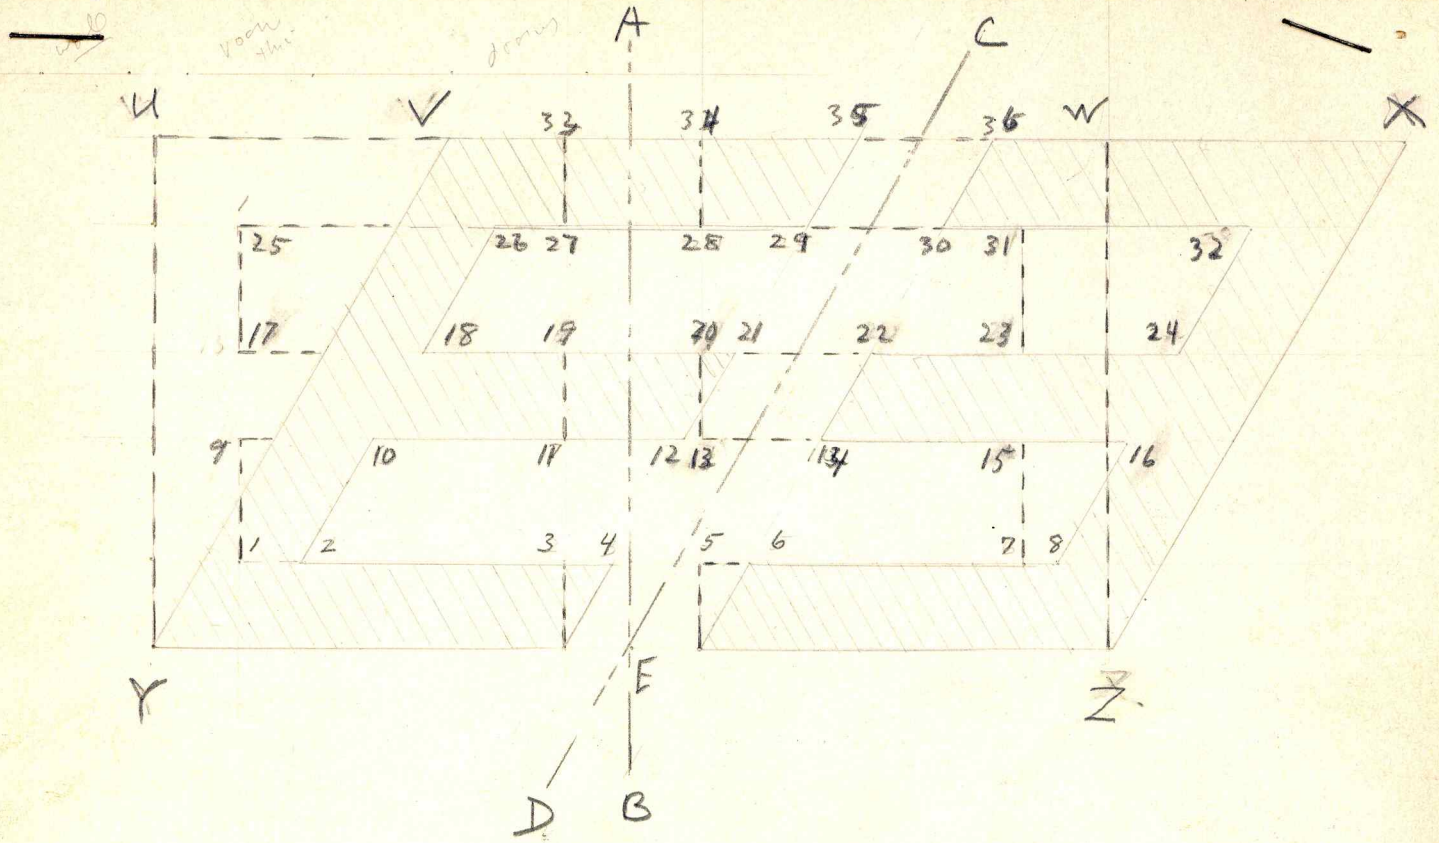
Fig 3

The divergence between a true and a rectified axis, starting from a point in the same facade, gives the same thing. There are on Fig. 3 the varying displacements of central doorways, using an exaggerated original outline angle.

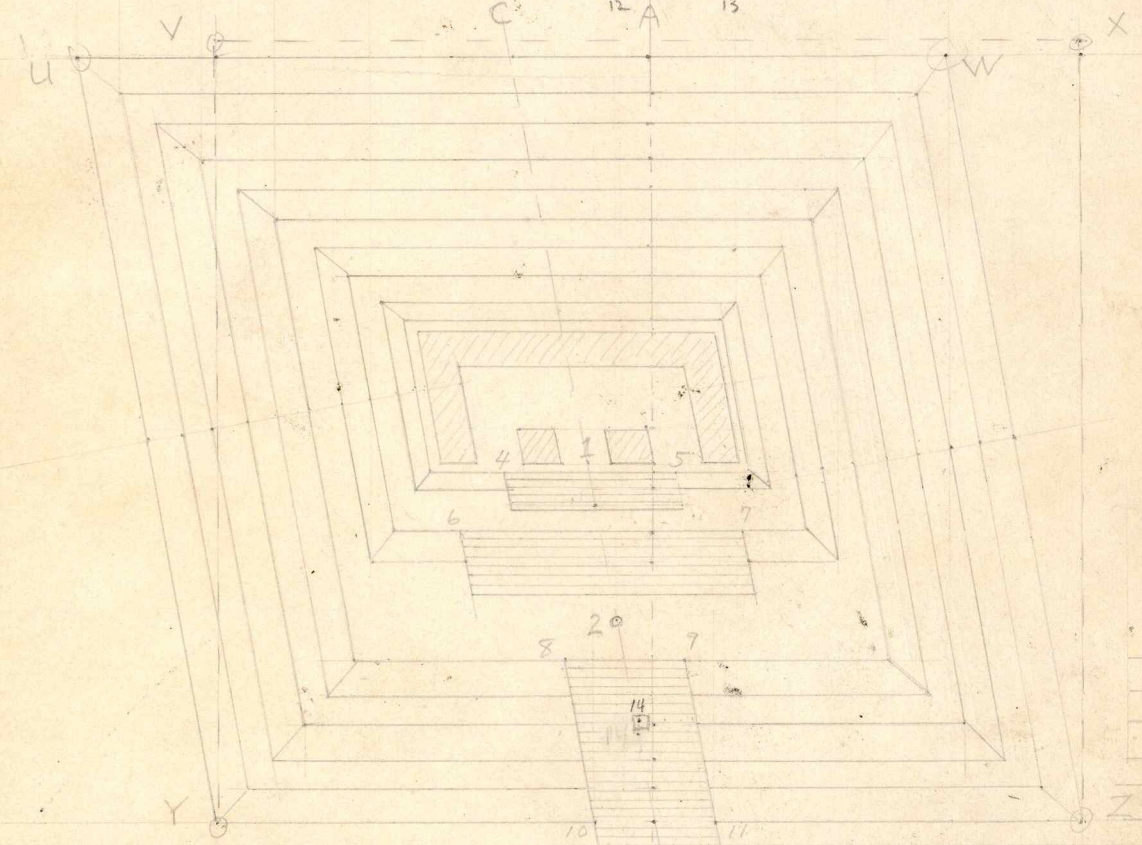
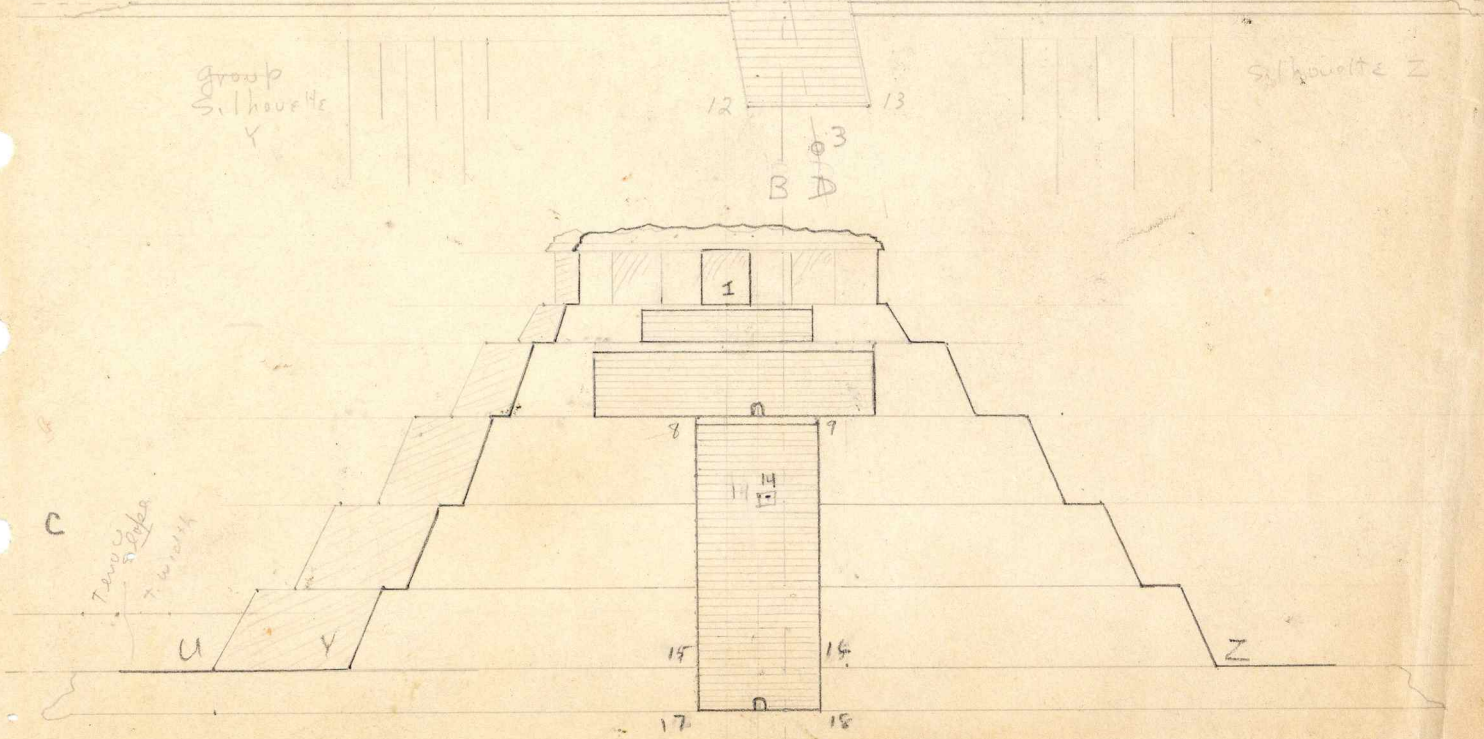
Rectilinear
Silhouette

Group
Silhouette
Y

Silhouette Z

on a parallelogram pyramid. Displacement ^{that of} tended to make the silhouette steeper ^{than a true cross-section} on one side, less steep on the other, provided one looks at the facade at right angles to it ^{as in an elevation drawing.} (Fig. 6, a and c). Outsets, ^{presumably} measured equally from the corner points defining these silhouettes, would show a similar horizontal crowding ~~xxx~~ on the obtuse side, stretching on the acute side of any facade. Allowing for irregularities due to cumulative errors there is some evidence that this actually occurred. In any case, ~~non-symmetrical~~ ^{irregular} horizontal spacing of a rising series of

Accurate measurements in building up a pyramid would therefore tend to cause this type of asymmetrical silhouette. Outsets in terrace walls, presumably measured from the corners (generally missing above ground level) ^{be similarly affected.} would duplicate ~~it~~. ~~W^d~~ actually have this illustrated ~~xxxxxxx~~ ~~K-5-2nd~~ front facade. The ^{horizontal} spacing of outsets should be irregular, as seen, due to accumulating errors. But at the rear obtuse angle, while the ^pspacing between outsets of first and second terraces is narrow, as required, the next is very wide. It seems fair to conclude that measurement and construction errors are a sufficient explanation of irregular outset spacings, ^{that they were not considered,} and that a non-rectilinear ^{basic} ^{if present, would} outline ~~will~~ tend to throw them into a pattern. ~~it would tend to make them steeper on one side than the other.~~

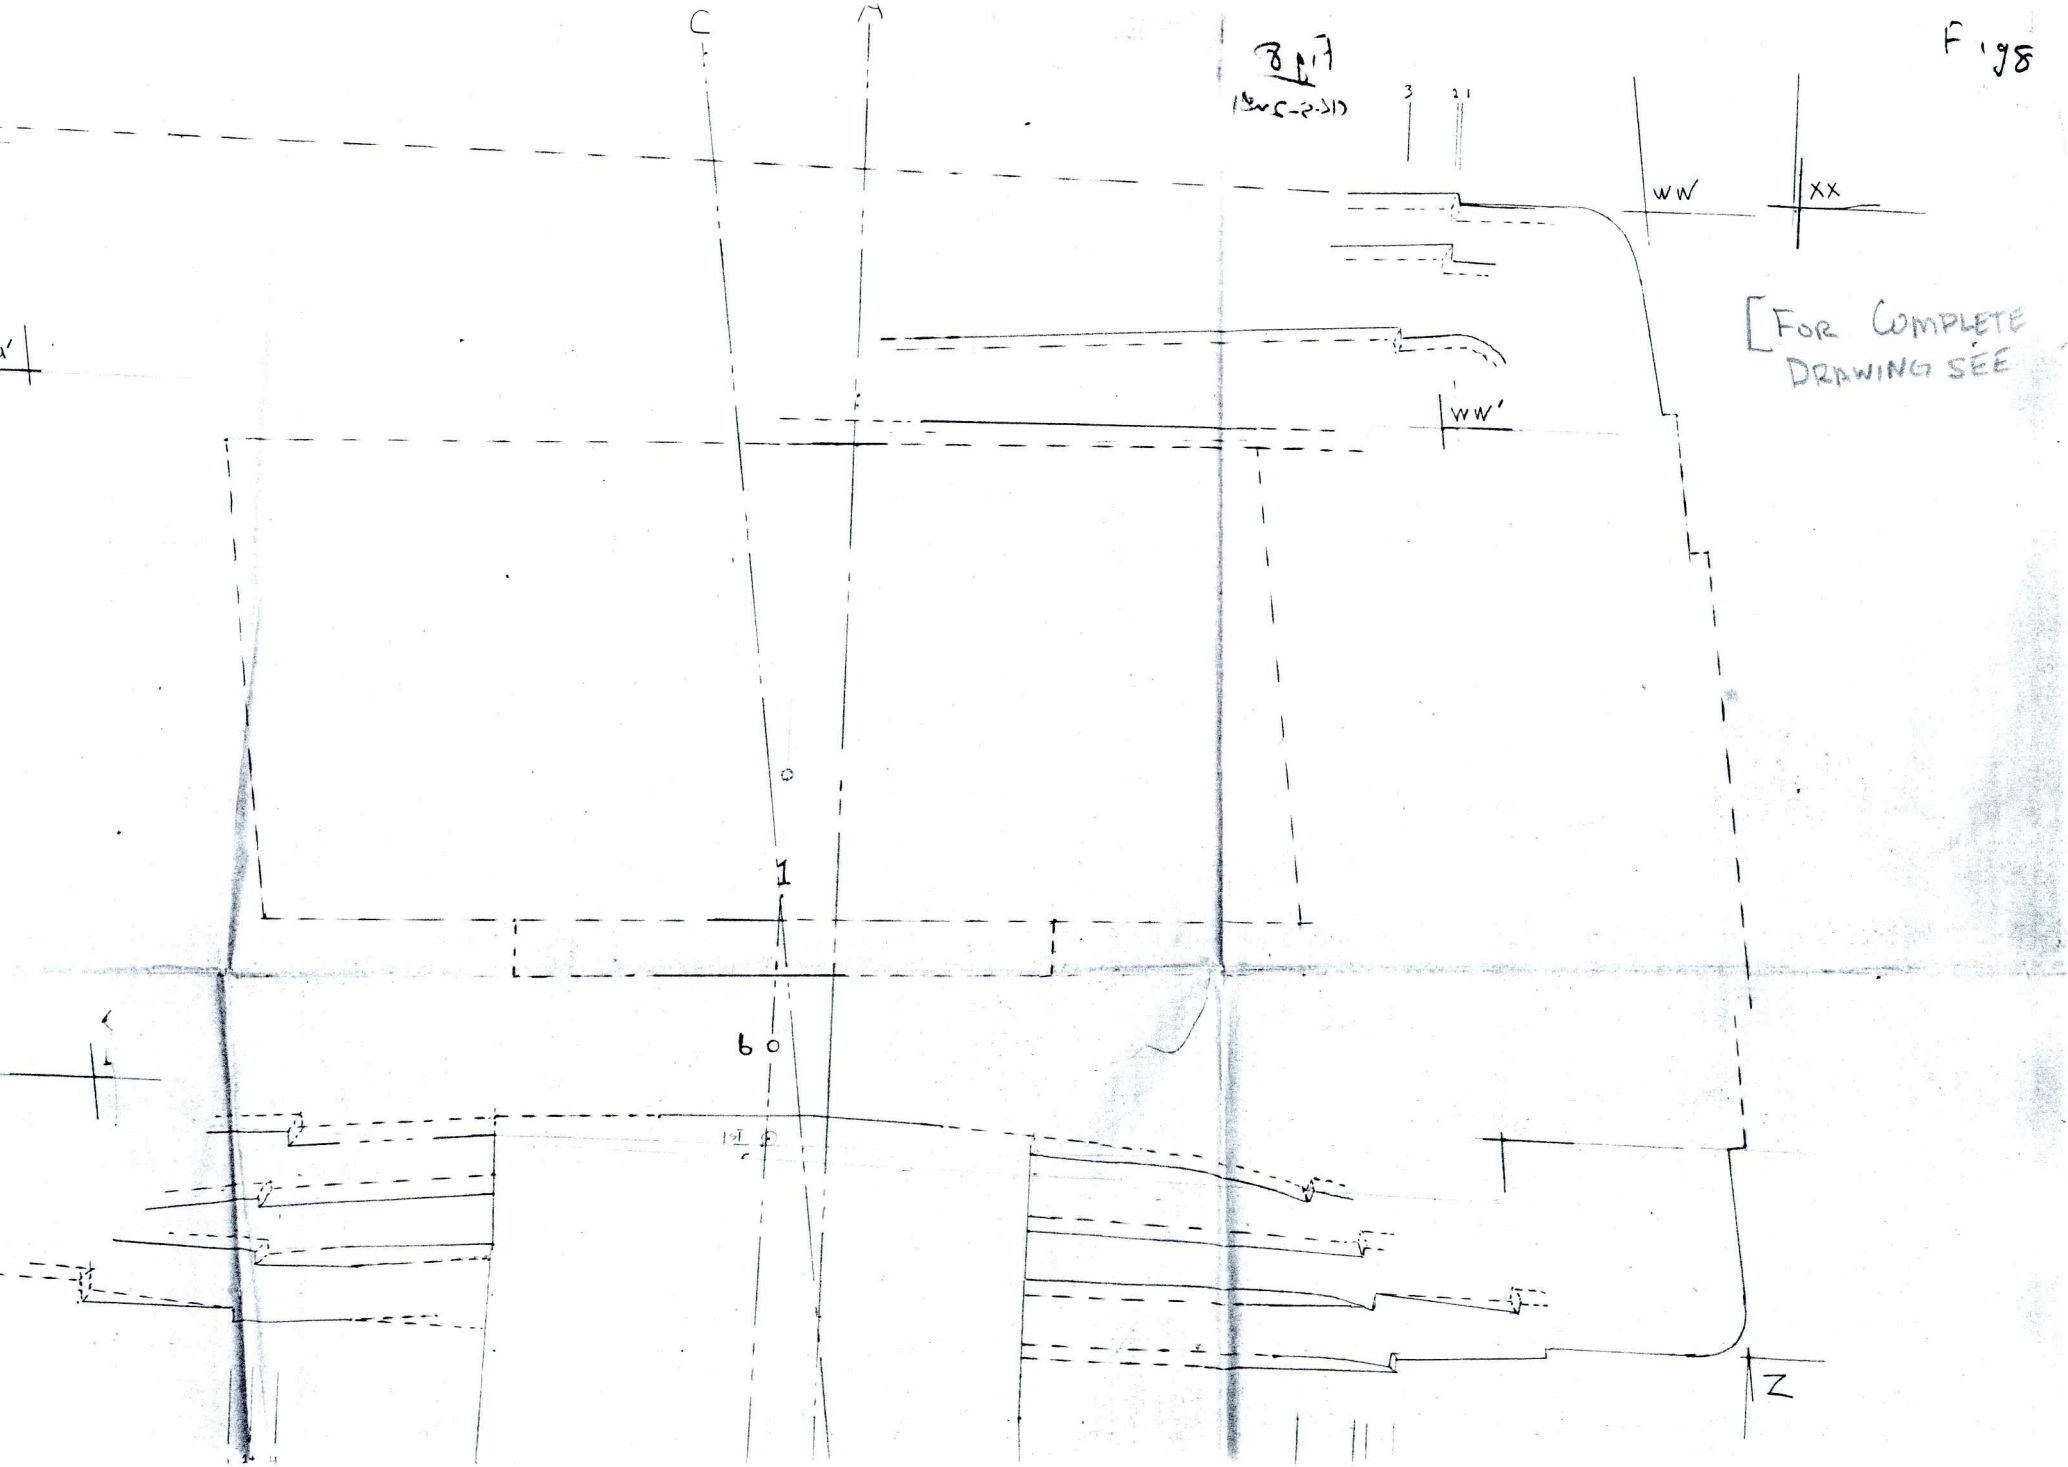
K-5 Plan. Pencil on tracing paper.

The plan and elevation of Str. K-5-3d, much better known than R-16, can be explained in this way. Unfortunately the main stairway side walls were destroyed by the Maya, and ^{must be} ~~restored~~ (Fig.). In spite of many other restored points, ^{at least the} ~~found~~ angles of the original outline ^{were} ~~was~~ clearly the parallelogram UWYZ ~~xxxxxxxx~~ or a slightly larger one enclosing the outsets, and not the rectangle ^{VXYZ}. As in Fig. 6, the axes of rectified and actual basic outlines, AB and CD are drawn through their ^{front} ~~common~~ center.

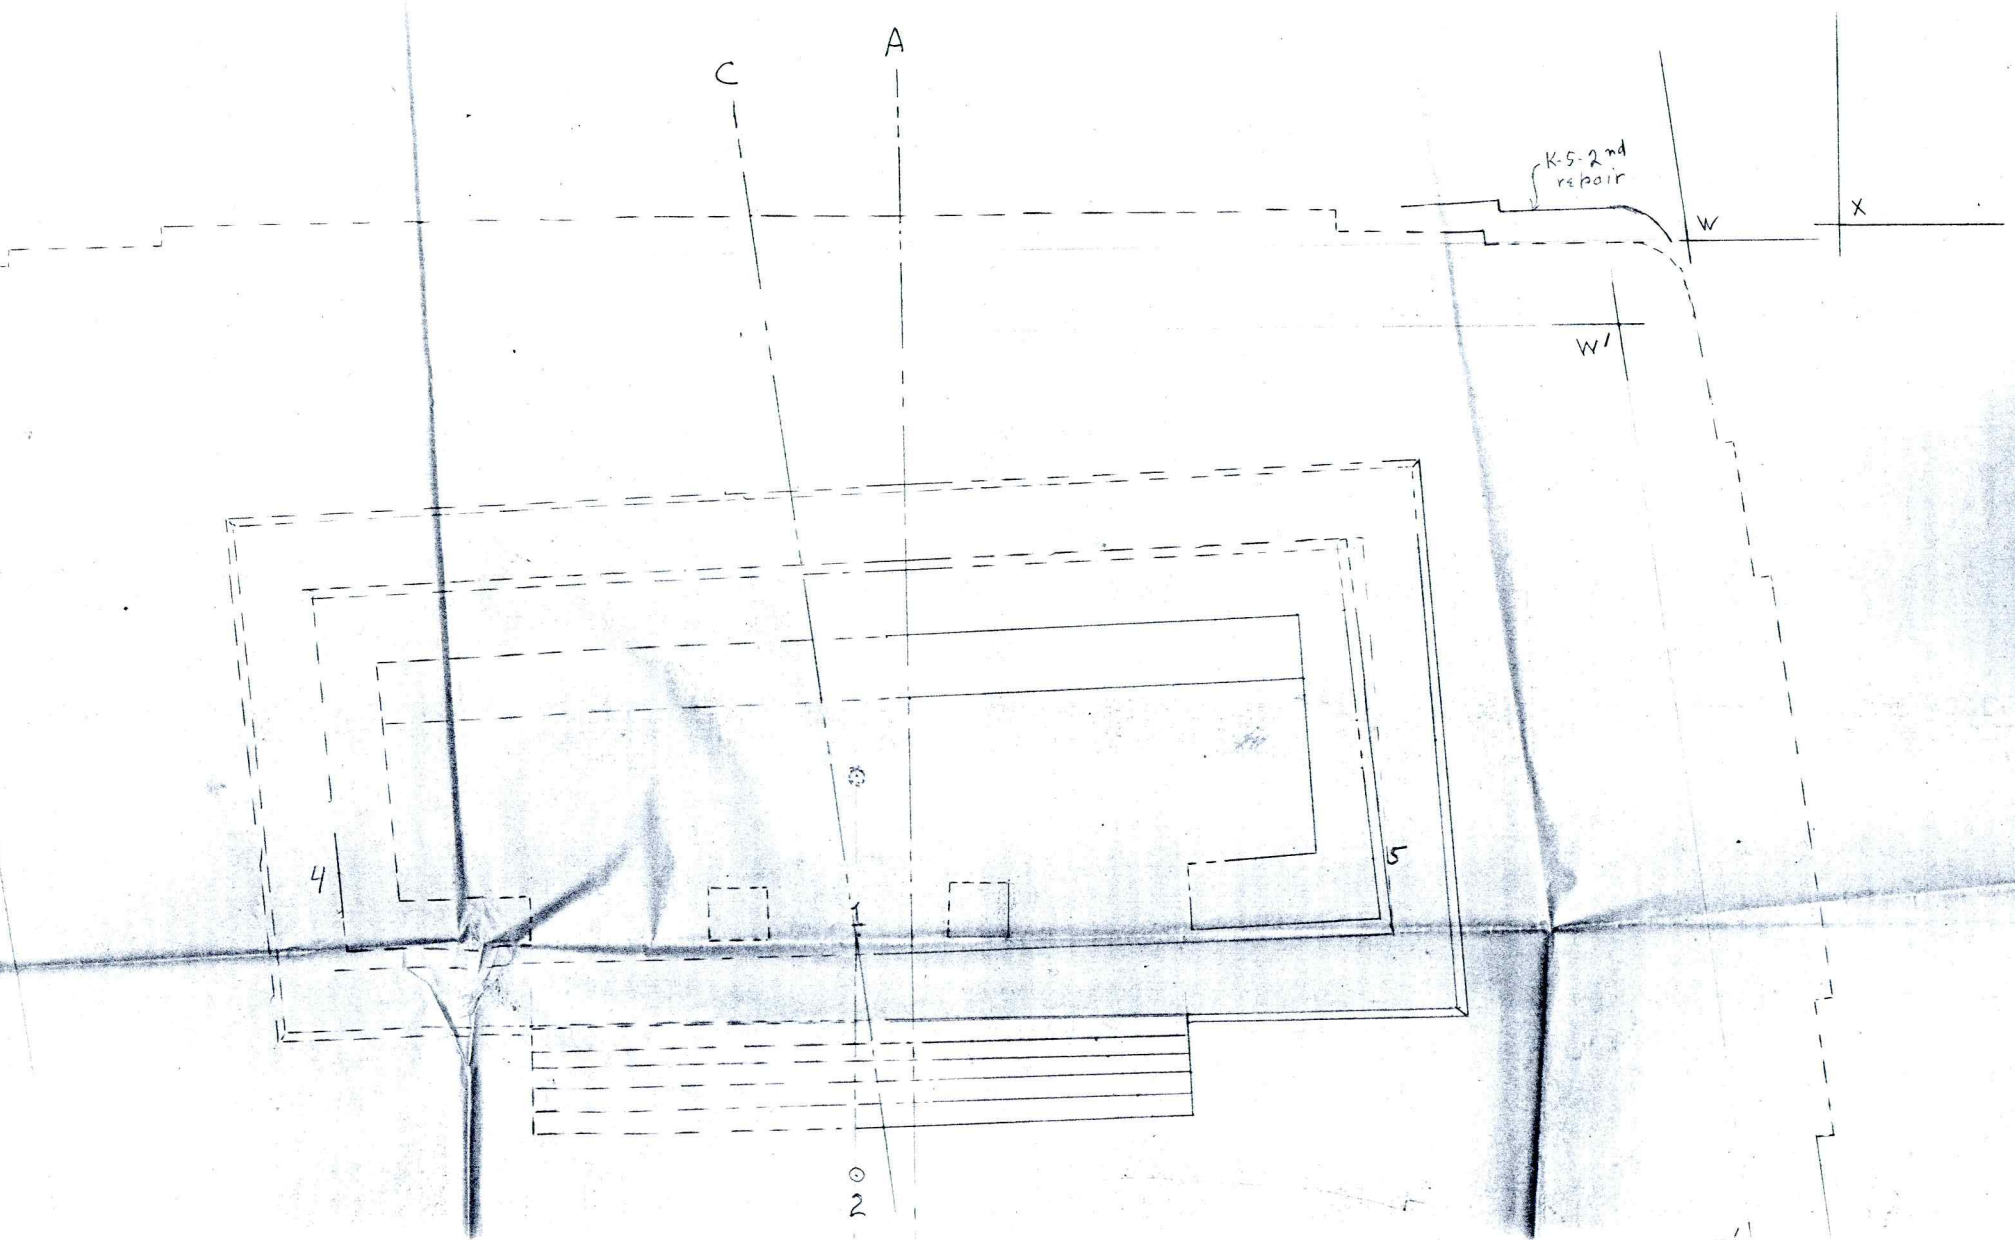
Fig 7

better judgment of stairway angles could produce it, unless some further adjustment was made. The conspicuous stairways, though each is rectified, are badly displaced with reference to each other. To correct this it would be easy to lay out all stairway side-walls at once, or ^{from} ~~on~~ a single ^{stairway} center line, swinging from the temple instead of the pyramid top level. On our elevation we would push the platform stairway to the left till its center was under that of the doorway, and move the main stairway still more till its center was also below ^{further} that point. This would ~~increase~~ ^{increase} the discrepancies in terraces lengths on either side, ~~xxxxxxxxxx~~ but would yield a straight line of sight (Fig. 7)

possibly accumulating errors are ^{probably} responsible. This was not true in the original period (Fig. 7) in which pyramid, platform and building show the same type of parallelogram outline, though not corresponding precisely, as expected. ^{with continuous measurements from the bottom up,} The reversal of displacement direction in the higher units of the final period would have shifted the doorway center appreciably nearer the rectilinear position, and away from the actual axis of the main stairway, already fixed in the intermediate period. ^{(Since this did not occur it} and plinth were ^{pre-existing} It seems probable that the building was centered on the ^{axis} stairway by sighting, rather than by measurement from platform sides. ^{The building was located from the sides by measurement, and} In the early case everything indicates, both stairways and the pyramid altar were centered on the ^{at} building by sighting, ^{and} all therefore share the ^{same} building ~~side~~ displacement, as they do.
