Field Photo Catalog
Nos. 1-280 (L.S.)
1937

1937
nos 1-235
(L.S. complete)

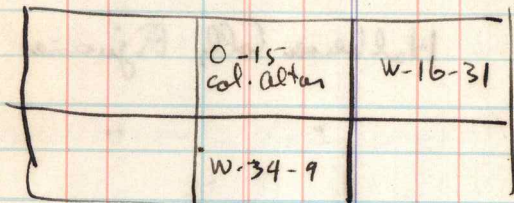
S-11-2 ← horizon line →

D.M.
stones
Objects.

L to R (notes on left).

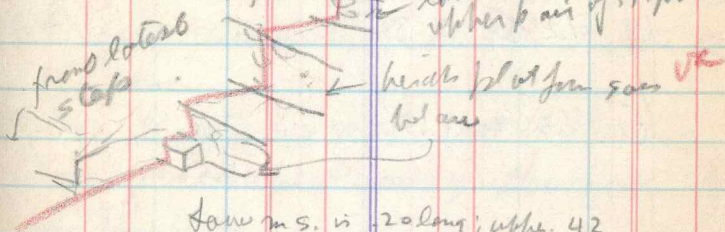
R-9

Center section, front. ^{lower of lots}
^{when to air of steps}

Saw m.s. is 20 long; wth. 42
 Being on 7th (from top) complete tread of
 earlier stairway
