Piedras Negras  
FIELD CATALOGUE - 1934 Photographs.

2 1934.

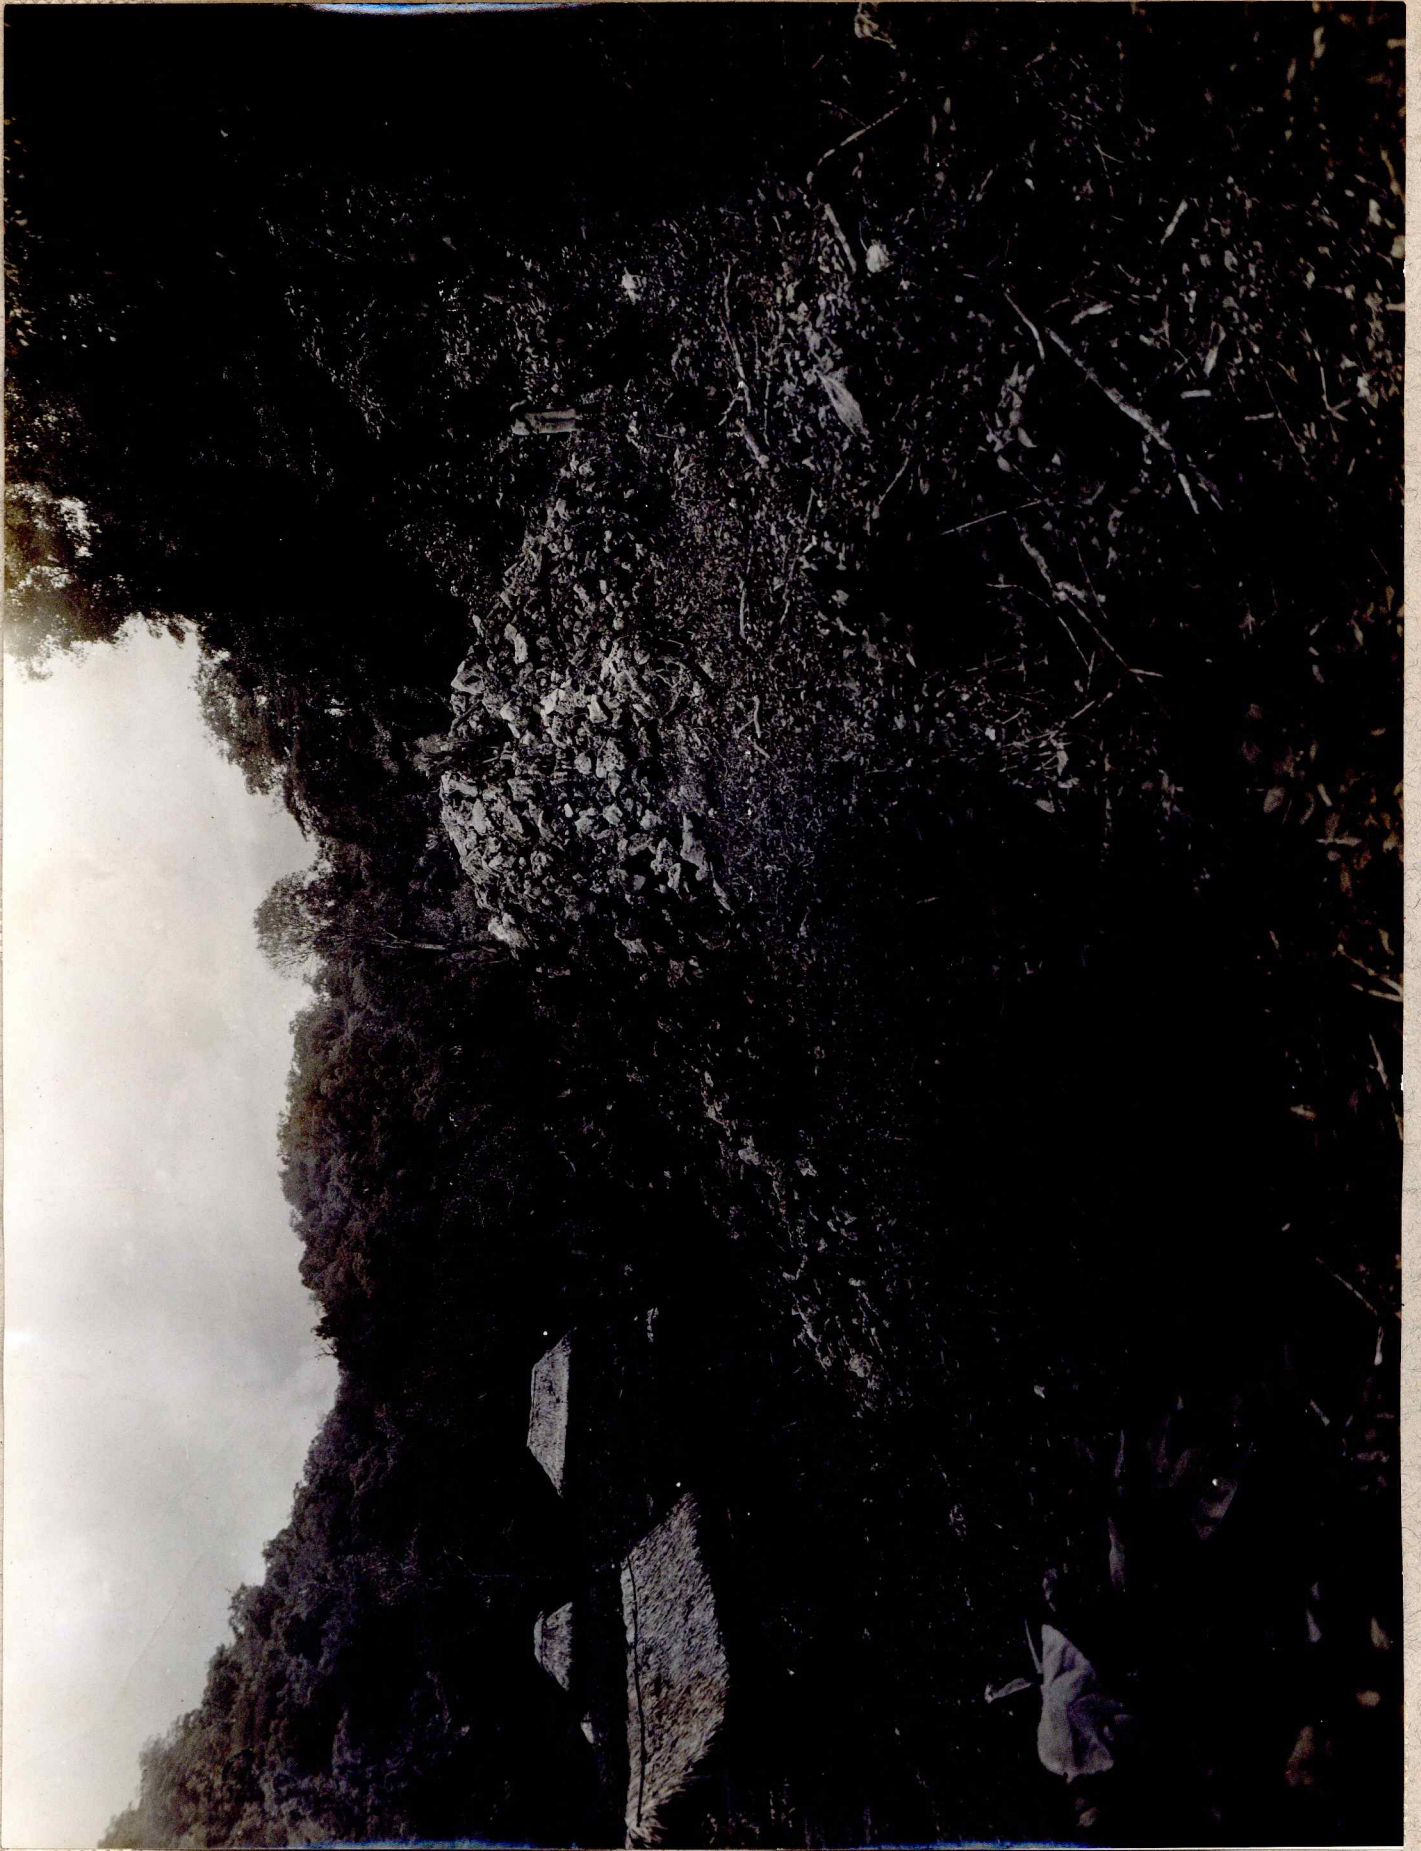
34-1

<u>1934</u> <u>No.</u>	<u>Str.</u> <u>No.</u>	<u>Dir.</u>	<u>Remarks</u>
1	F-2	NE	After clearing bush only - tripod on terrace running NE from Str.F-2.

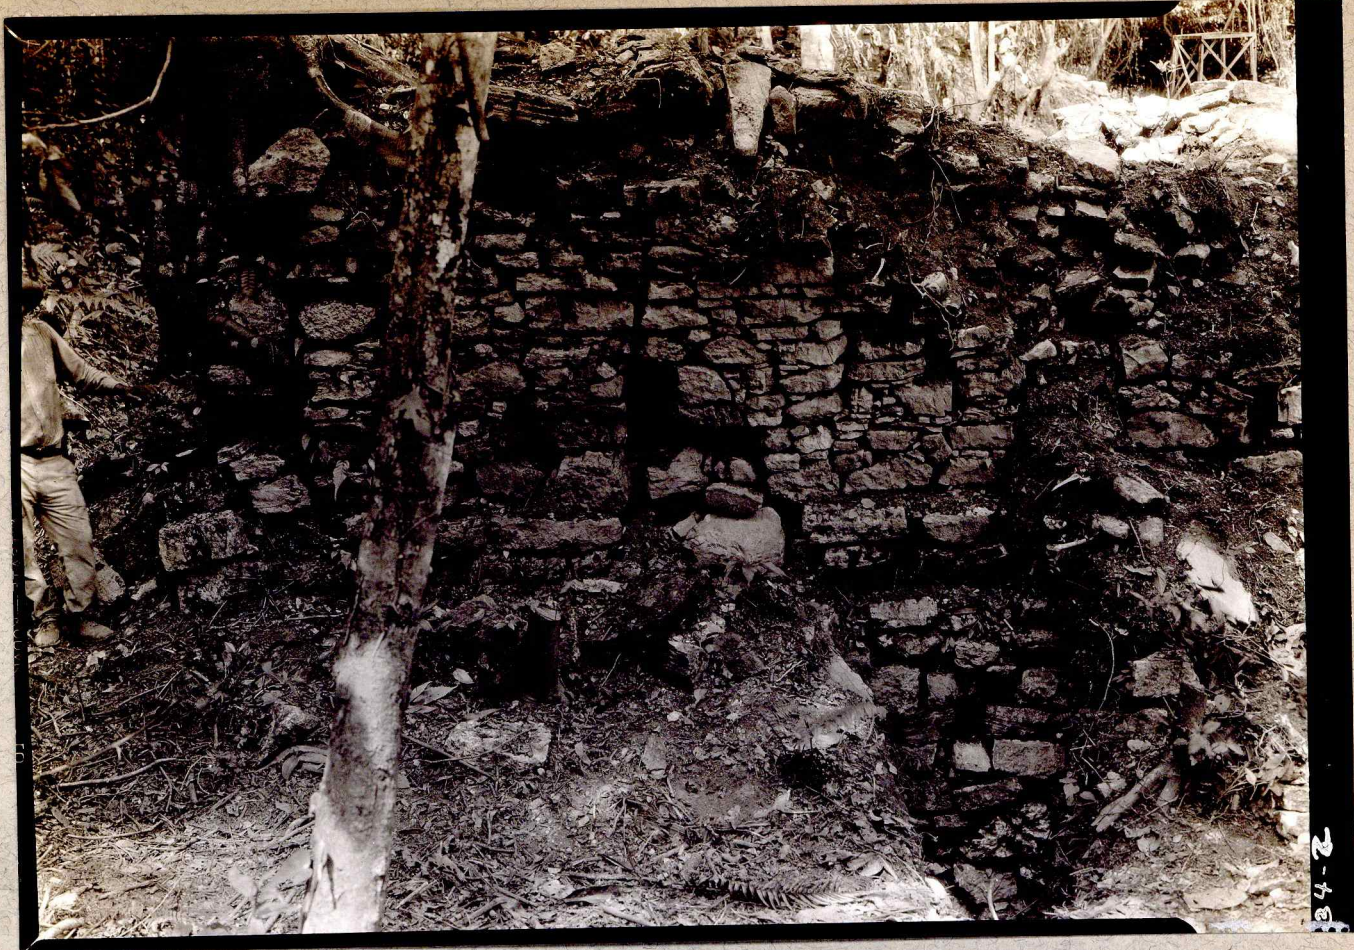
2-4-3

- 2 F-3 W Rear Facade - note pit showing platform wall- not so well chinked as free-standing wall above.
- 3 F-3 NE From tower to N. - front facade exposed by trench - Note round stone "portable altar" exposed on floor, right, behind doorway. Meter stick same position as in Nos. 34-9 and 34-10. Note secondary pavement, platform running below.

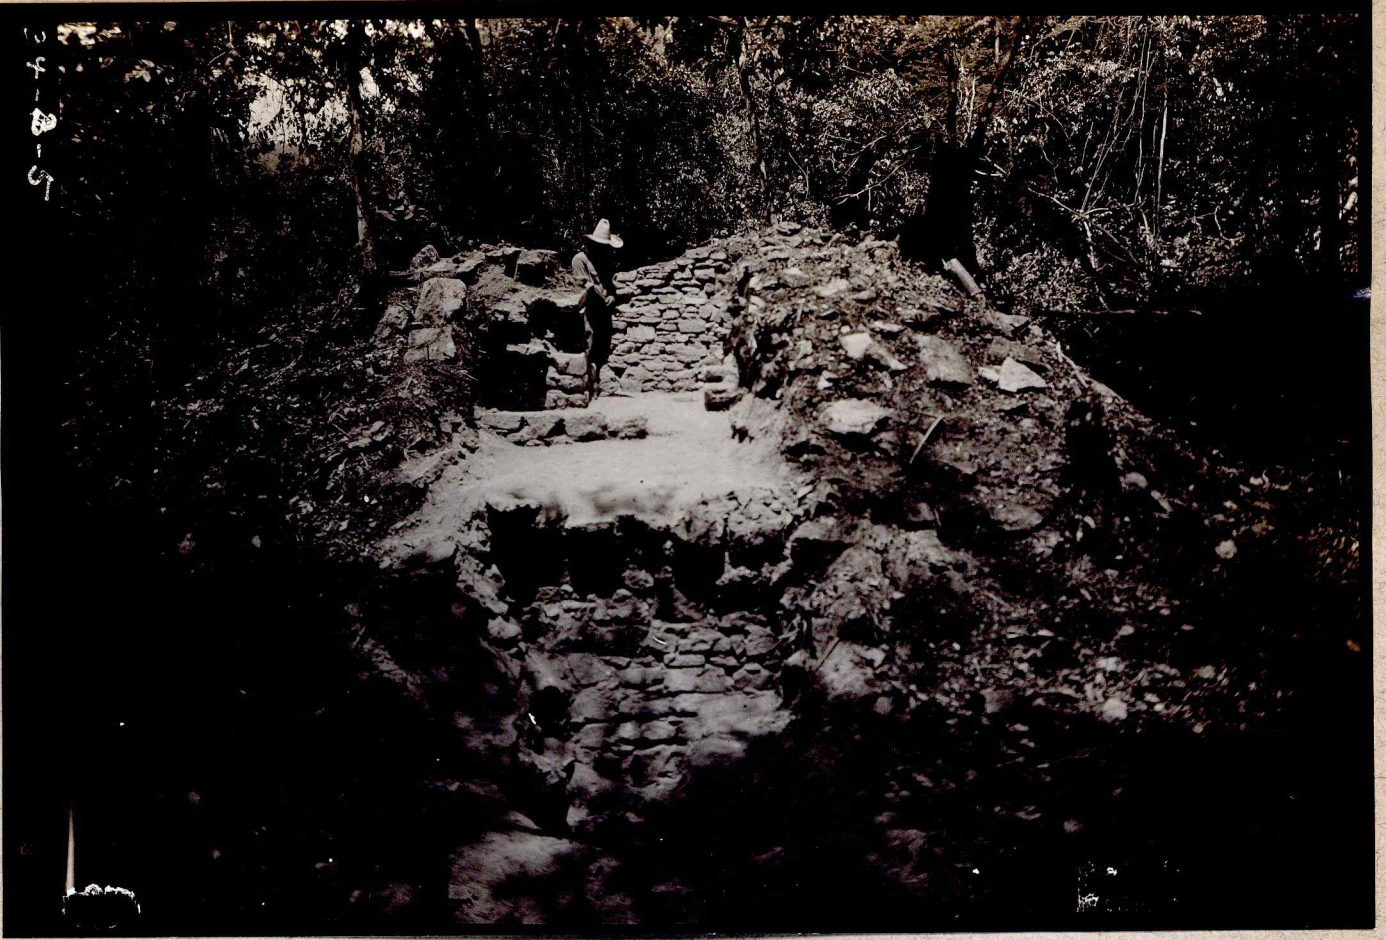
- 7 F-3 E Inner surface of rear wall of chamber: note use of small slabs, blocks, with chinking and plenty of mortar, which is grayish-yellow; remnants of thick finishing plaster here and there. Wall was pretty rough. Portable altar in right foreground, has not been moved.
- 8 F-3 SE Center trench from above and SE; Note round portable altar; a cut through floor ought to determine finally whether this was set in floor or not. The rough stone leaning against it, plus red color on sides suggests not, though no finished floor could be found under the altar, or immediately around it. The small odd-shaped stone (front of meter-stick) was reported to have been found in about position shown; the altar has not been moved as yet. Doorway at right - front part of left jamb has been torn out, probably by our men.
- 9 F-3 E Masonry of platform, front - see also 34-6

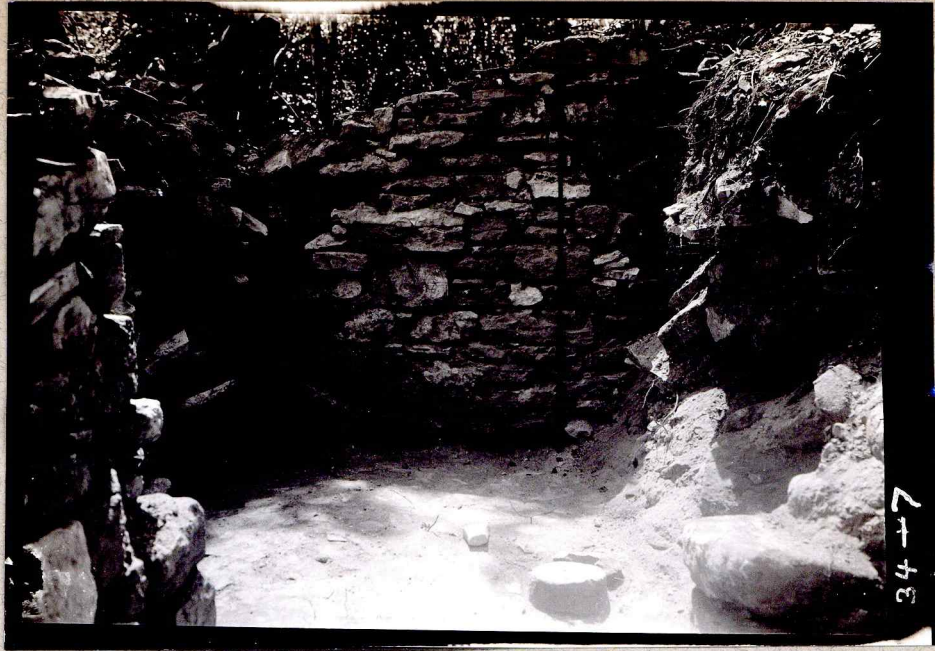
- 10 F-3 N Cut-section through debris in chamber, 50 cms right (SE) of SE jamb of center (and only?) doorway. Jamb appears at left. The large stone on floor to left, and one over-lapping are rough-worked on edges, possibly cap-stones. In general, note slabs and masses of mortar, which is grayish-yellow. Stick extended to 1.40m. Note: Further to the northeast the rear wall stands higher and debris slopes to front (see cross-section drawing in 1934 notes.)
- 11 F-3 Same as above.

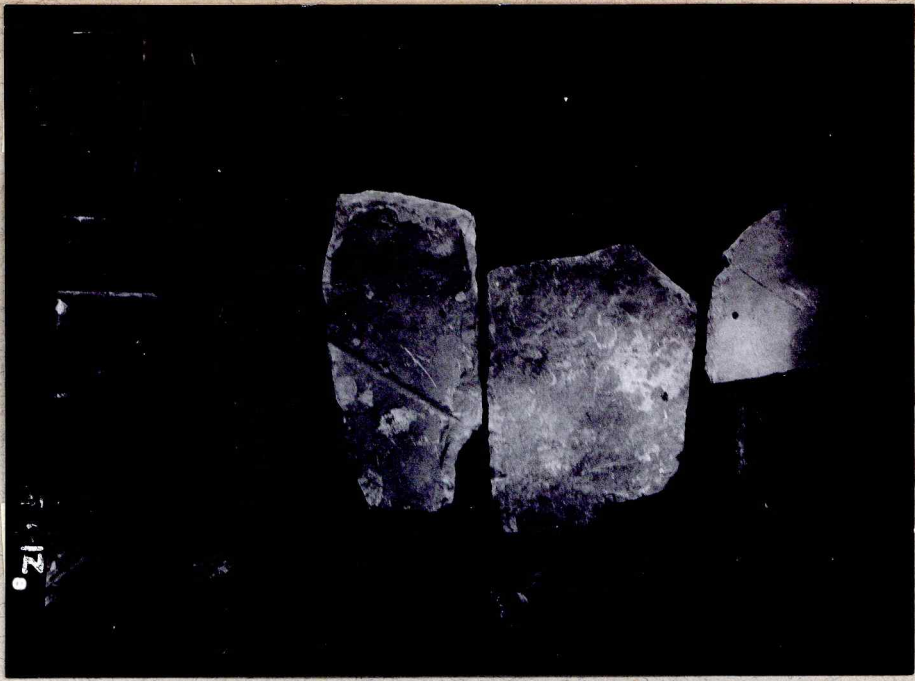
- 12 F-3 Cap-stones from center trench. That at right represented by one end only. The holes are probably not artificial.
- 13 F-4 W General view of mound from right end, at court level near juncture of F-2 with court platform; F-3 out of picture on immediate left of camera. The white stones on slope are from excavation but not deep enough to distort shape of mound much. Boy at right is on the plaza level, to which the front of the mound debris reaches. Boy at left on court level, which is higher.

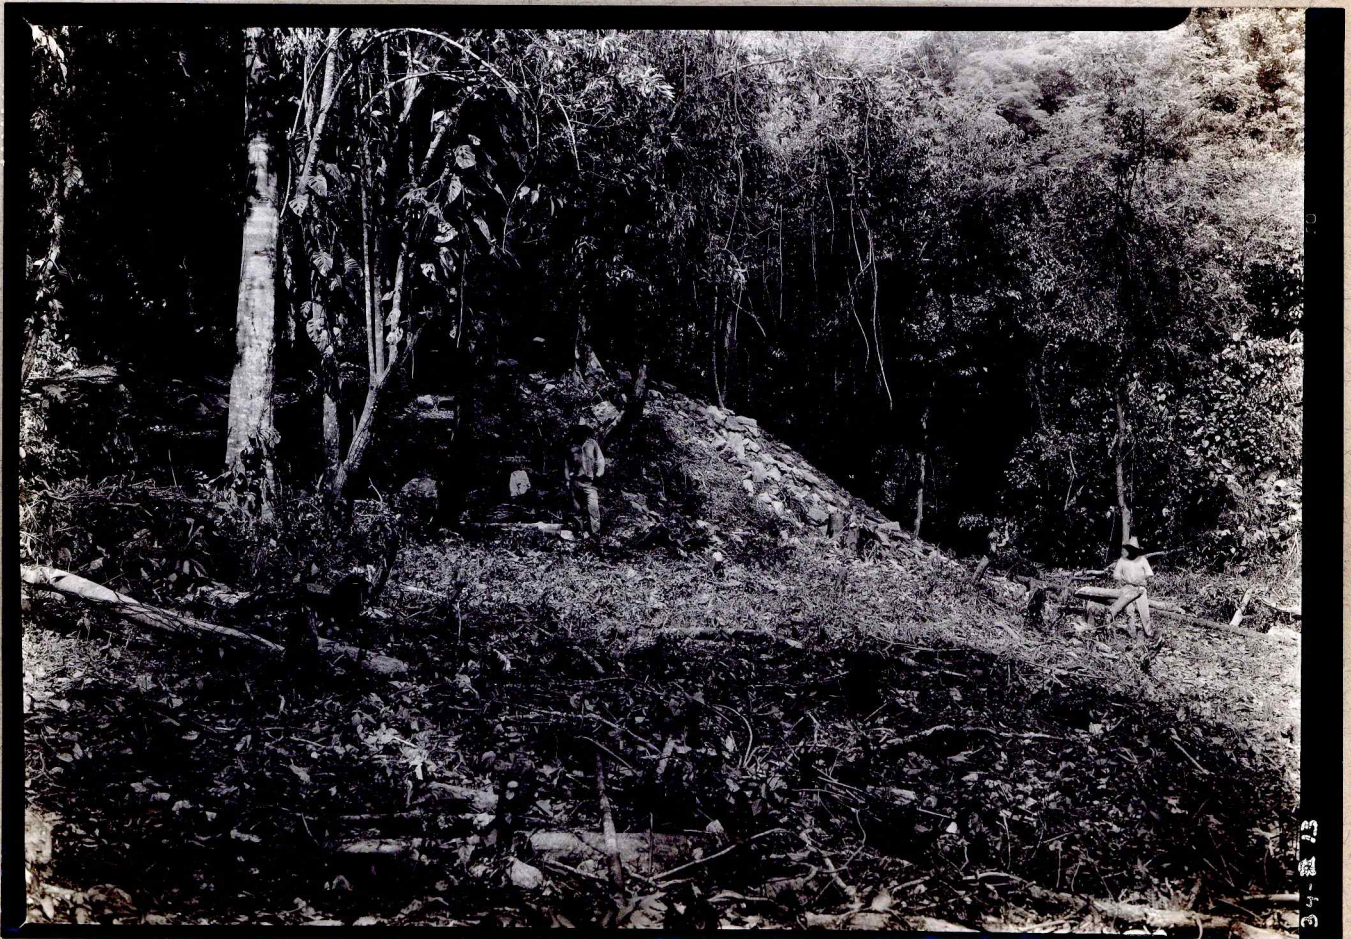
14 F-4 S From tower at front; the wall in foreground retains the narrow esplanade; the next is the plinth of the building; beyond the portable stone altar on the floor; behind this the inner face of the rear wall. Picture is through central front doorway, the jambs of which are badly fallen.

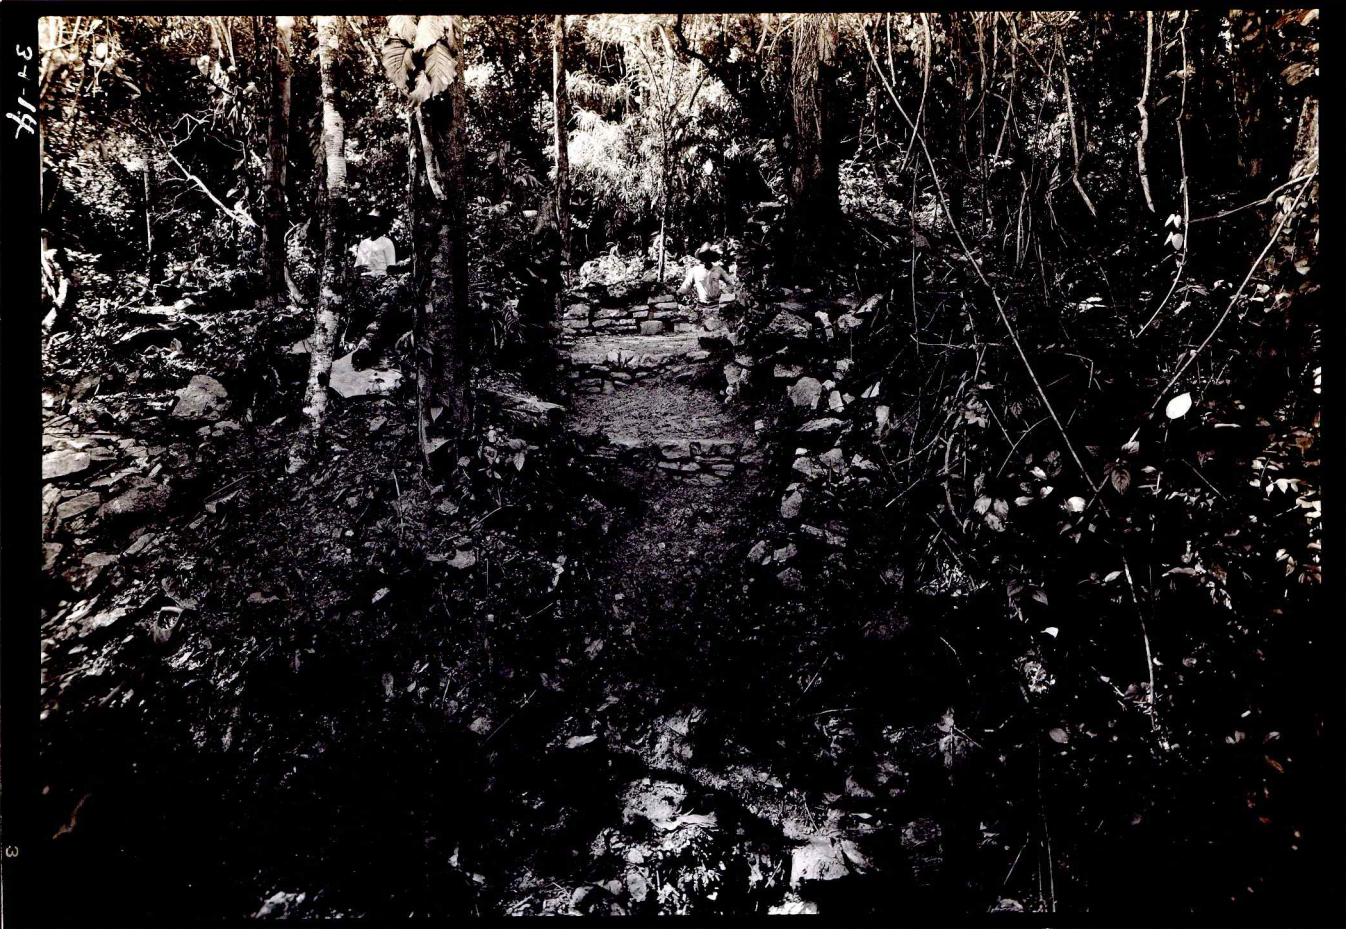
15 F-4 NE From rear, to left, after 1934 excavations; note stump of rear wall, fallen out; portable altar (unmoved); right jamb of front central doorway joining right partition buttress; doorway to right room; right jamb of right front doorway and left jamb of ~~1/2~~ right end doorway.

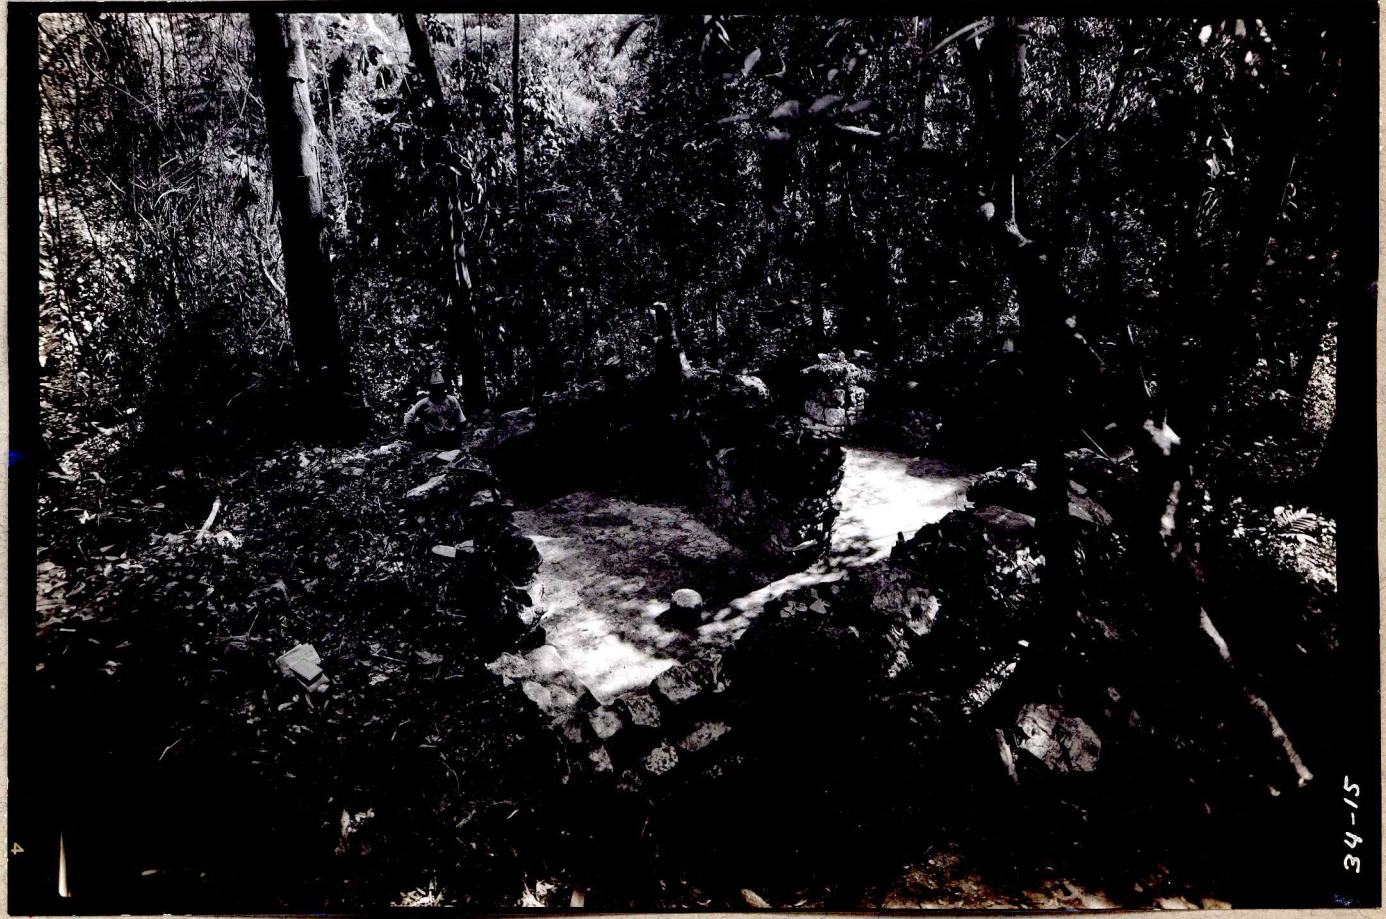
16 F-4 NW Similar view from rear, but to right; shows left partition buttress (broken down toward rear) with debris-filled doorway to left room in front of it; left jamb of central front doorway; left jamb of right front doorway (the rear half fallen so that the partition appears to stand free at the front, which it does not as appears clearly from other side in #34-15); boy stands in front of right end doorway, facing it.

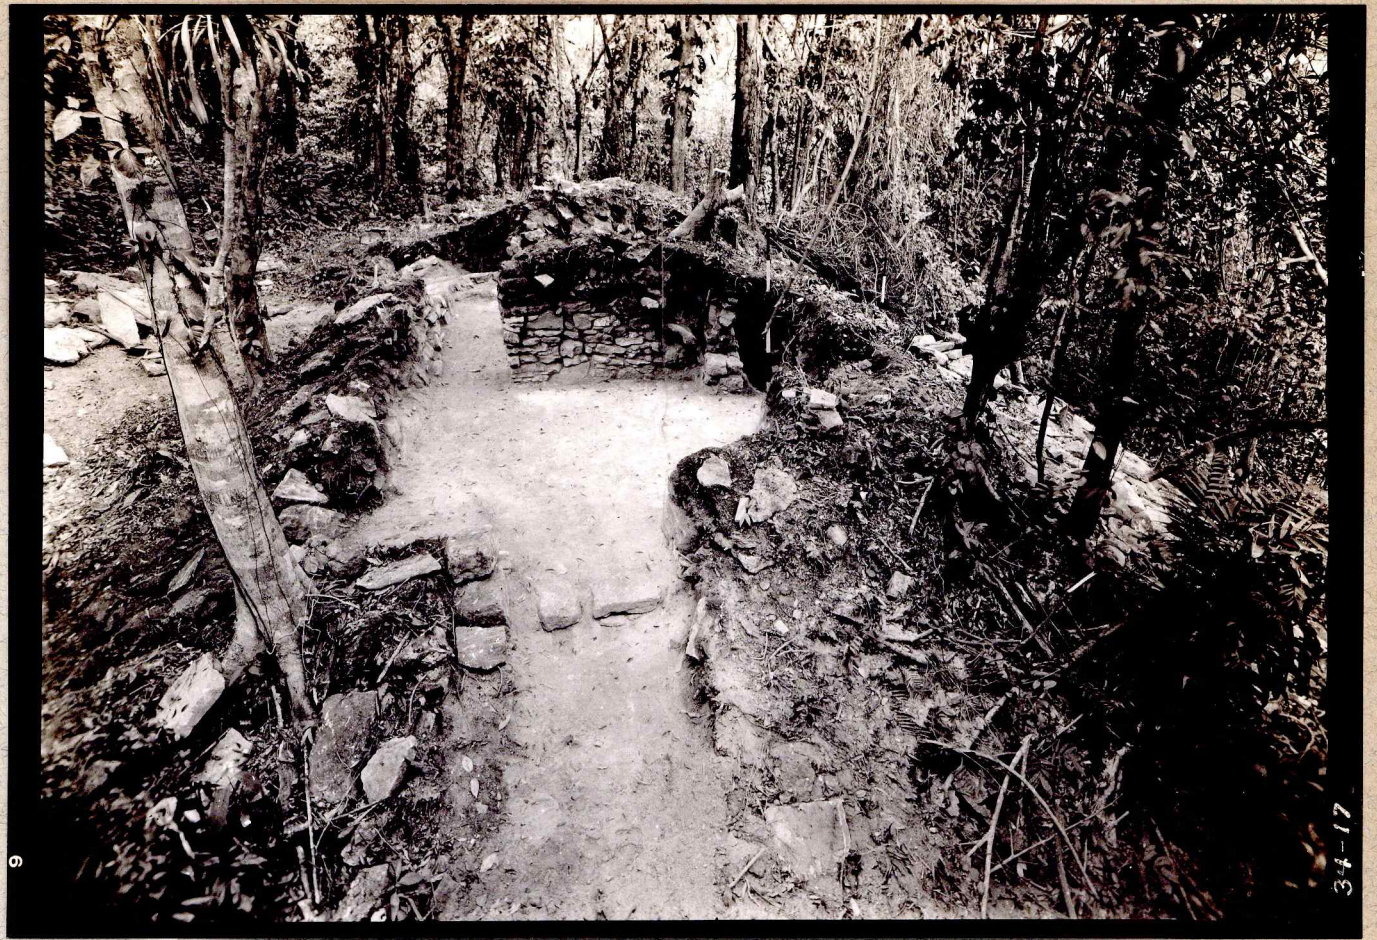
34-17

- 17 F-4 W Similar view from tower, from right of building, looking over and through right end doorway.
- 18 Same view as 34-17.
- 19 F-4 NE D tail view of center room, right partition buttress and portable stone altar. Note white plaster floor, turning up to buttress; meter stick extended to 1.40. The debris on the buttress represents undisturbed original surface.

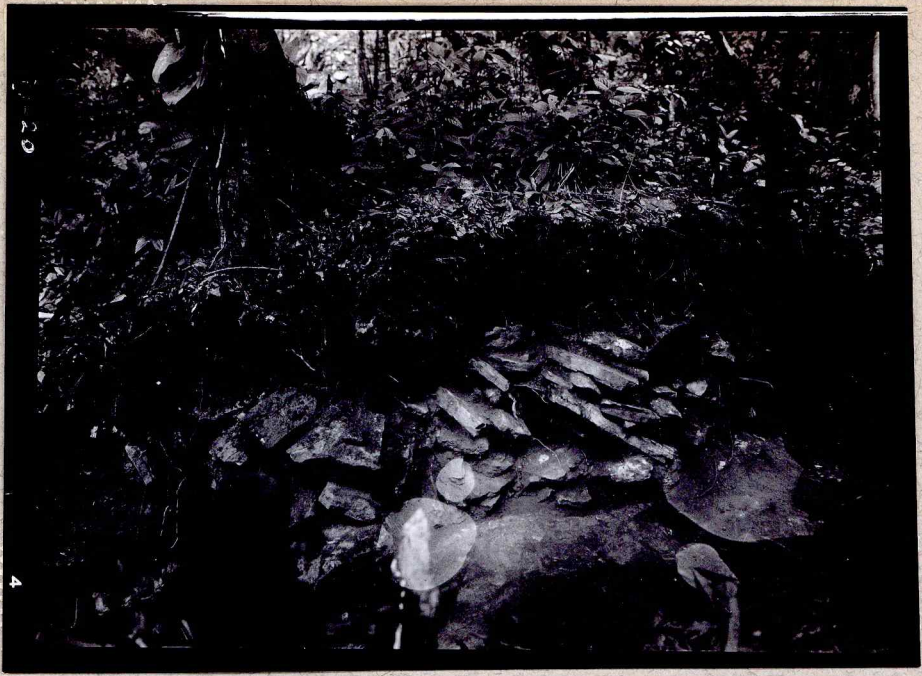
- 20 F-4 E Cut section through debris (line A-B in drawing), 50 cm right of center, from front (left) to ~~six~~ altar; thence to rear cut back. Stick extended to 1.20m. At extreme left, section projects toward camera to show fallen wall stones in doorway.
- 21 F-4 Same view as 34-20
- 22 F-4 N Rear wall from outside - lowest course only, plus section of plinth revealed by shallow trench; note left partition buttress beyond, torn out at the rear (near end) except the lowest courses, which run back to the inner face of rear wall.
- 23 F-4 Cap stones from excavation.

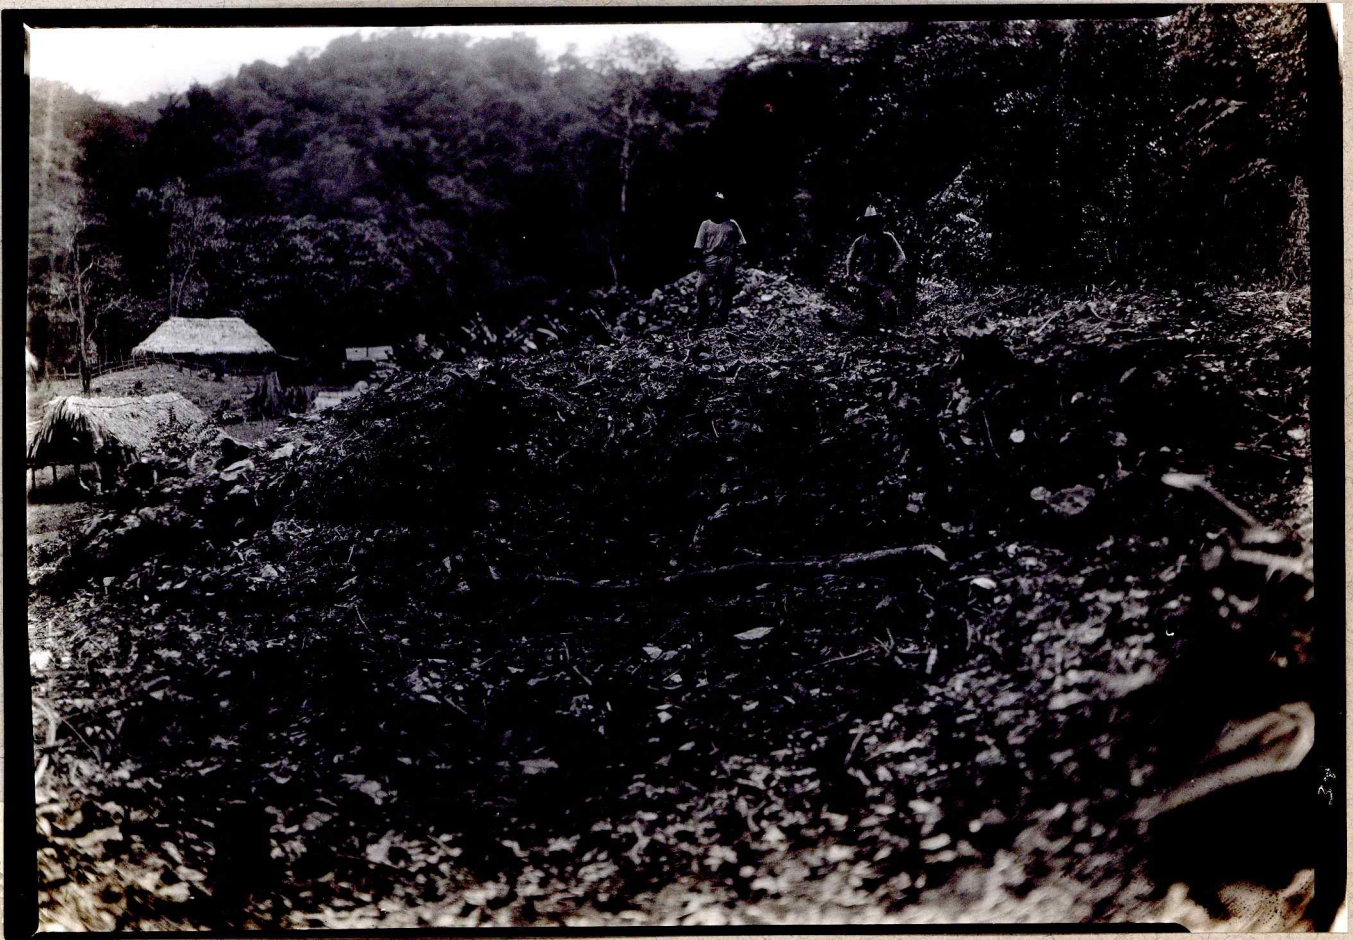
25 F-5 NE A non-vaulted mound, with small hillocks of debris,  
similar to P-6, and Strgs. 5 and 15 at Yaxchilan.  
Camera is on plaza level, the top of mound about  
on eye level; do not be confused by the top of  
Str. F-2 behind the boy on left. That boy stands on  
the forwayd hillock, the boy on right in the little  
valley between this and the next, on the general level  
of the surface.

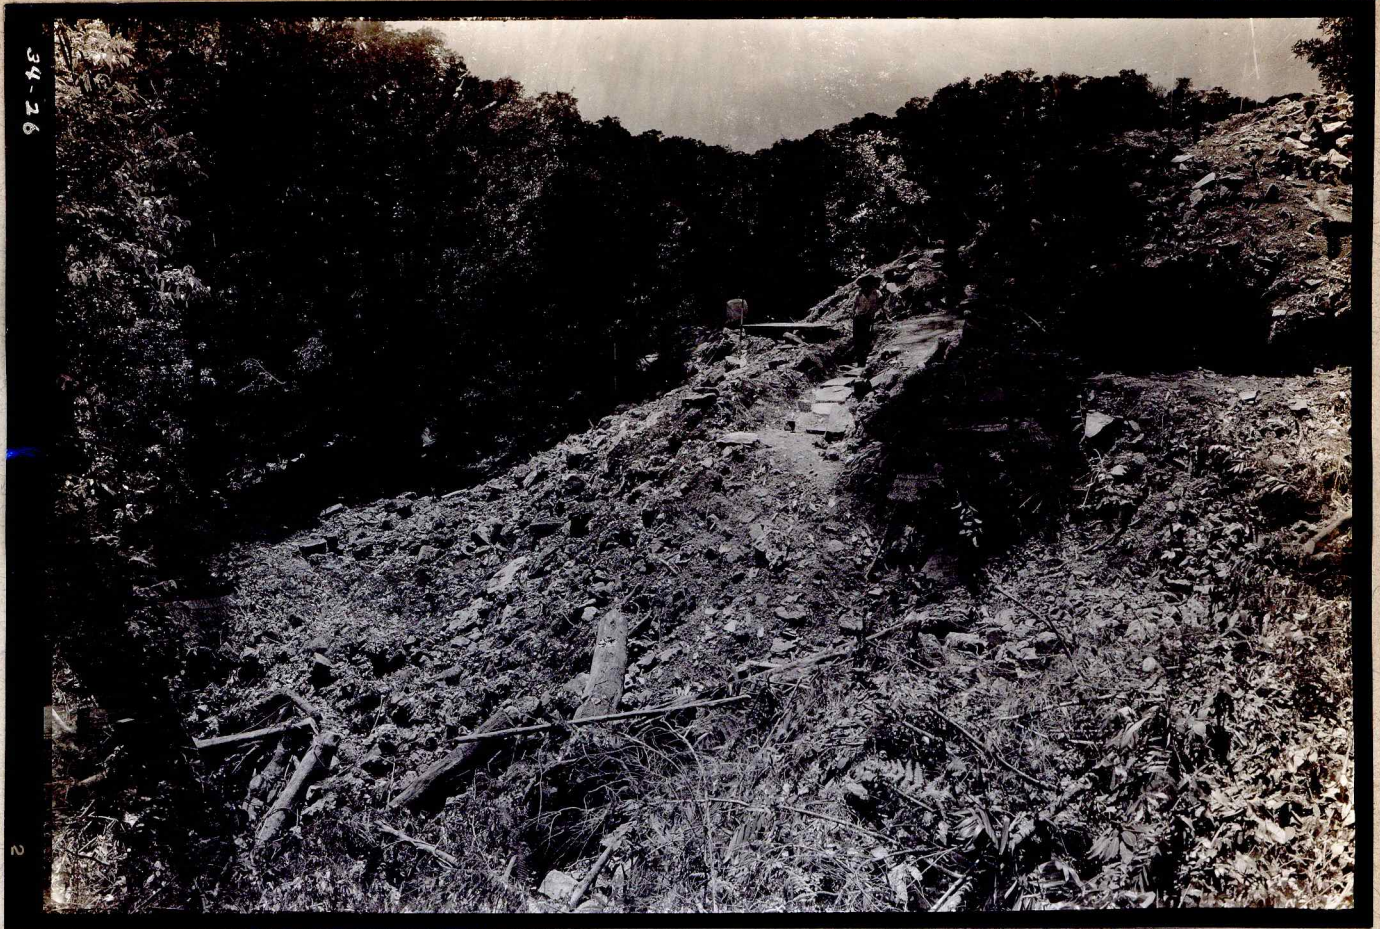
- 26 J-29 NW View from left, double exposure, same as 34-27 except that it shows sky-line.
- 27 J-29 NW From edge of cliff which carries great stairway (Str. J-28), camera about on level of ~~max~~ eye of person standing on promenade in front of temple, but slightly farther front. Note at right the angle formed by left end wall; to front of this the ruined left corner, the source of all but one of the recovered fragments of Miscl. Sculptured Stone No.13;

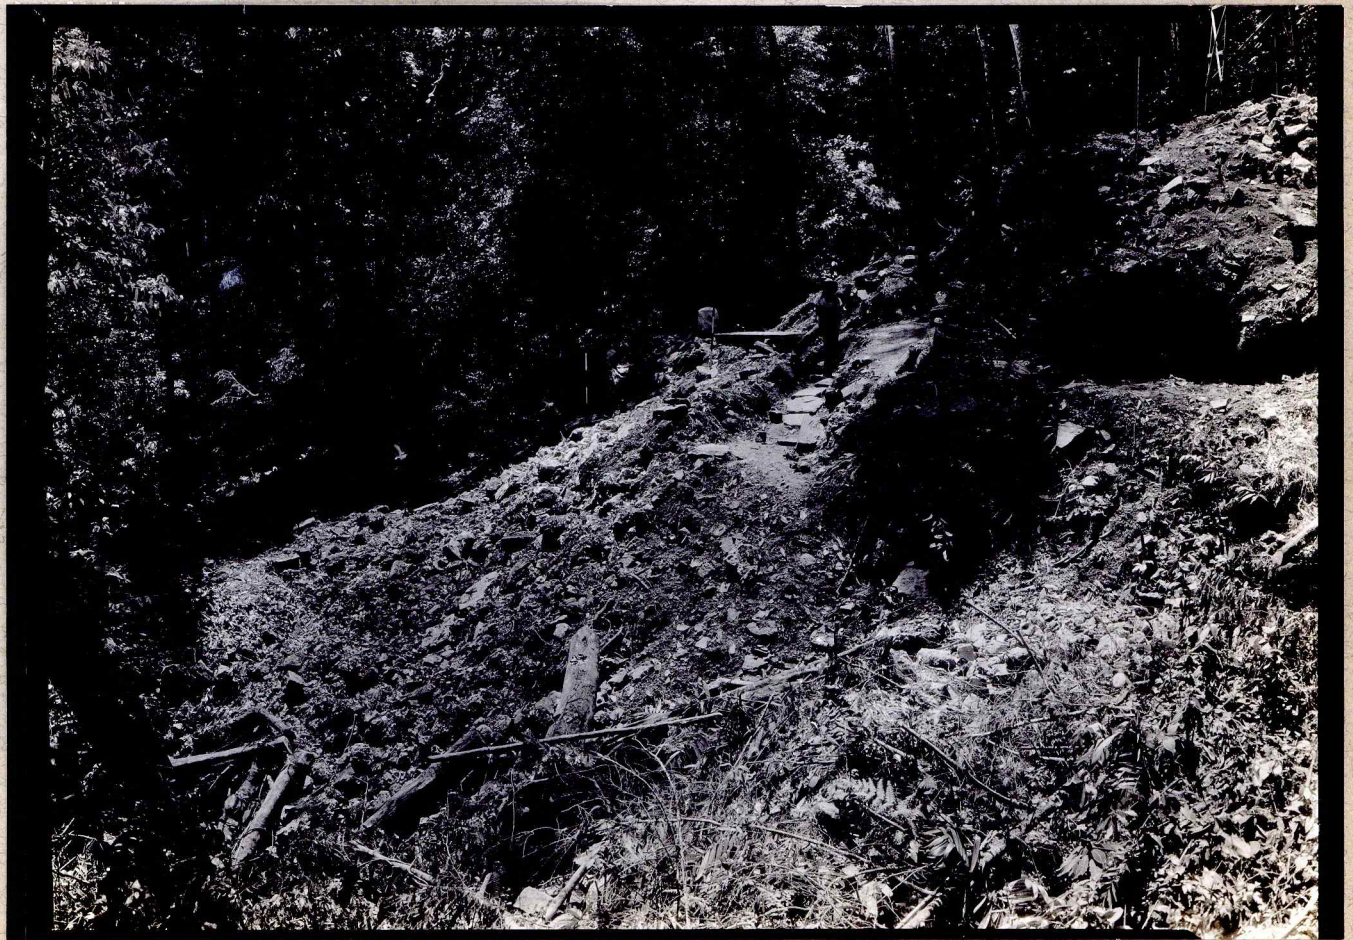
- 28 J-29 NW Similar to above, but a little lower and farther front, Besides above features shows part of left and side of middle pier. The boy near center is on terrace level below fronting promenade, behind a line of stones which we put there; the boy at left is on surface of top of pyramid proper. The center boy stands in our trench; behind him and to his left a small hump of debris thrown on the slope by us. Otherwise picture shows untouched debris surface back to the center axis marked by the two range poles. The range pole at extreme right marks rear of building on center axis. The level rod (behind trunk) has base on chamber floor at edge of rear sill or bench, just beyond center axis.
- 29 J-29 NE Front elevation after 1934 excavations, from tower on pyramid top. Note base of wall of "promenade"; plinth, doorways, niche and altar; heavy slab rear wall.

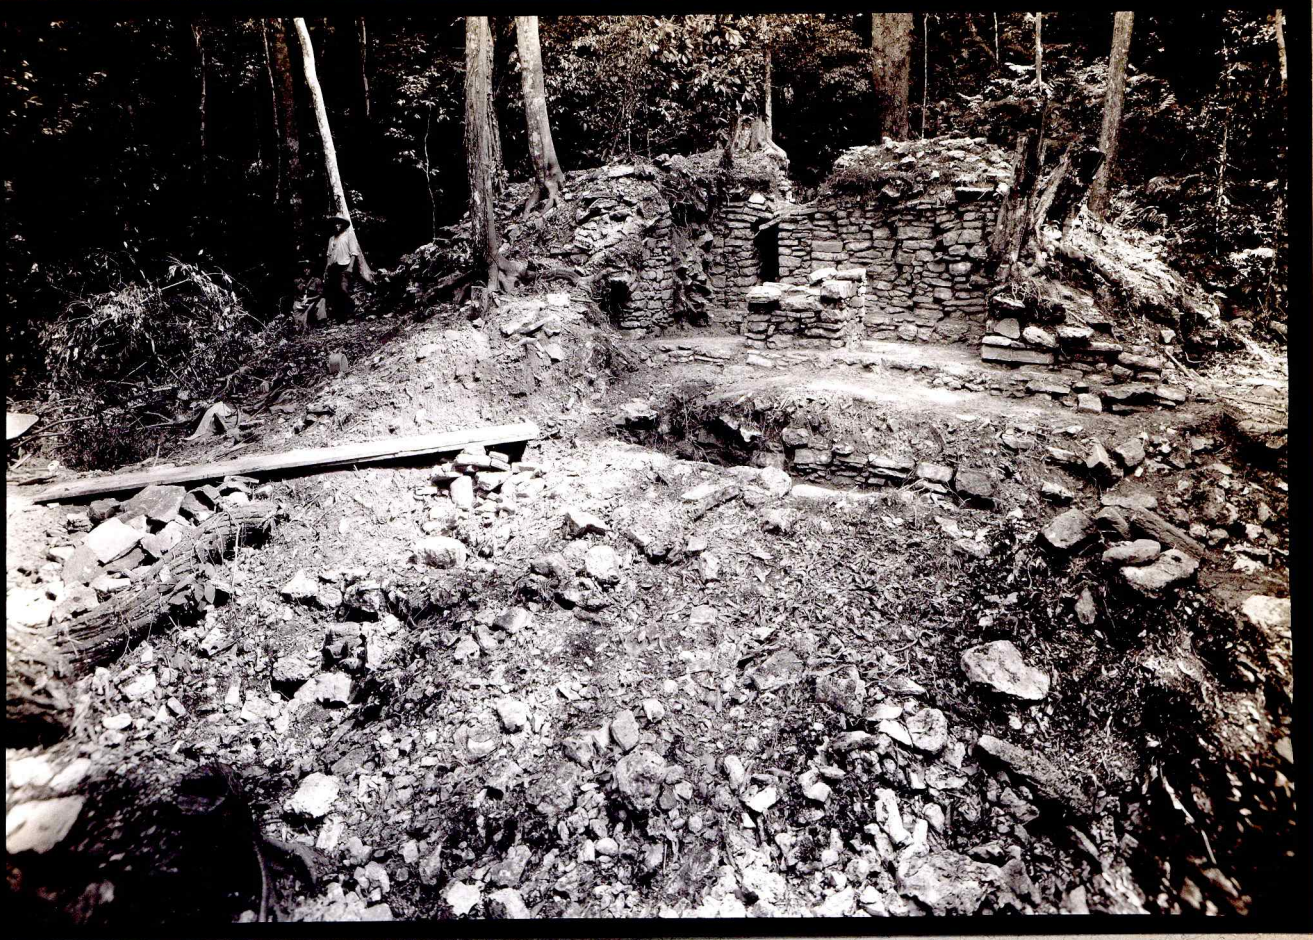
34-31

- 31 J-29 N Similar to 34-29&30, but to left a little. Note specialized long blocks in left pier and left jamb of left doorway.
- 32 J-29 NW The chamber from tower just beyond left end, shows original debris in position at right end, with cut section; rear sill or bench; left face of piers.

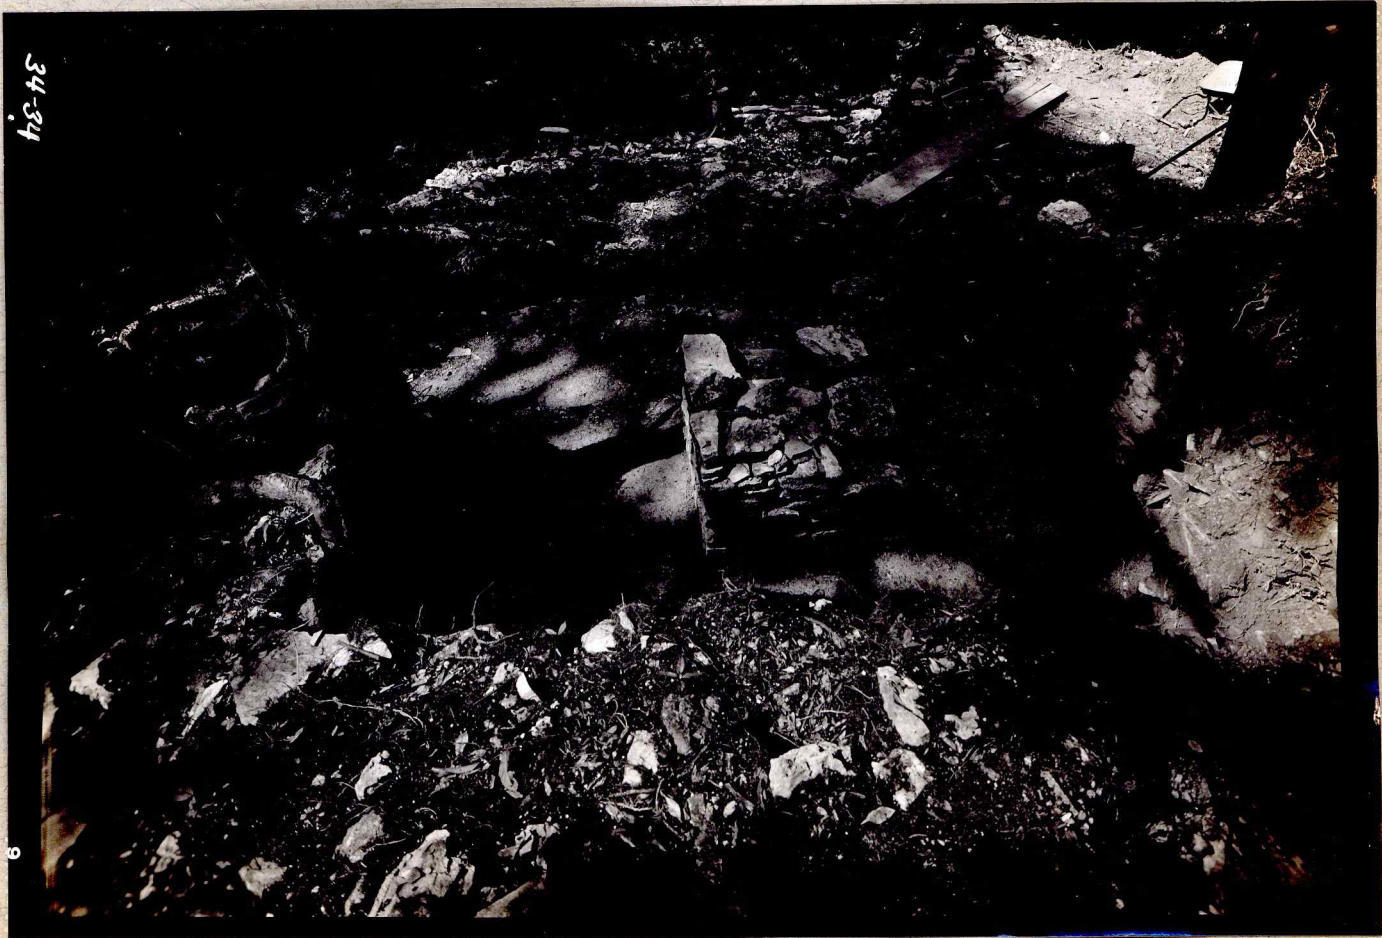
- 35 J-29 SE And from almost above (on tower); Looking down on flue, from which all but one covering slab have been removed; Note at left that flue runs outside through rear wall; At right slab construction has been removed to show left side of originally wider niche. The flue disappears at right under slab construction which has not been removed.

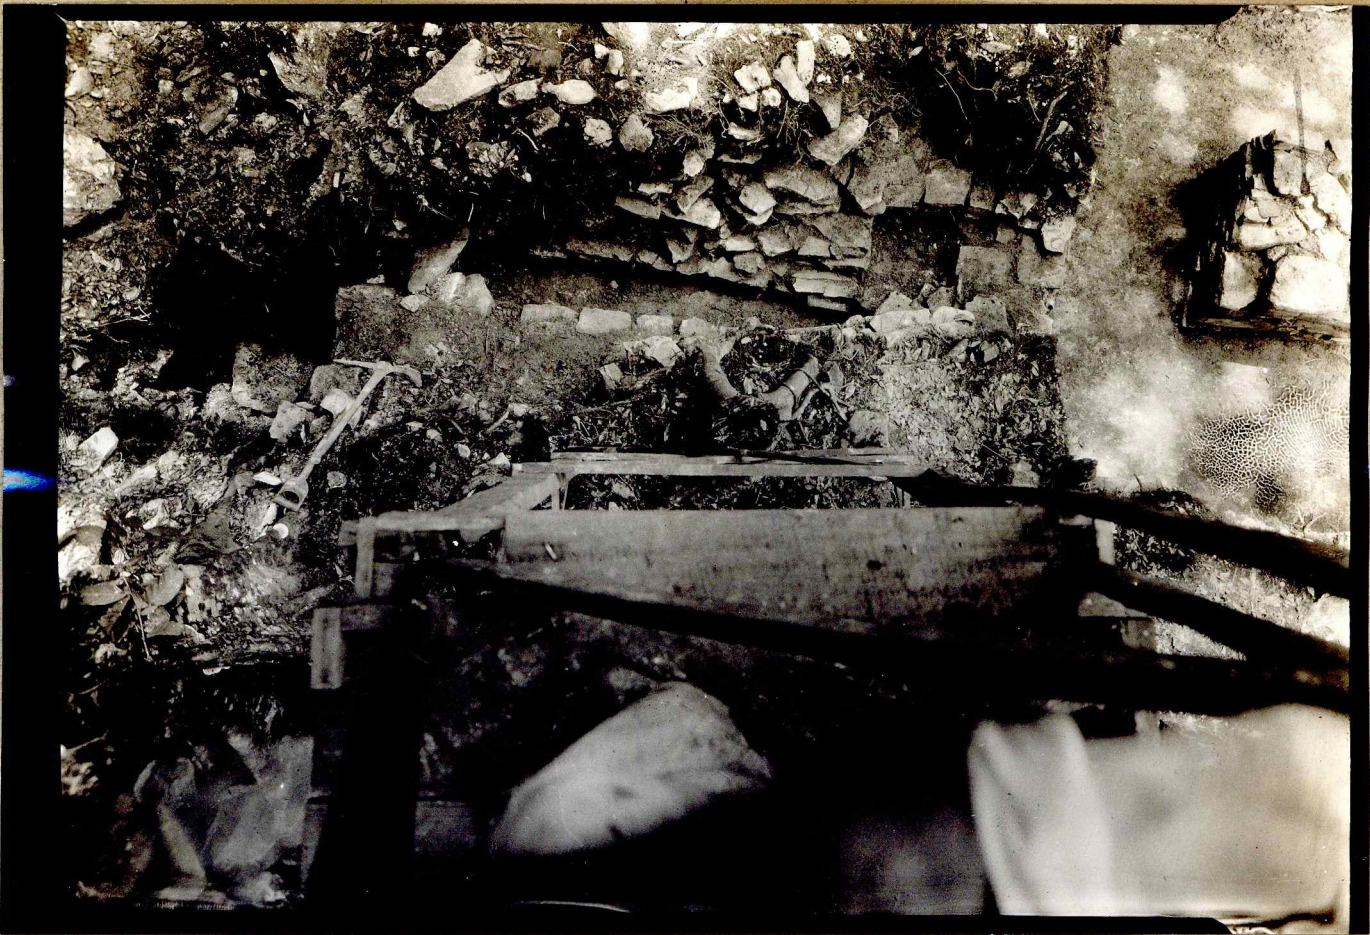
- ~~34~~ ~~J-29~~ ~~SE~~
- 36 J-29 SW Mound from slope at rear; in foreground, pit to show rear wall, meter stick at 22 cm; despite apparent slight batter wall looks like a free-standing one of heavy slabs, one block showing; latter probably part of general movement forward - it is very irregular. To immediate left of pit see opening to the flue, and the flue running forward under the single cap slab left at the rear end; Note the slab construction at sides of flue - this crossed over it. This construction extended from front to about 1.50 m from rear wall. At left see original mound surface, thoroughly cleaned of bush only - some slabs, blocks, small irregular stones; Left foreground, large boulders which have rolled down hill behind and stopped against the building after it had become a ruin - did not find these at lower levels in the pit. See 34-37 for close up of wall and flue).

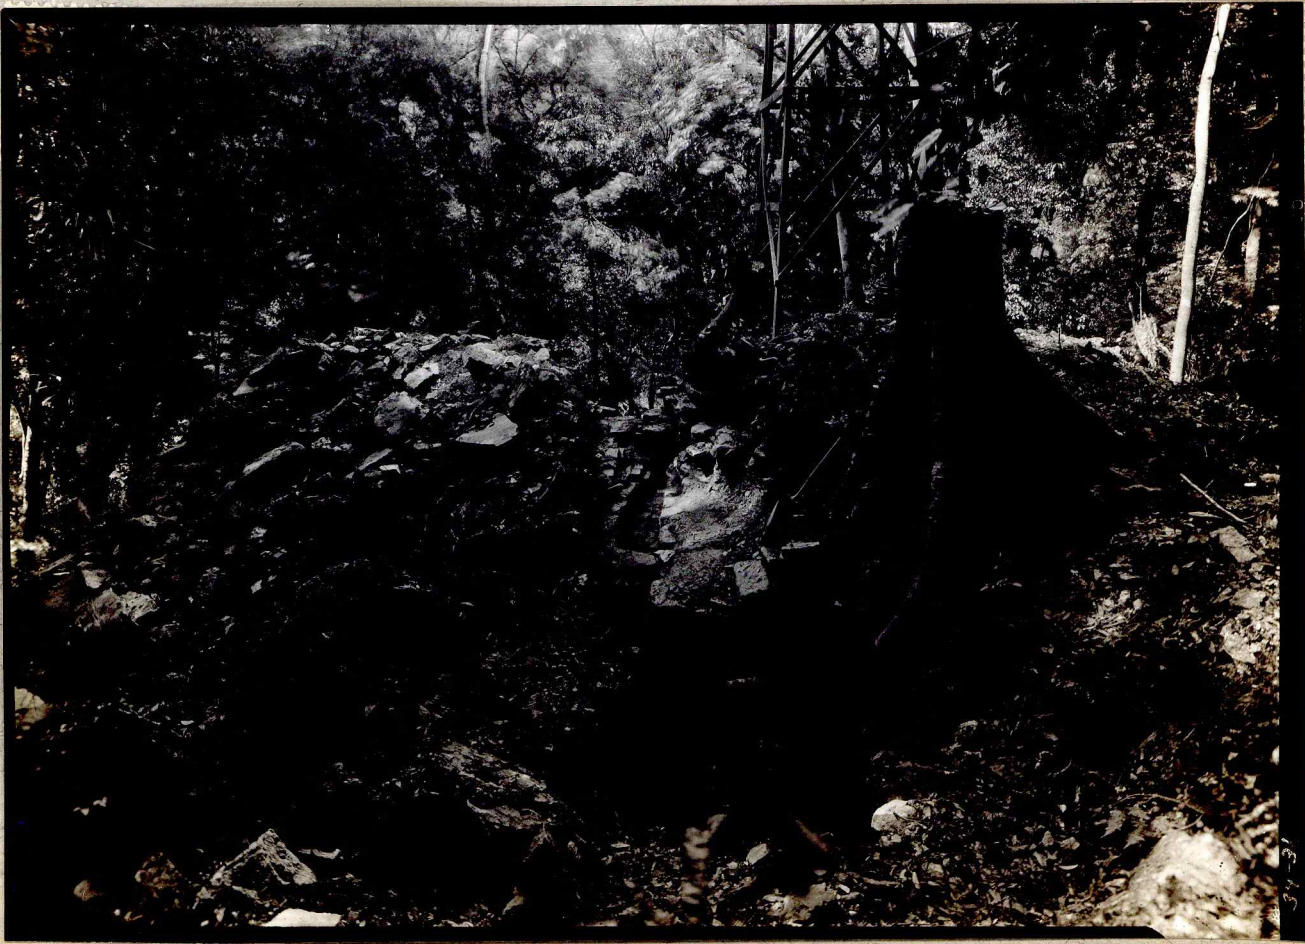
37 J-29 SW Close up showing constructions mentioned above in der  
34-36. Meter stick @ 22 cm.
