Piedras Negras  
FIELD CATALOGUE - 1934 Photographs.

2 1934.

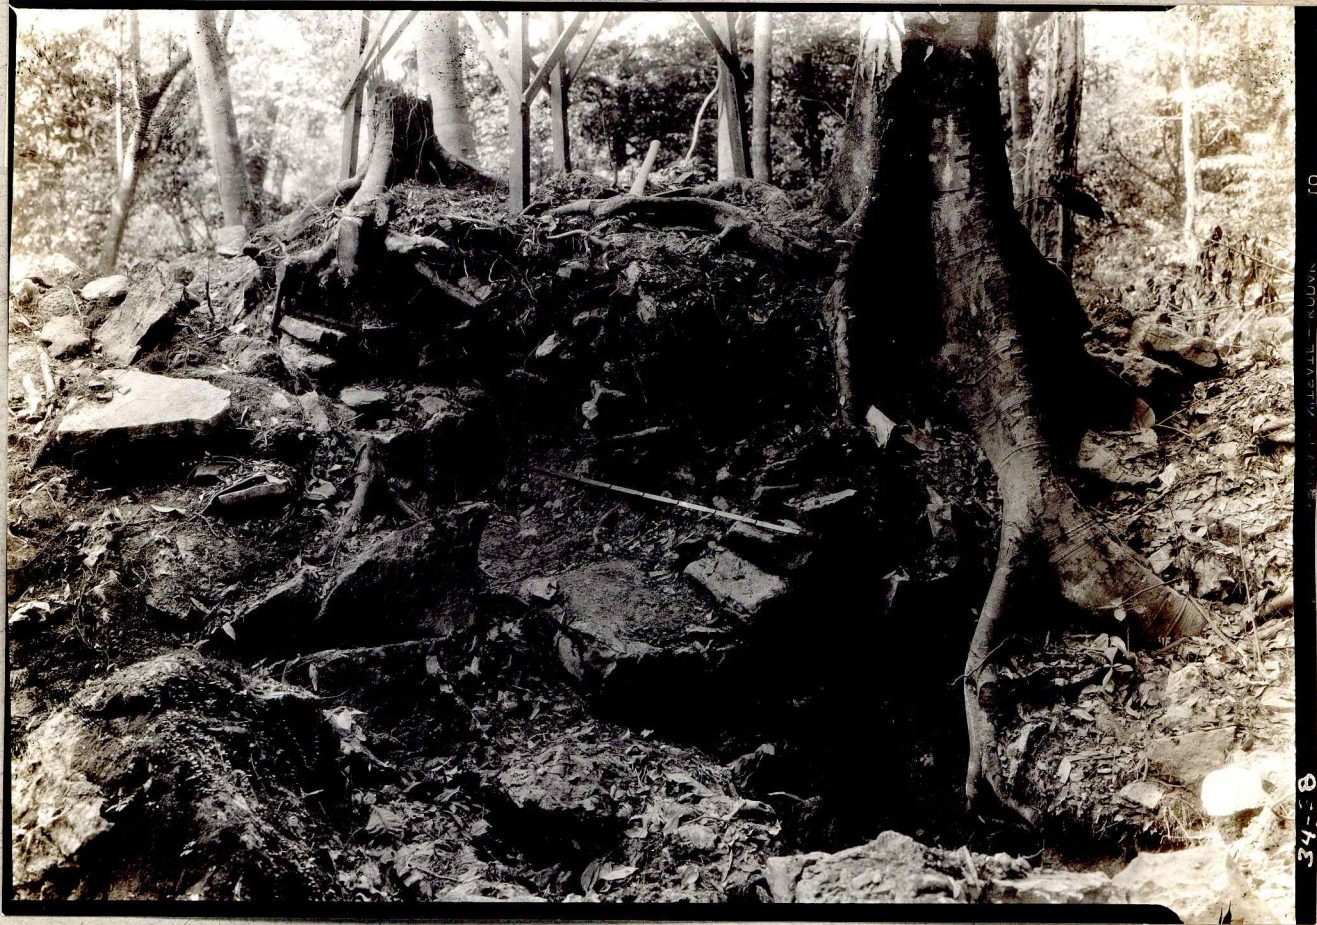
38 J-29 SW From rear, to left; left end of stick, extended to  
82 cm, points to approximate location of last fragment  
of Misl. Sculptured Stone No.13. Note that slab  
construction is doubtful from here back.

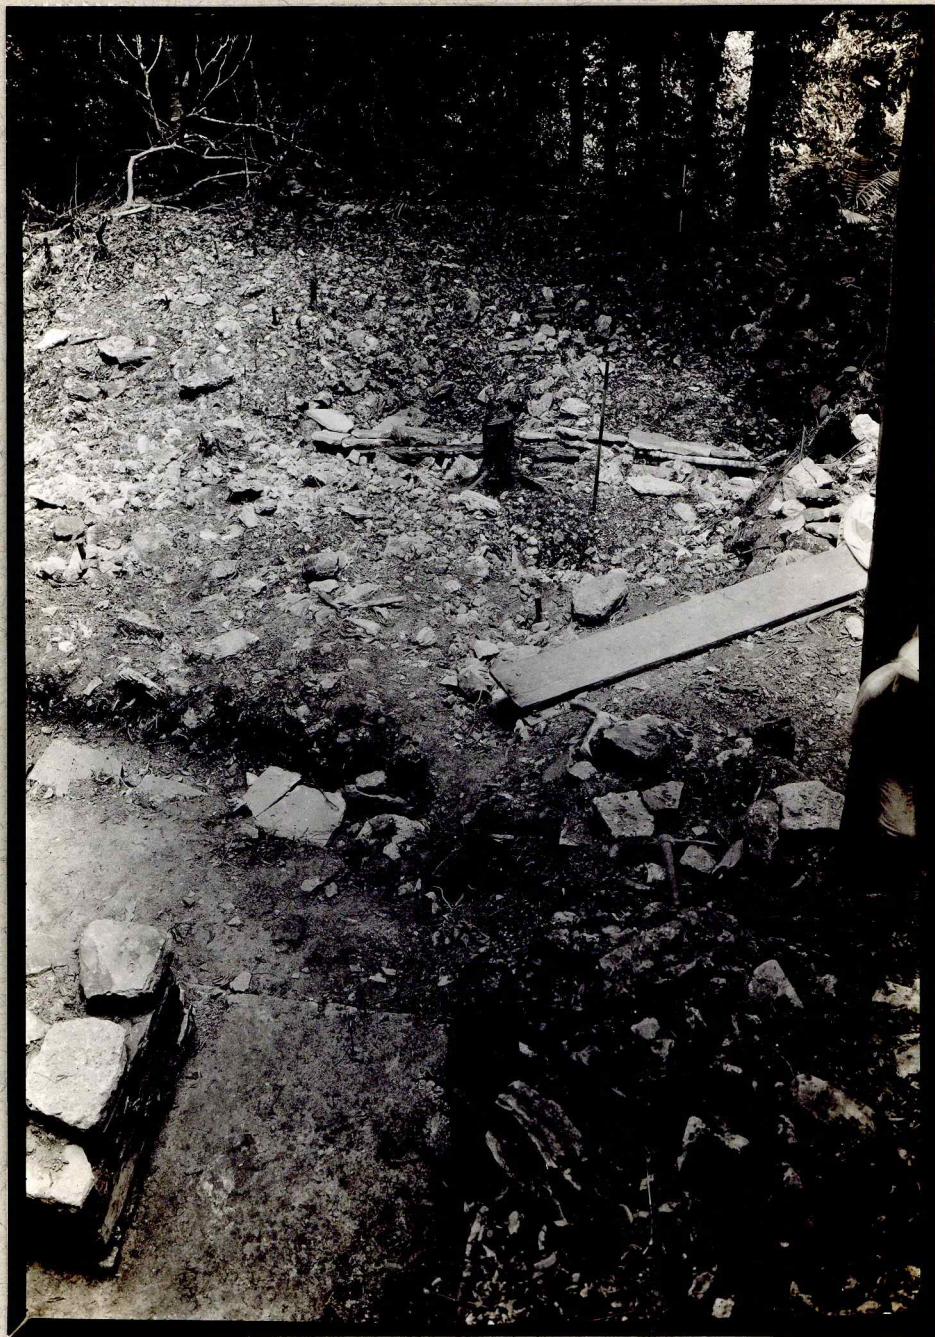
39 J-29 S From tower, right to center of rear portion of building; shows corner of left pier; in upper left background, the left front corner of pyramid proper; range poles are on approx. center axis.

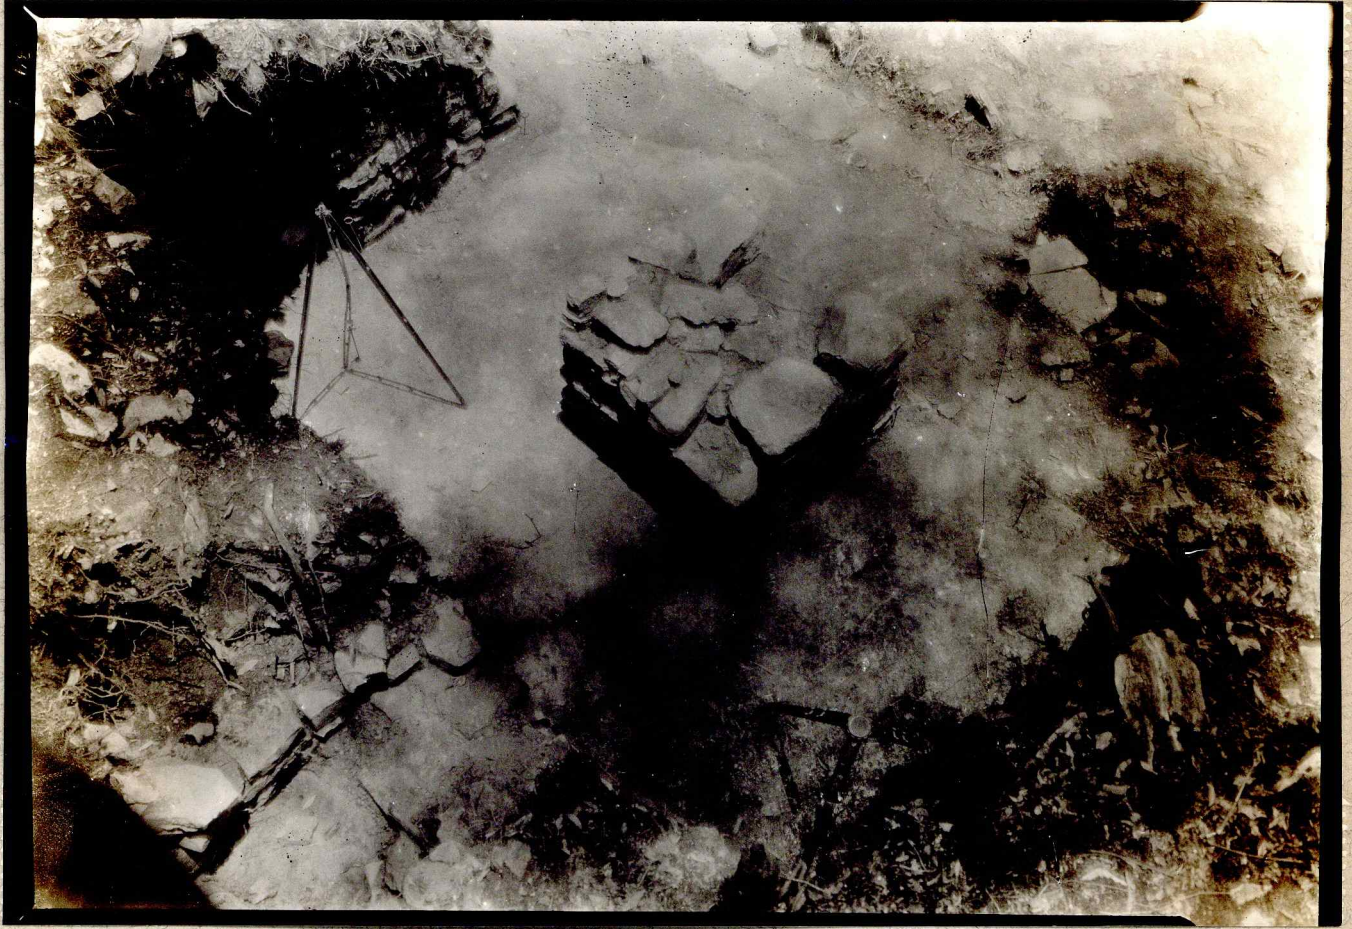
40 J-29 SE From same tower position, looking more to left; shows  
left pier and left end plan - poor negative (camera  
moved?)

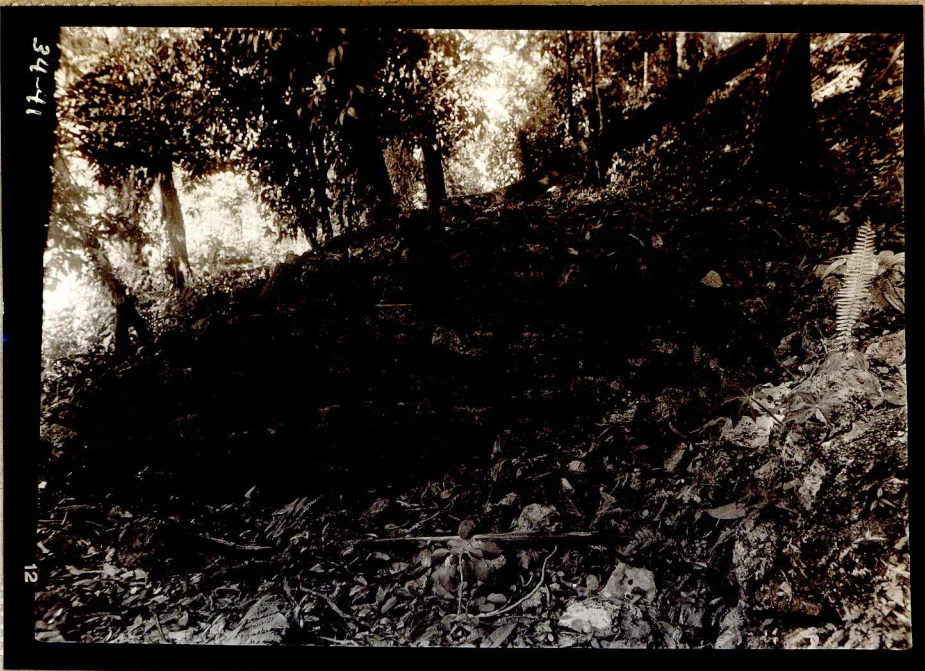
34-41

- 41 J-29 NW Retaining wall at left end of basal front terrace; small slabs, slab-blocks, and occasional blocks; no remaining signs of mortar.
- 42 J-29 NE Niche and column-altar in position, close-up; cut section of debris at left; meter stick @22 cm rests against altar; note that niche has been secondarily narrowed.

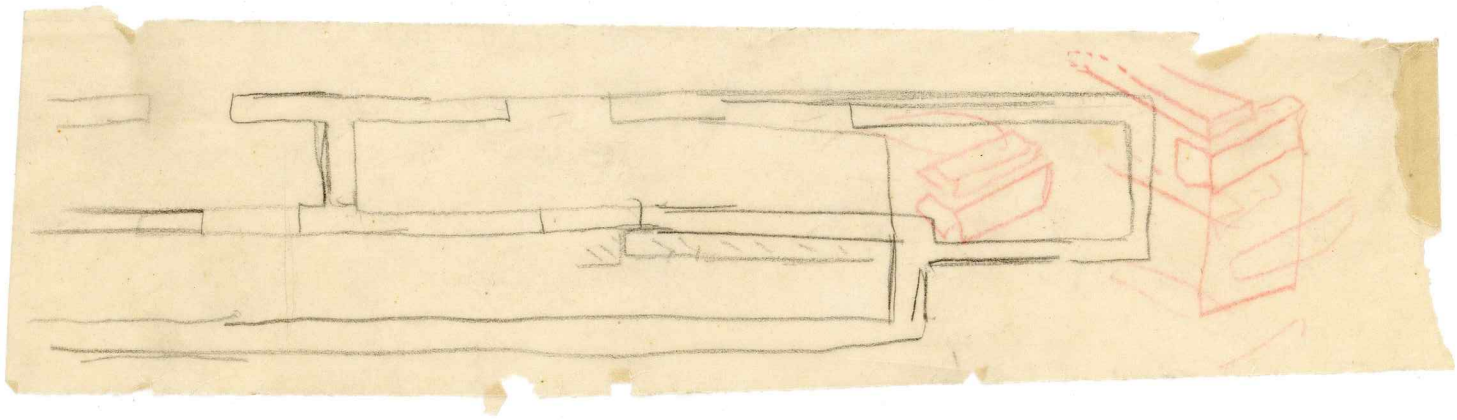
43 J-29 NW Niche and column altar, close-up; see 34-42; and  
1934 sketch-notes for details of broken slabs  
above, taken from in front of left pier.
