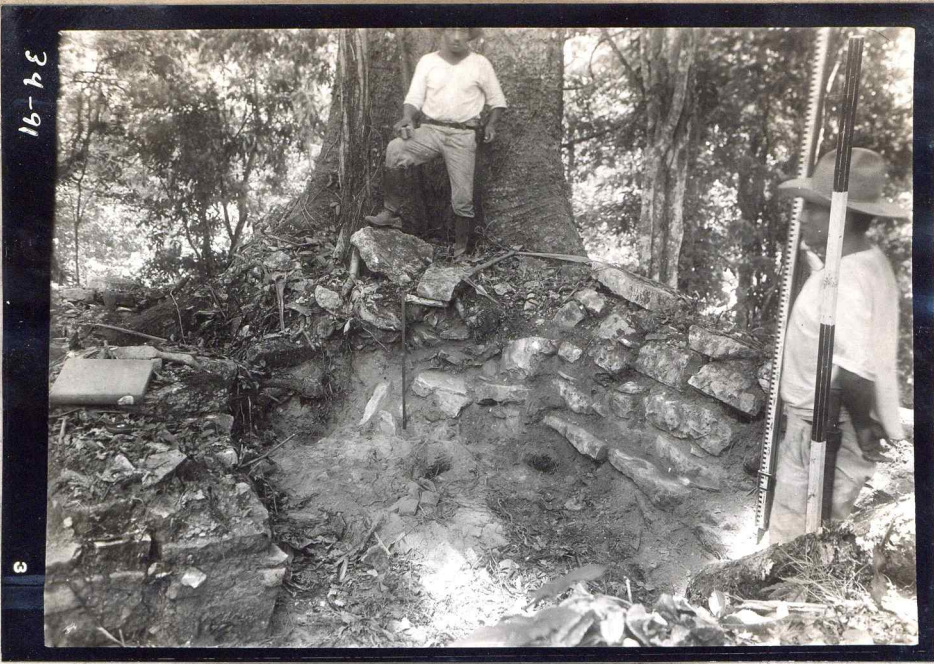
- 91 0-12 E Temple chamber from left front corner. Back wall and sill at right - the leveling rod rests on the sill; the meter stick on debris 9 cms above floor level as determined at front pier (i.e. the bottom of the pier - the floor itself is ripped up); Note that at this level (about 9 cms or less) slabs descend in the debris out of sight, and are present above. The large tree buries the rear part of the center of the chamber, and completely covers the area where a column altar would be looked for. The note book at left lies on the ruin of the left pier, the rear left corner of which is in the picture.

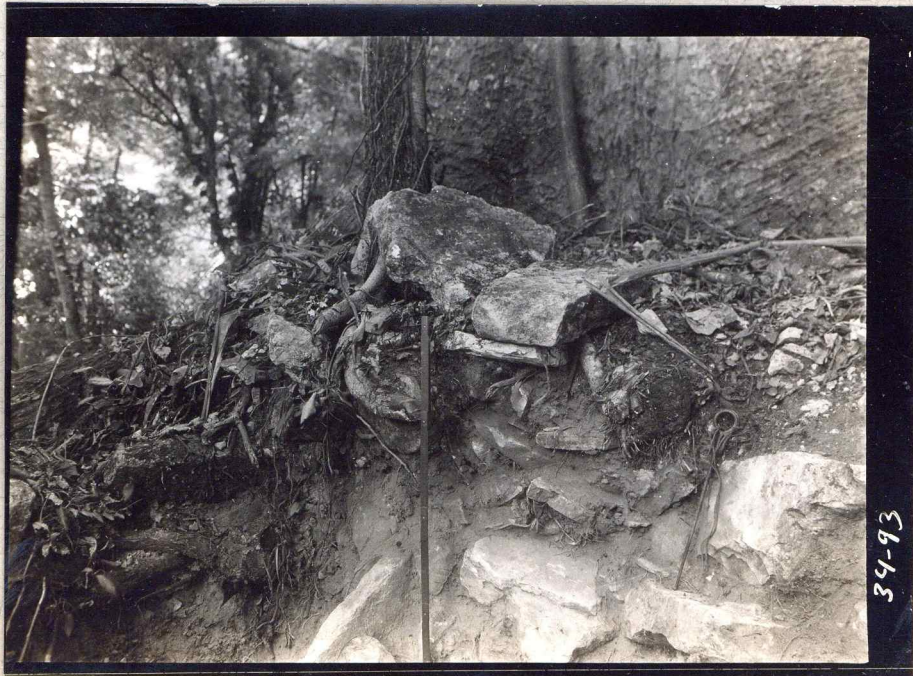
- 92 0-12 Same view.
- 93 0-12 E Close-up of cut section of debris in chamber, left of center (see 34-91). The camera must have moved so that bottom of cut is not shown. Very little is lost, however. Meter stick rests on debris 9 cm above floor level as determined by bottom of pier (therefore somewhat closer than 9 cms) It is extended to 82 cms.

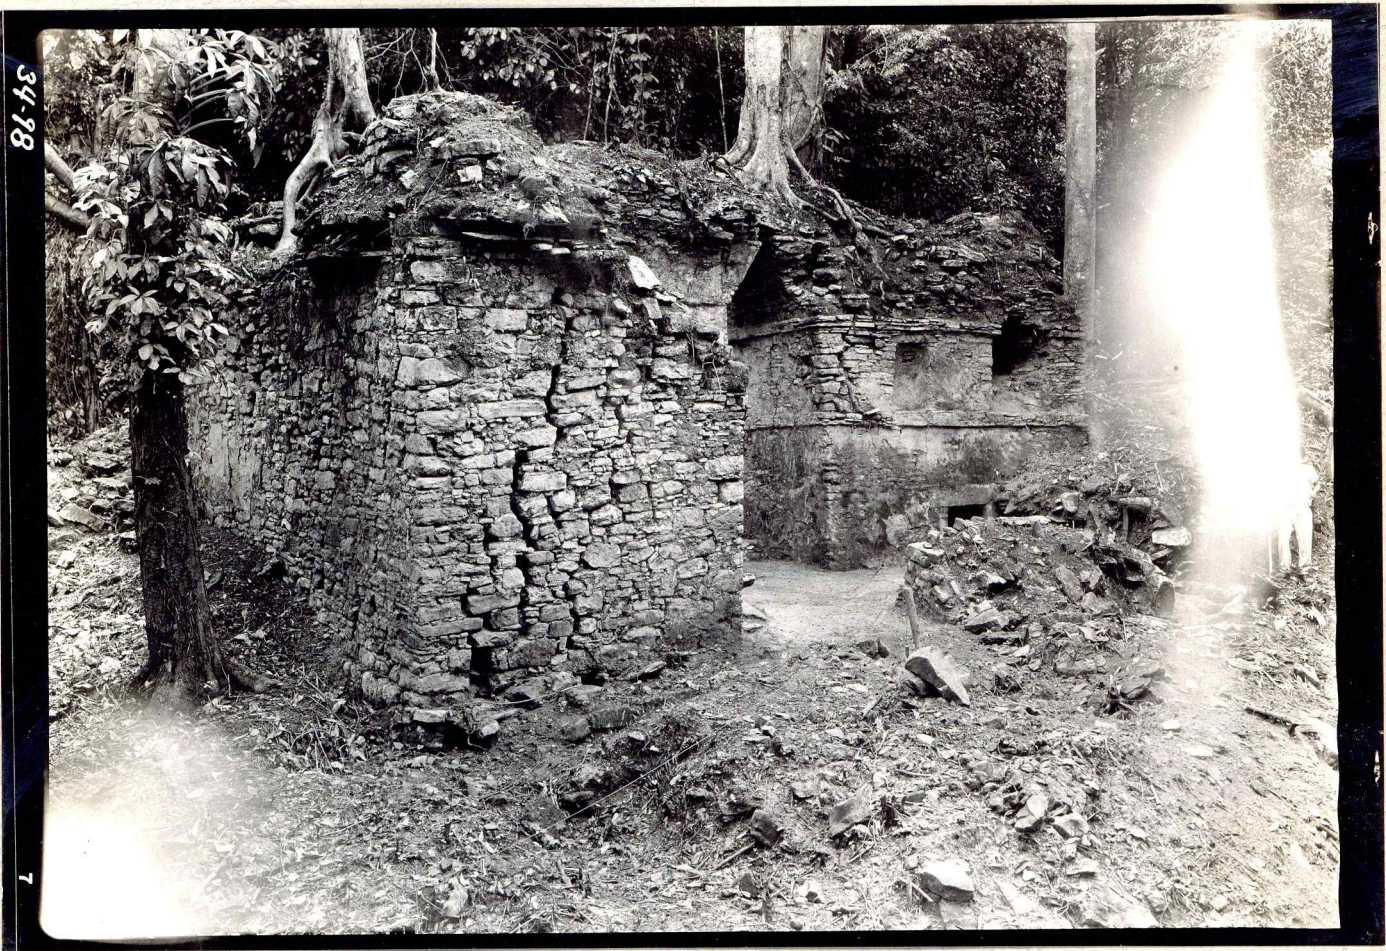
34-98

98 P-7 W View similar to 34-97 (light-struck at right).

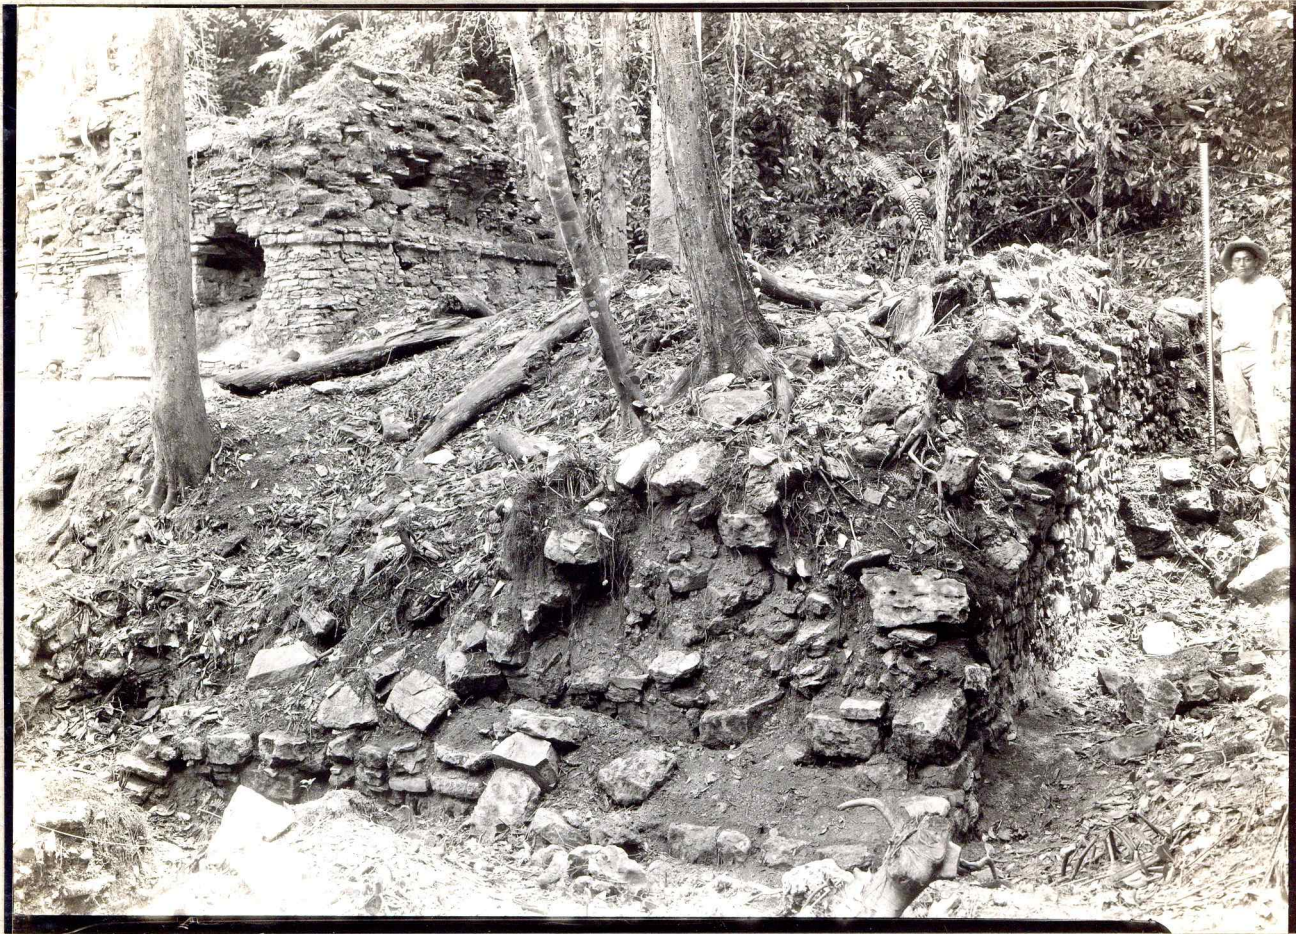
34-100

100 P-7 S Left front corner and left end wall from same point on tower as 34-99; the two pictures can be tied together by noting trees and fallen stones common to both. The left end wall is at right; note ruined front facade, plinth; boy with rod stands on debris about 1.00 m deep - there is no big deposit of debris here and it looks like all wall stone - conclusion, the end vaulting fell in and not out, as at the right end it will eventually do.

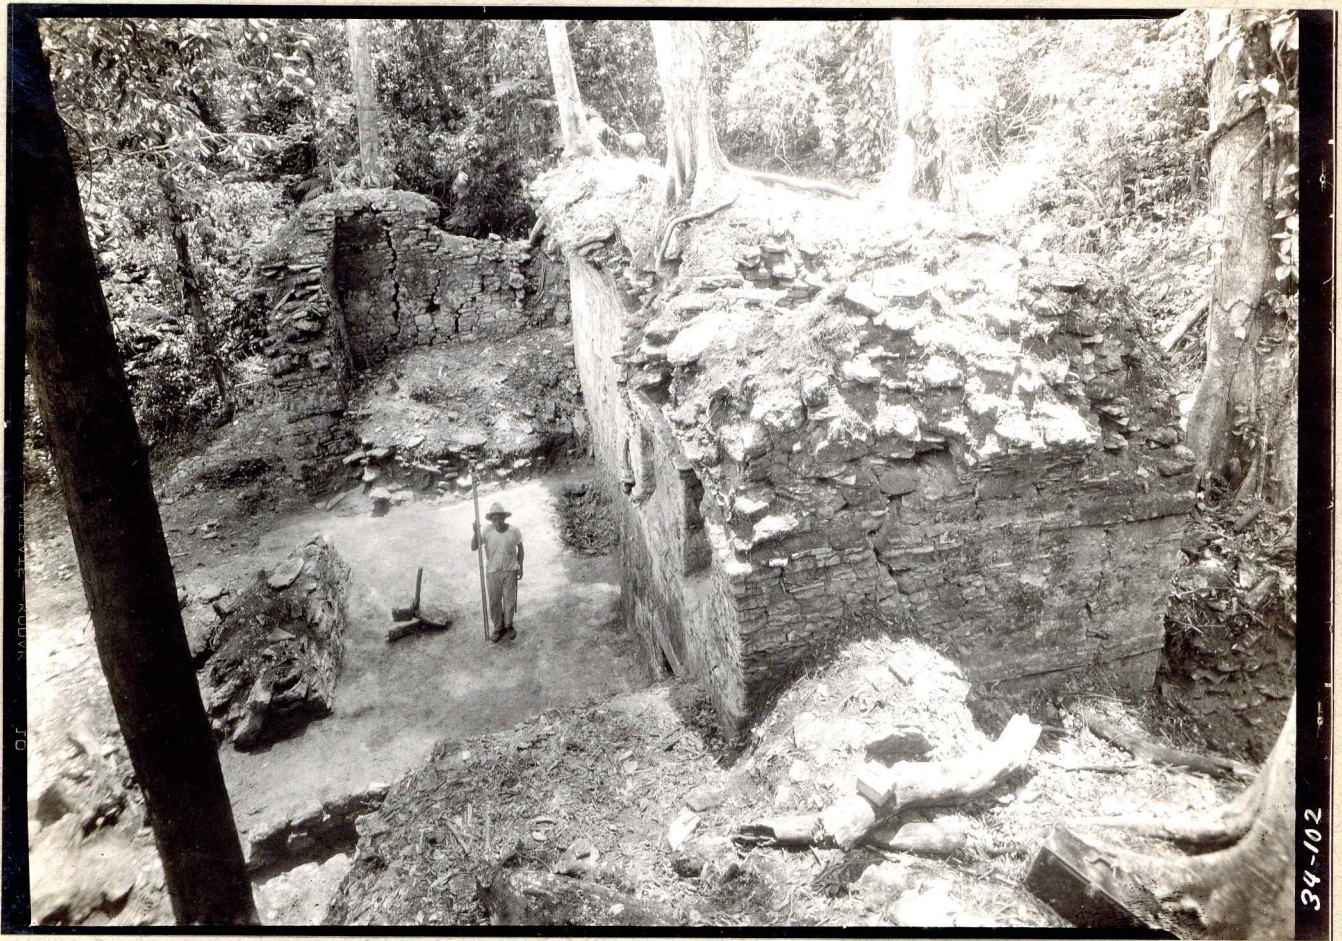
34-102
16629

102 P-7 SE General view similar to 34-101, but from farther away,
showing roof and left end wall of central sanctuary.

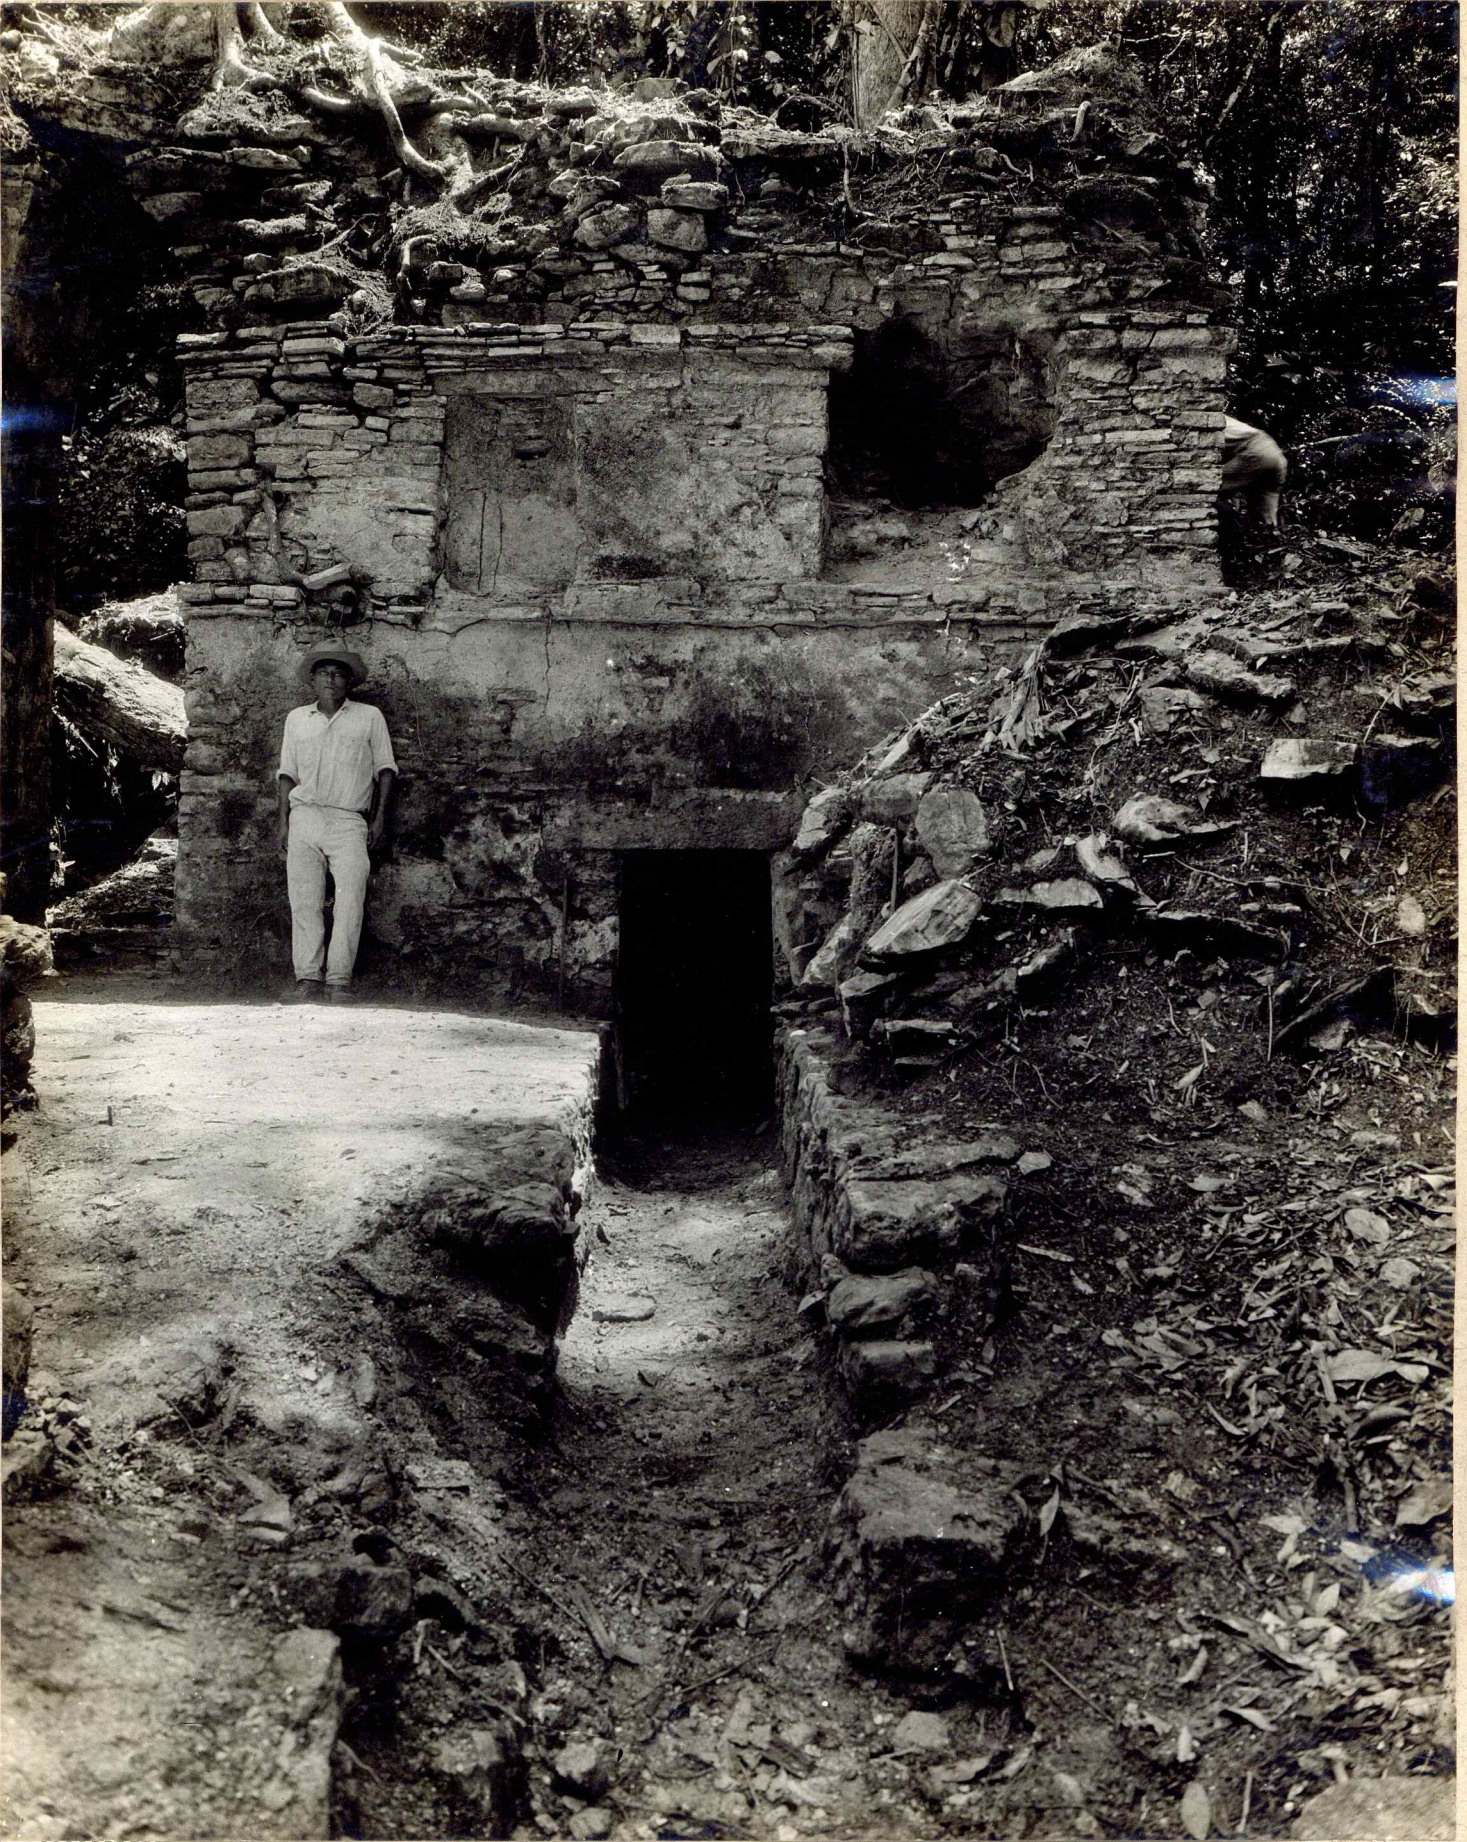
34-103

103 P-7 SW Close-up of Sanctuary, front elevation view, from end of depressed passage. Note heavy stone lintel in place, with plenty of over-lap at the ends. The floor where boy is standing was taken as zero level for all 1934 notes on this building. Note that it seems to slope down to edge of passage, even after allowing for loss of surface there.

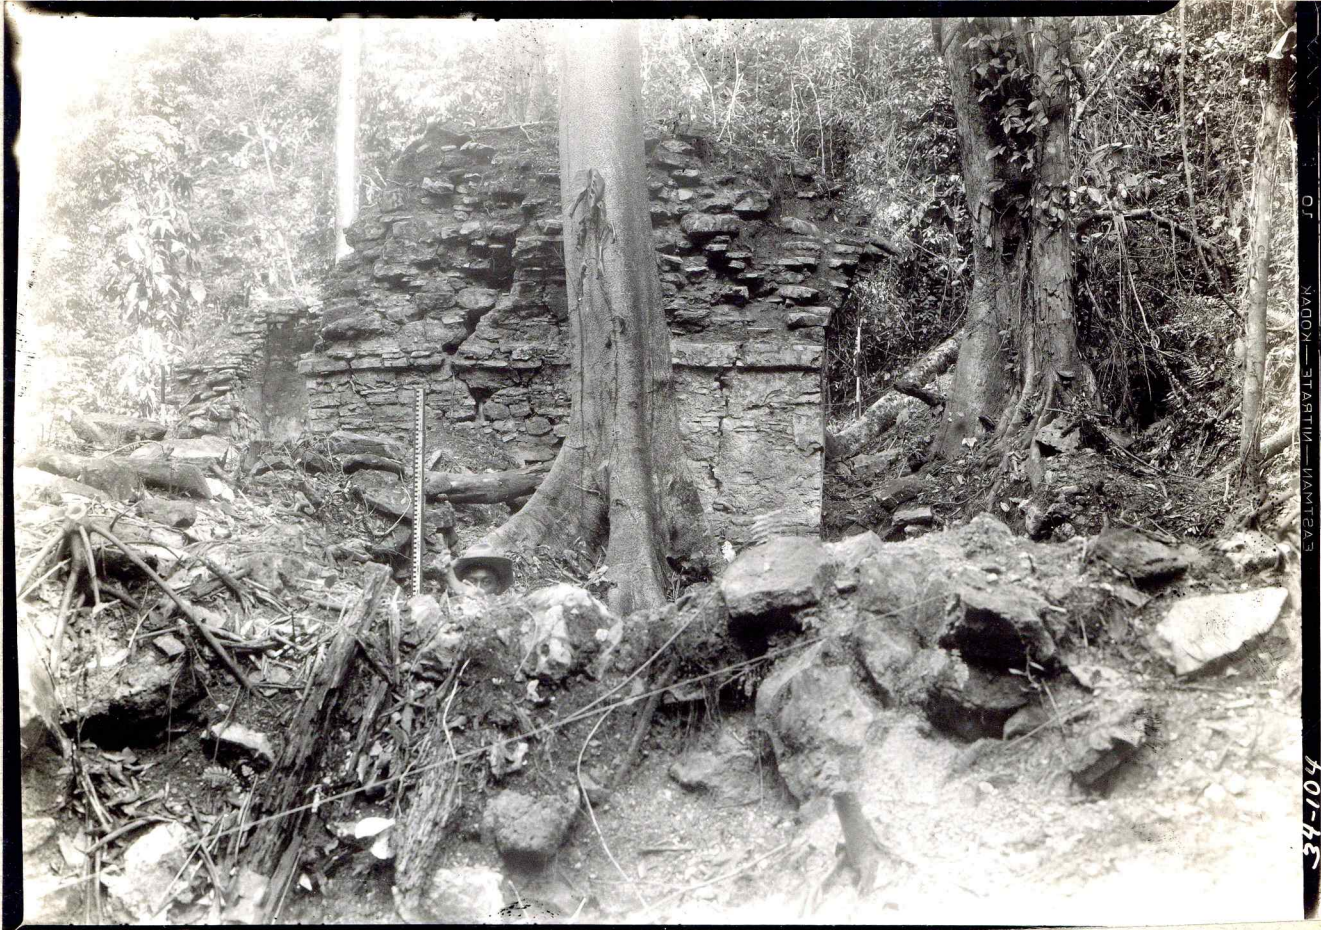
34-104

104 P-7 SE Left elevation (SEly side or end) of Sanctuary, in background; immediate foreground, left (SEly) end of mound. Camera about 1.00 outside left end wall, to the rear. The rod rests on approximate ~~XXXX~~ level (upper floor in left rear chamber) and is closed (i.e. about 2.28 m in length). It is close to the left (SEly) end of the masonry bench or altar of the left rear room.

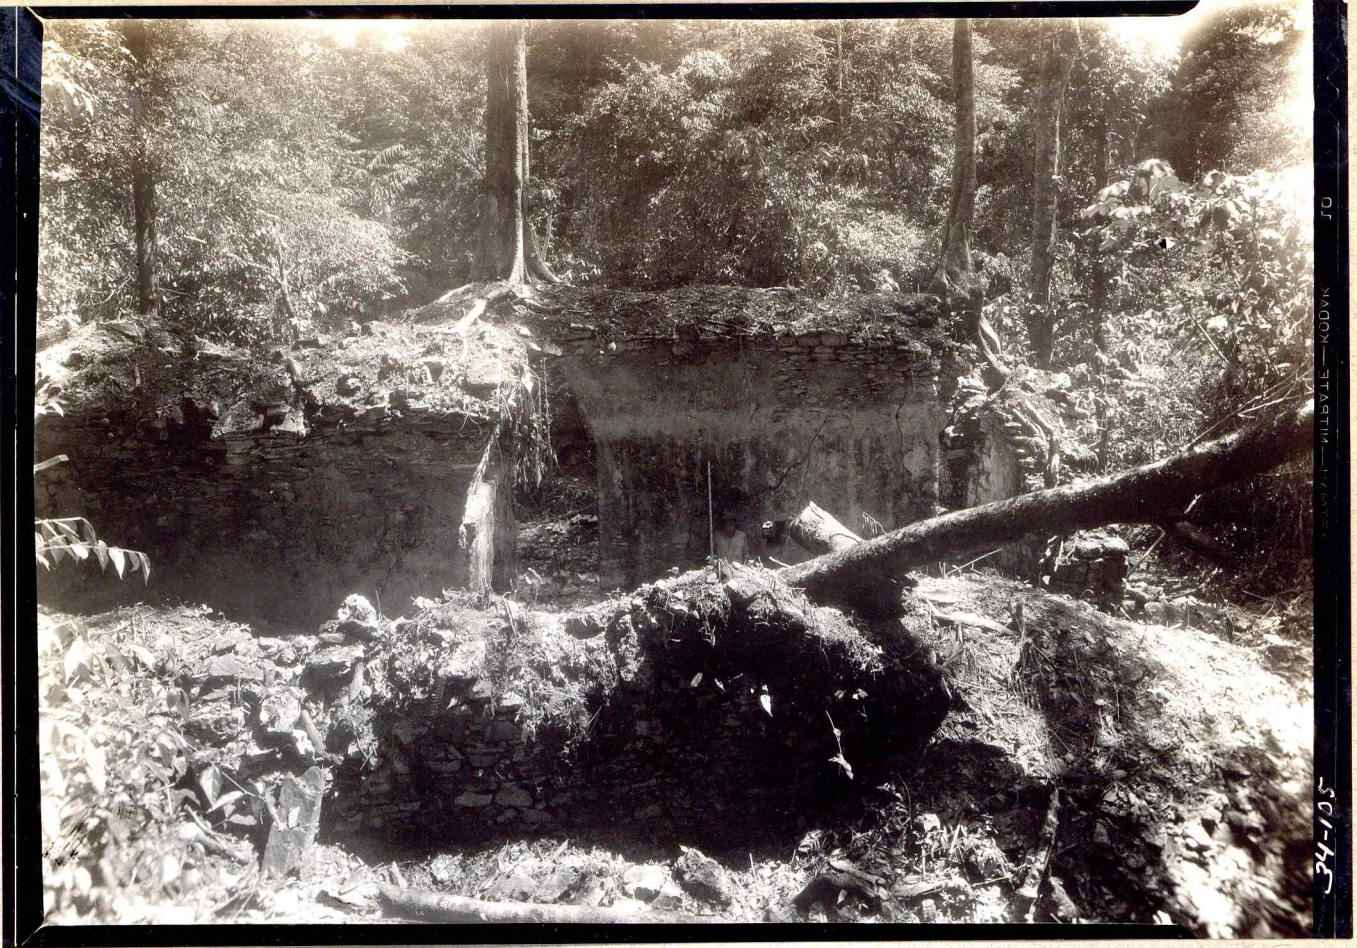
34-105

- 105 P-7 NE General view of right rear room, rear passage to left; in foreground outside of rear wall. From the terrace at the rear. Boy with rod stands on ruined (S^{ely}) part of bench altar, the bottom of rod about .35 m above ~~xxxx~~ rear floor level. Note the level ruined surface of the balanced medial vaulting - the irregular surface of the vaulting on Sanctuary at left. See 34-106 for a better negative of the same view.
- 106 P-7 NE Same view as 34-105, which see for notes. This is the better negative.

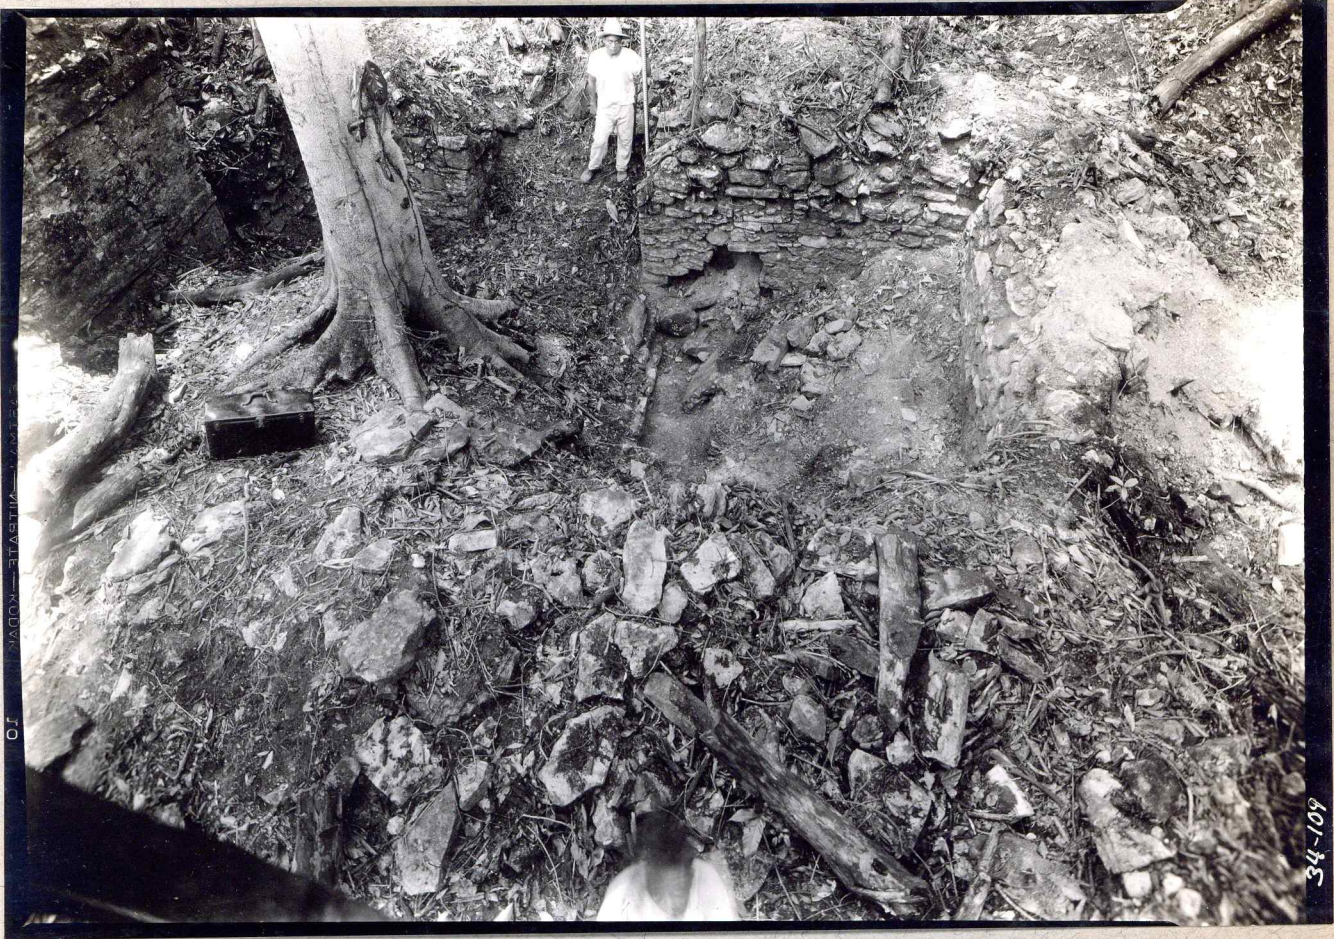
34-109

109 P-7 SW Left rear room from tower on debris in left front room.
Upper left - sanctuary; boy stands in rear doorway, with
rod at outer jamb; note sill or "drain" running from
a point a little to right (in picture) of this doorway
toward front. It is below floor level there; upper right,
inside of left rear corner of room.

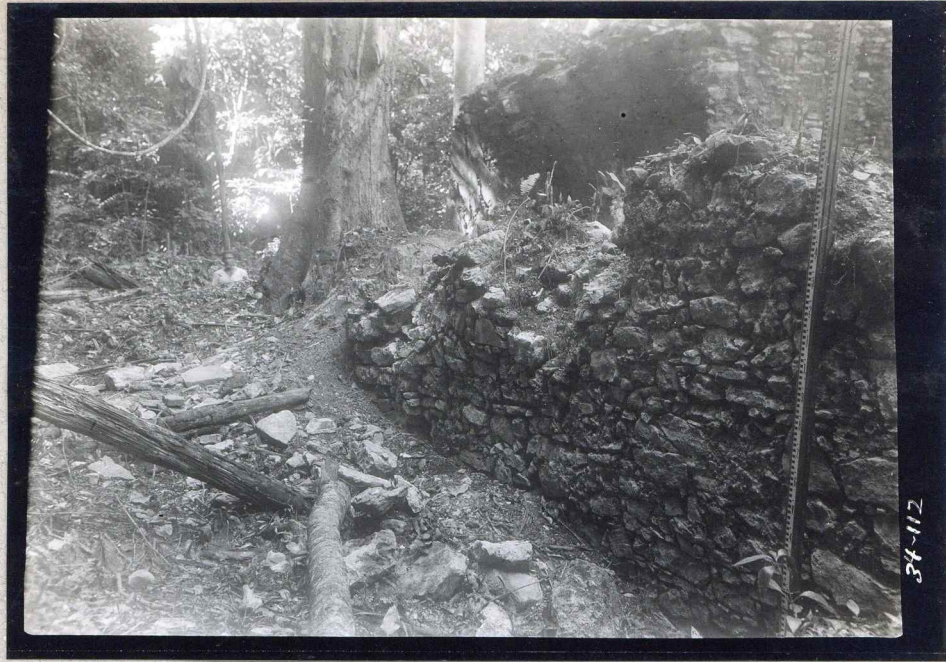
34-112

- 112 P-7 NW Standing portion of rear wall from outside (this is the rear wall of right rear chamber). Rod at point 75 (on sketch sheets), meter stick at NWly jamb of NWly doorway in rear wall. Rod rests on point 75 level. In distance at left, boy stands in SEly doorway leading from rear to left rear room.
- 113 P-7 S Roof of Sanctuary from above and outside left front corner; Boy holds rod resting on debris a few cms. above floor of closed upper chamber, in which he stands. Shows ruined slab construction of vaulting; looks down into sanctuary niches.

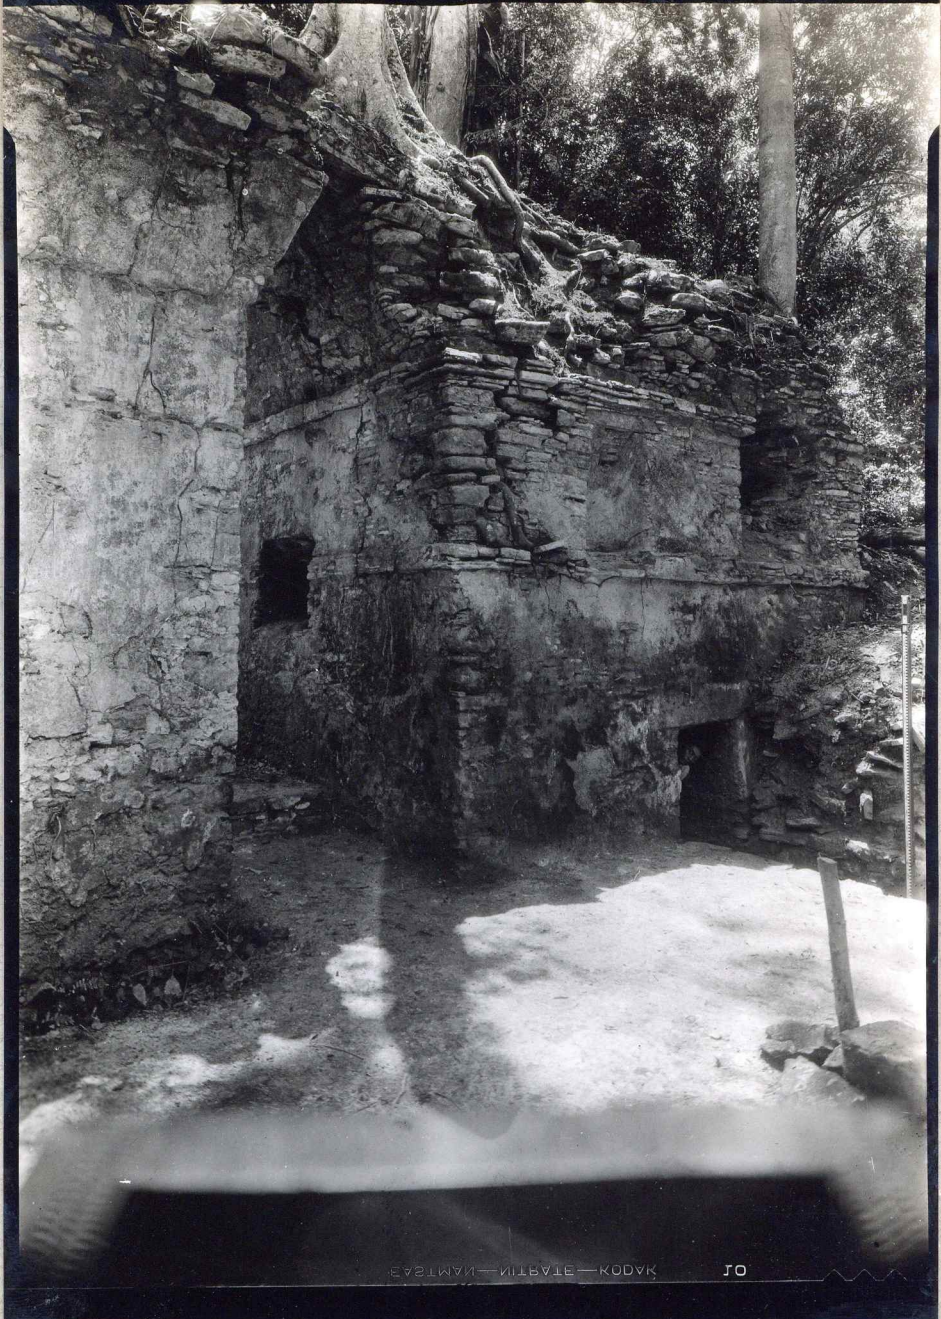
34-116

- 116 P-7 W Sanctuary from right front doorway of front chamber. Rod is on ~~xxxxx~~ depressed passage floor and passes in front of fallen (roof?) ~~xxxxx~~ concrete of river pebbles, with smooth surface, with vault slabs above (surely from the sanctuary vaulting (~~xxxxxx~~) the front half of which has fallen.
- 117 P-7 Looking straight up at cap-stones of vaulted doorway between front and right rear chambers. Rear chamber is at end of picture with most sky (left). Note here the overhanging slab; slab on edge instead of flat like the others next to the last remaining one at front. See drawings to understand this picture - it is clear that slabs overhung the vaulting of both sanctuary and medial wall. But roof beams were certainly not below this level - could have been at about same or above this level.

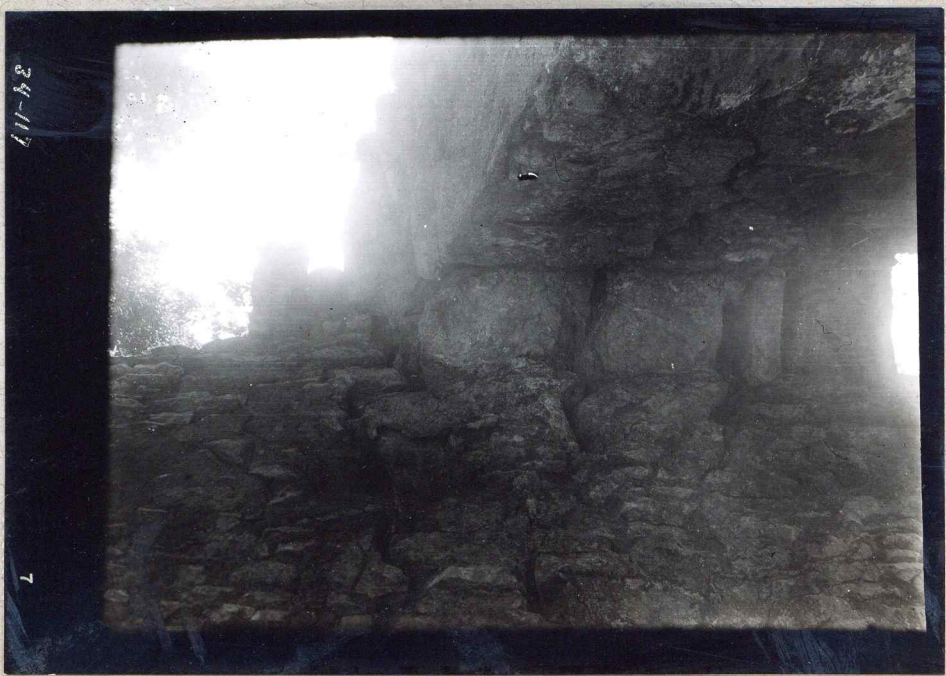
118 P-7 NE Inside of section of wall forming right "pier" of front chamber. Note that stumps indicate present top of this pier was original surface before excavation - they are good hard growth. Meter stick on wall at 22 cms.

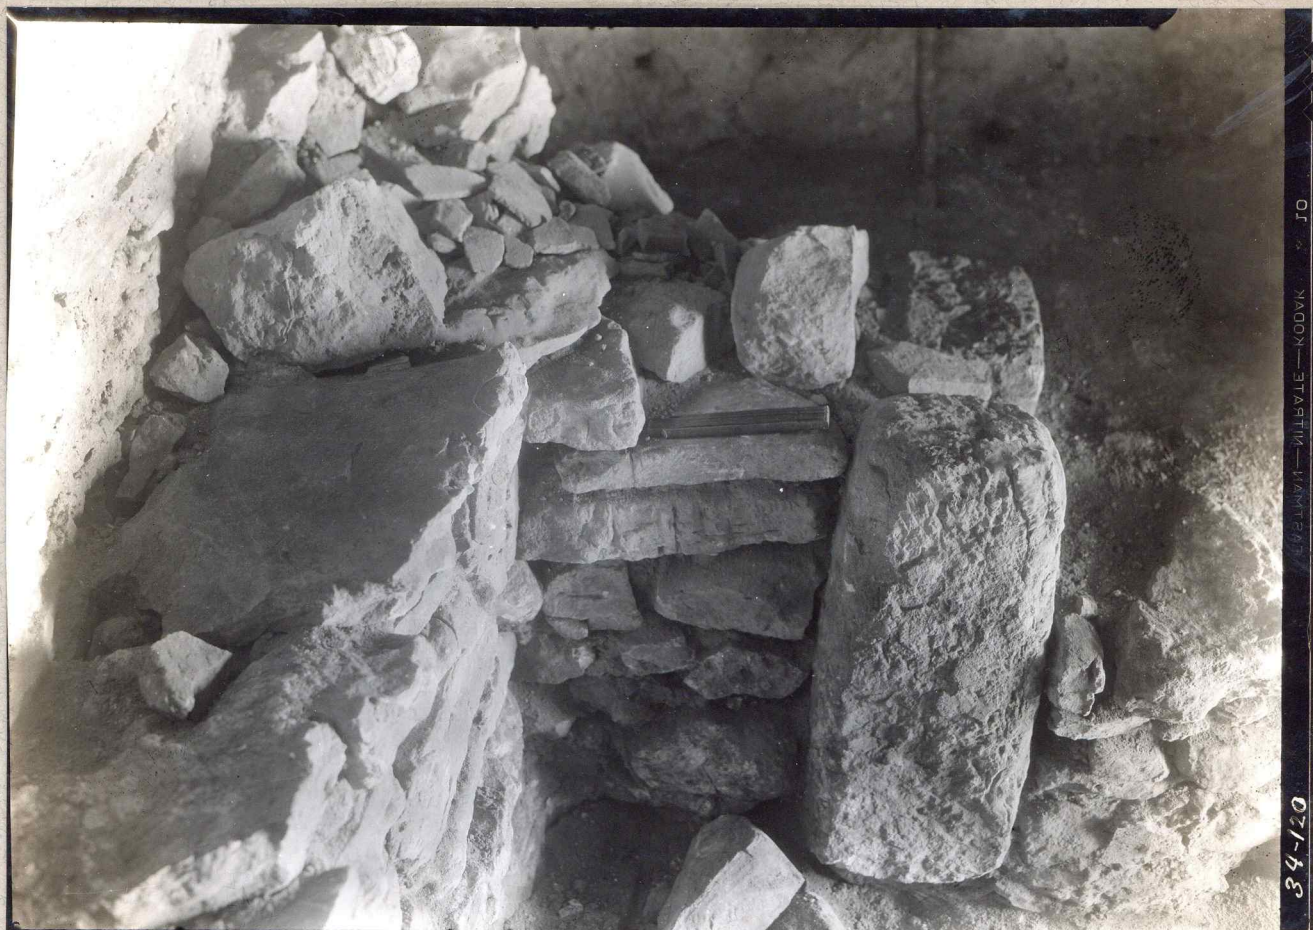
34-120 KODAK SAFETY FILM

- 120 P-7 NW Sanctuary Altar, seen from hole in left wall made by predecessors of Maler. This view shows the inside of the altar. Note that top slab at rear has left the rear wall (wall falling forward; monolithic jamb (the right jamb is fallen, which makes this view possible). This is after excavation in 1931.
- 121 P-7 N Vaulting at juncture of medial wall vaulting with that of right side of Sanctuary. Note stone projecting from Sanctuary vaulting at top - see cross section sketch for its inner end - is at same level as cap-stone-like stone projecting from medial wall vaulting, which is in deep shadow. Tape hangs from corner under slabs projecting from both vault systems.
- 122---P-7

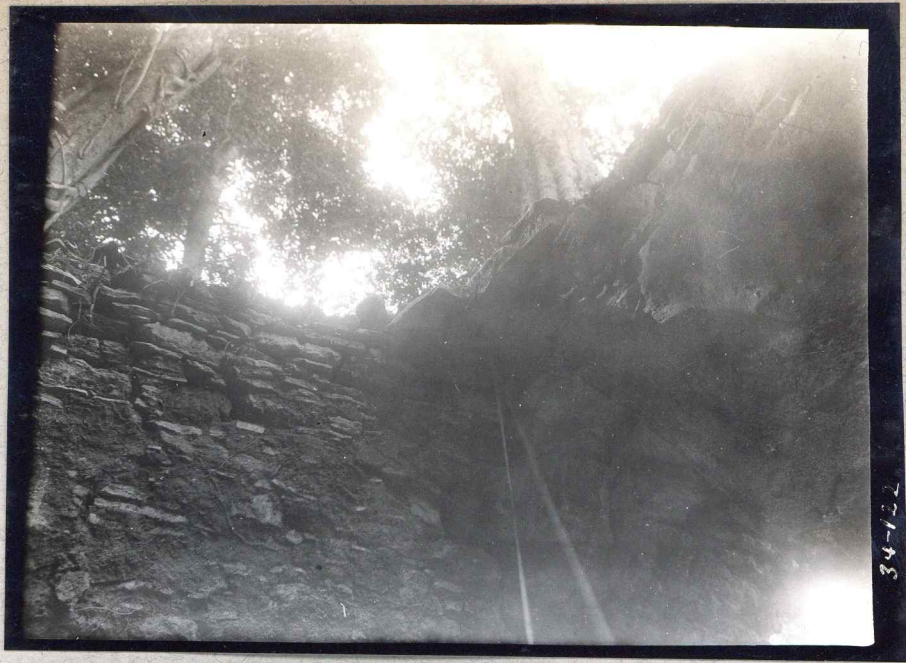
34-122

- 122 P-7 Same view, another negative - no better.
- 123 P-7 S Vaulting, rear right room; tape hangs from under side of projecting slab at point where it passes horizontally outside the plane of the soffit slope (medial wall vaulting). See sketch. Poor negative.
- 124 P-7 SE Left end wall; rod on point No. 51 of sketch notes. Note liberal use of small thick slabs, but of irregular blocks also. For other end see 34-125. (Cp. with 34-127, inside).

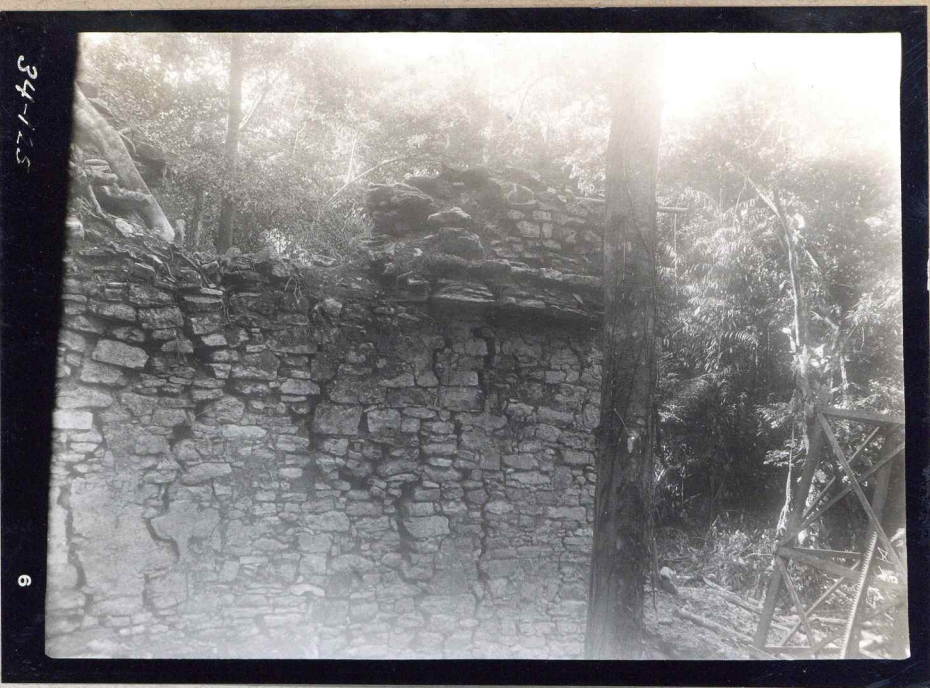
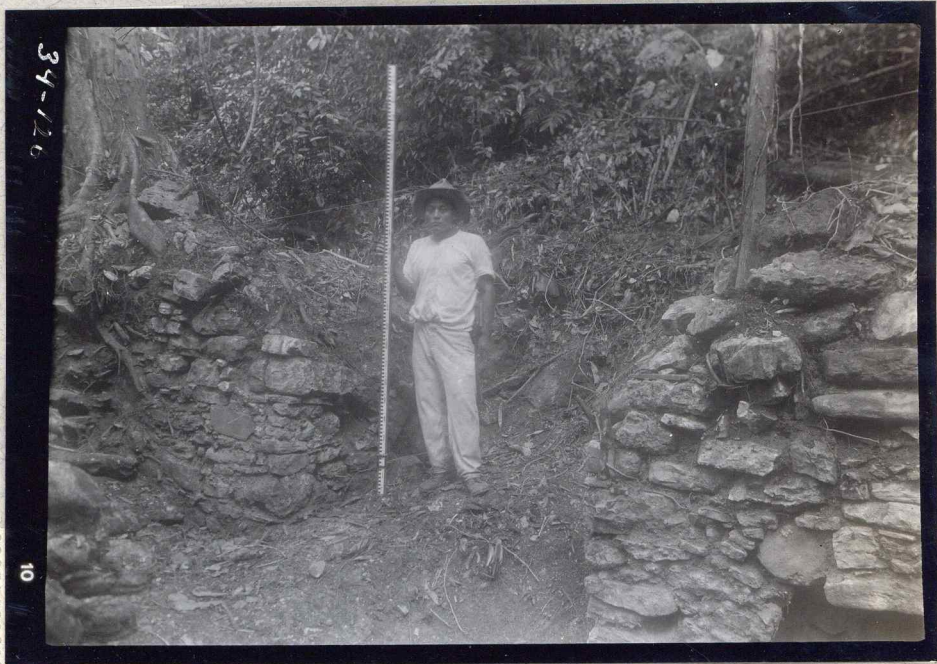
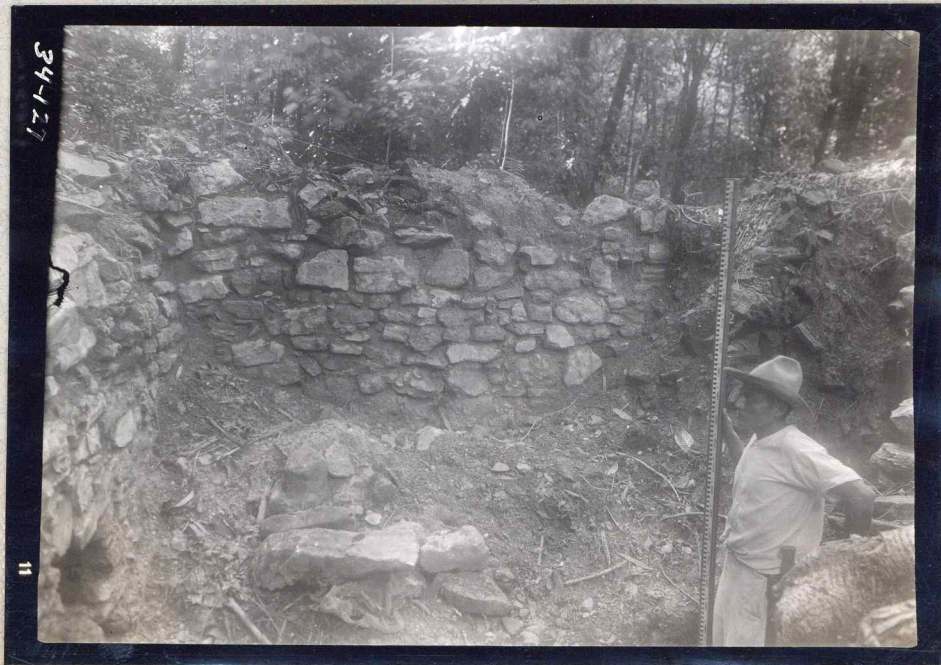
- 125 P-7 NW Right end wall including cornice and upper zone. Note generally thick slabs in upper course of cornice. The two flat stones of upper zone are on same level, giving slight indication of total height of entablature. Other data points to this as a reasonable height.
- 126 P-7 S Left (SEly) doorway of rear wall, from left rear room, camera just SE of bench-altar. Meter stick is about .70 m (? - stated as 1.70 in original note) above surface of lower course of "flue" or "drain" stones.
- 127 P-7 NW Left end wall, inside view (Cp. with 34-124). Note irregular blocks.
