131 P-7 SE Upper Chamber of Sanctuary, right (NWly) end wall and vaulting, from inside. Note drain at bottom (meter stick projects from it; Tendency to block vaulting and chinking. Cp. with the other end (34-132) where the chinking persists, but blocks appear only toward the top. Why are the inner sides of this vault system in such poor condition? the other side of this balanced vault is in good condition.

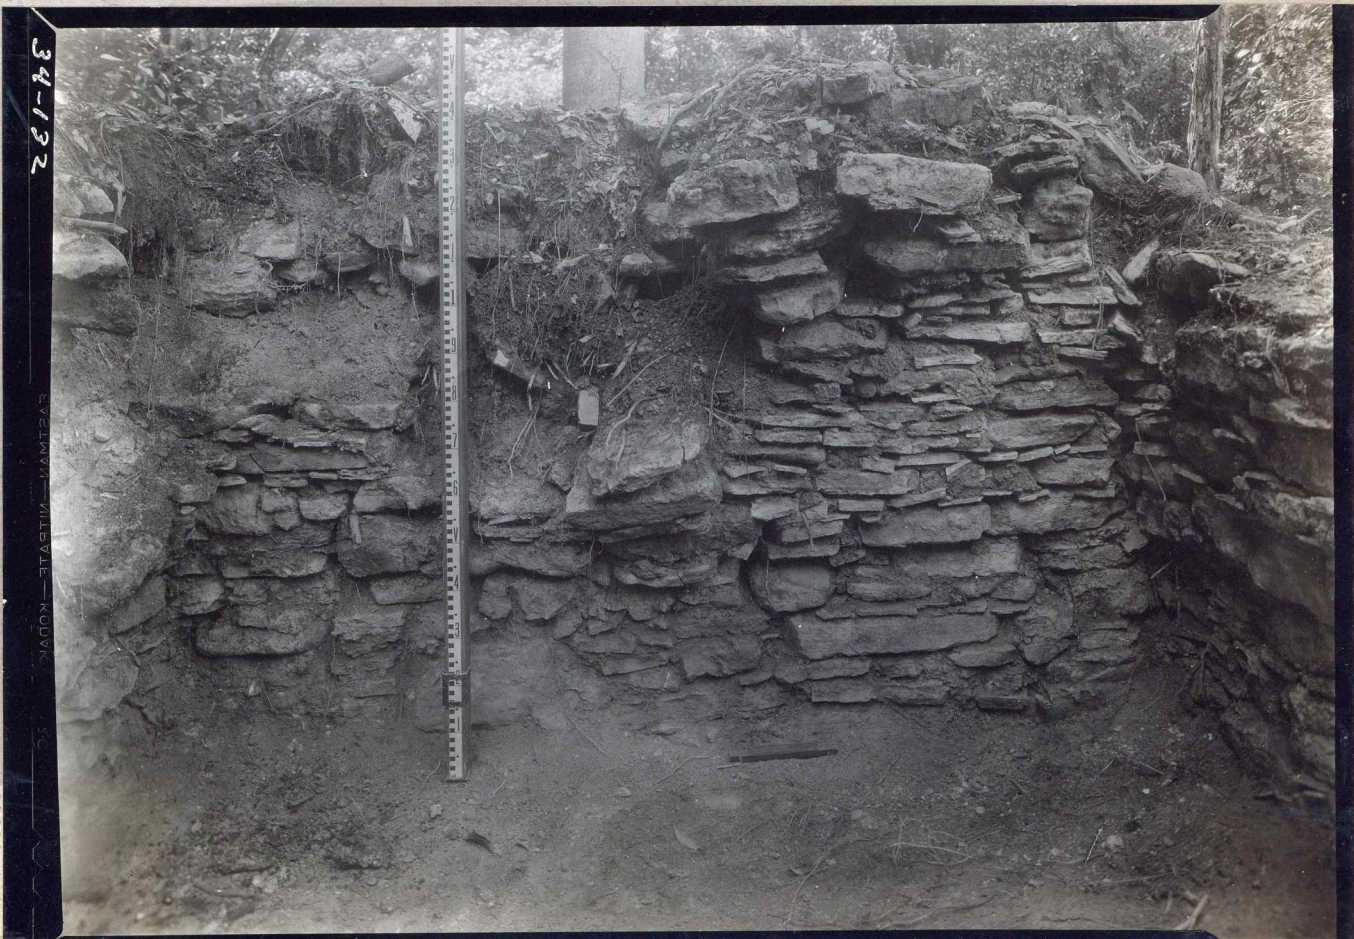
34-132

132 P-7 NW Upper chamber of Sanctuary, left (SEly) end wall and vaulting from inside. Cp. with 34-131 and 34-133.

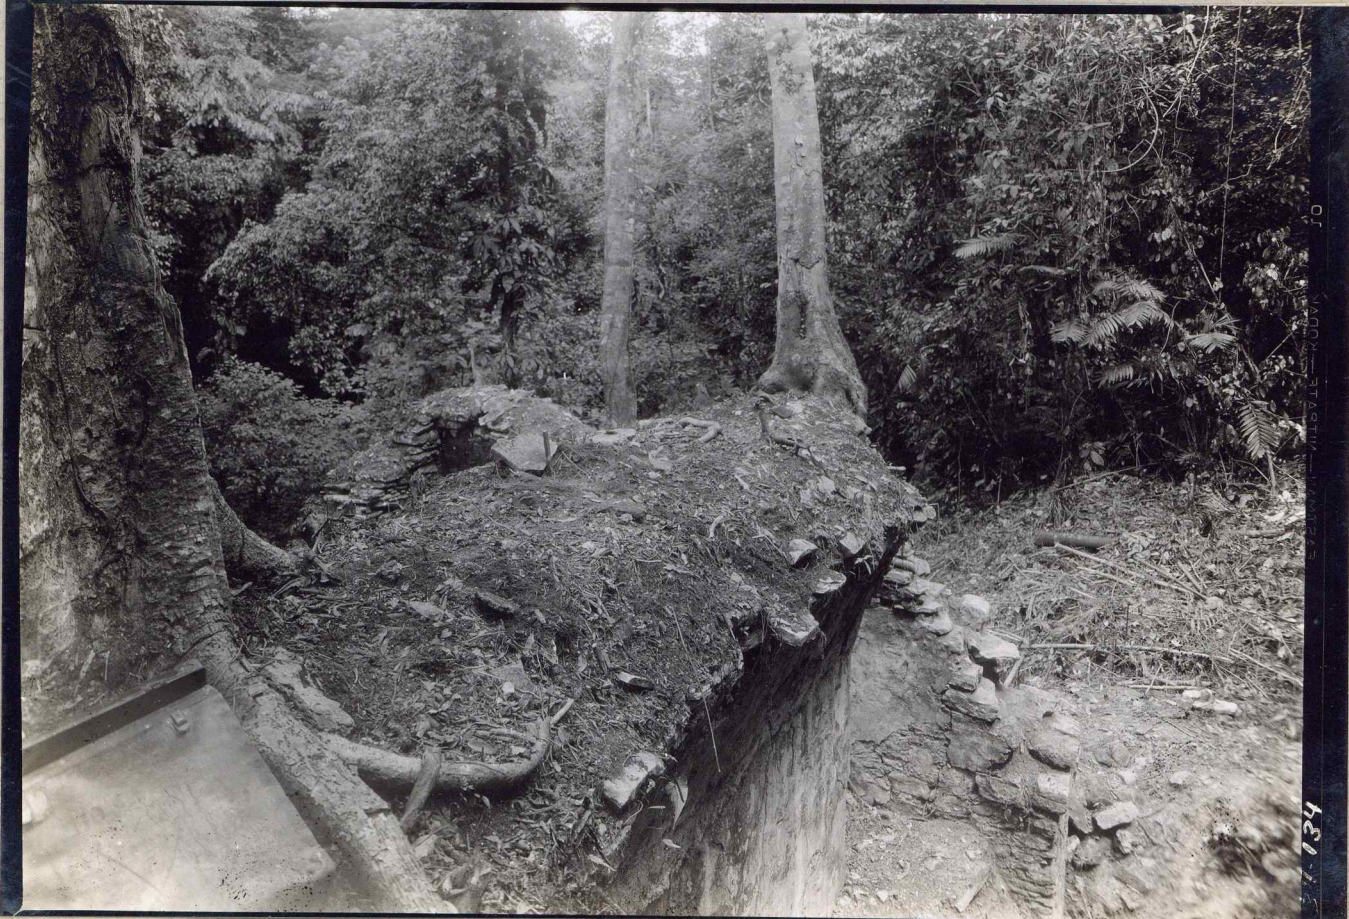
- 135 P-7 SW Medial wall vaulting from the front, from tower in front room. Meter stick extended to 22 cms stands on slab in position at center (same position as in 34-134), on which lay river-pebble concrete. The sticks point to pieces of this concrete, loose but not moved by us. The lowest one rests in a cut into the vault, its upper end pointing to the concrete at one side. The slabs in the cut were laid in ordinary (no gravel) mortar. The lower level of the center surface at left, which seemed to have been cleared off a bit in course of excavations, is strewn with river pebbles, ~~mix~~ though loose. Note use of heavy ~~mix~~ block-like slabs at top of remaining soffit slope. A satisfactory picture of the lower part of this slope could not be had without stripping off the plaster.

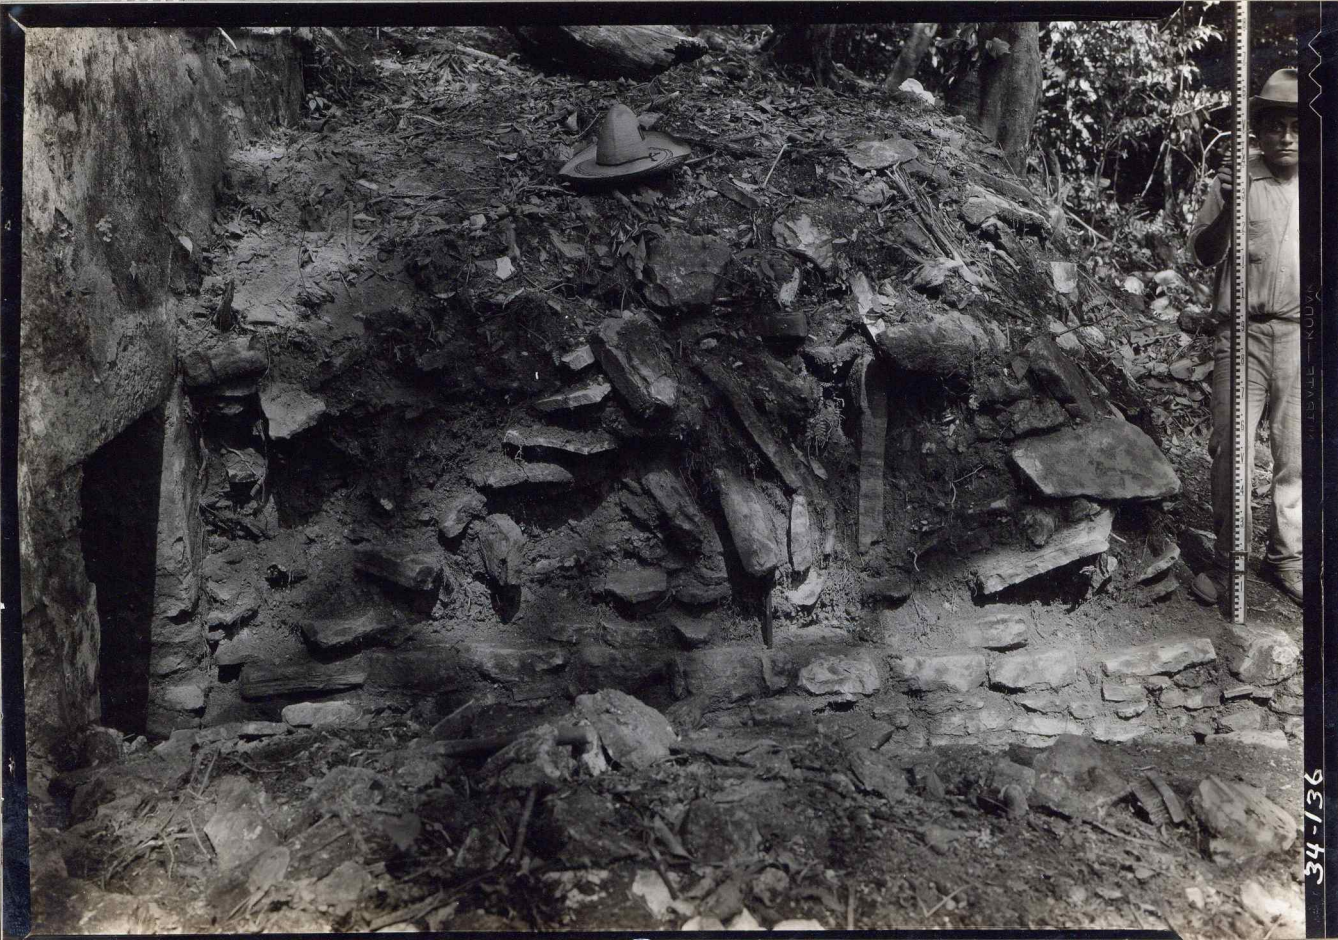
34-136

- 136 P-7 NW Cut section of debris just left of left wall of depressed passage. Rod rests on this wall, near front. Note large slabs do not reach floor level, though small ones (such as seen on surface of medial wall vaulting (33-134) do. Gravel-concrete on floor, and a little above - note large mass about 50 cms. left of meter stick, over a small slab and below large ones. See 34-137 for close-up of this, with the surface (up) cleaned off.

137 P-7 NW Close of part of cut-section of 34-136, with better cleaning. Meter stick extended to 22 cms. rests on room floor level (i.e. on top of left wall of depressed passage. From its top a large slab of river-pebble concrete, with smooth surface upper-most, runs to point behind trowel to right, over-riding small slab on which handle of trowel rests. This concrete slab is obviously fallen, sloping slightly ~~xxxxxxx~~ up to right (in picture) and away from camera. But it is below vaulting slabs which must have fallen from sanctuary front vaulting. See drawing of this section for other masses of pebble-concrete. Cp. with 34-138.

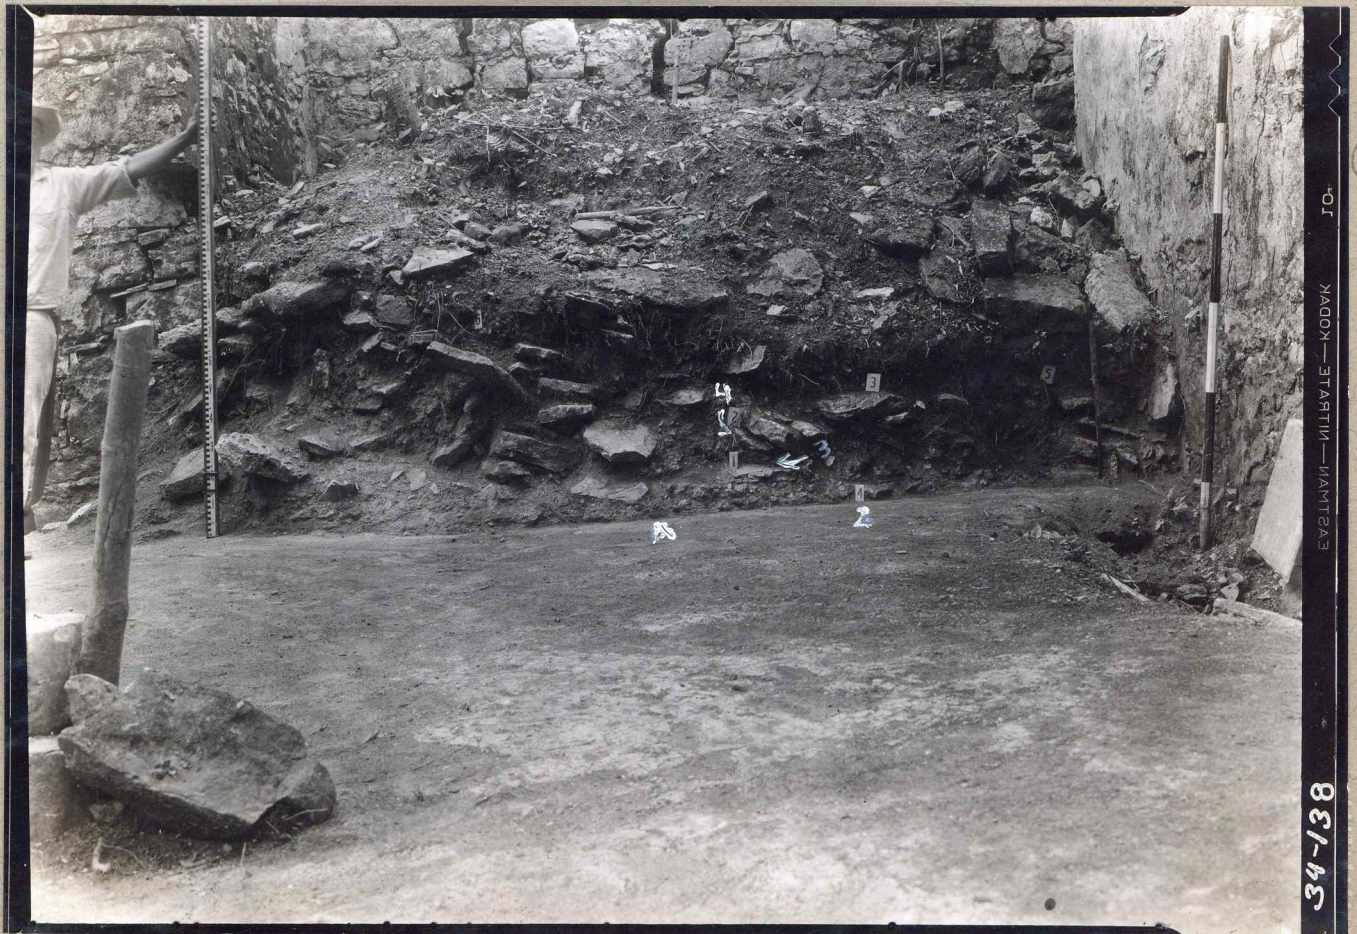
34-138

138 P-7 SE Cut section through debris of front chamber, 20 cms right of the cross-section drawing (i.e. of lines passing through center of right doorway). This debris was left in place during 1931 excavation, though a small amount was thrown over it. The numbers on cards indicate location of river-pebble (gravel) mortar) as follows; On the floor it runs from No. 4 to left (in picture) to low stone left of No. 4 (also left of No. 1?); This deposit is about 7 cms thick. The No. 1 rests on a surviving remnant of the white plaster smooth finish, confirming belief that this whole deposit is from a roof surface, although immediately on floor. The plaster finish is hard and rests directly on gravel-concrete. 34-147 shows close-ups of this concrete, the surfaced fragments coming from this piece. The gravel concrete seems to be integral with a layer of lime and broken limestone lying directly on the well-finished floor. The total thickness here (where we have the surface) is about 12 cms. Cp. this surfaced piece with similar one in the cut section of 34-137, which is a bit higher up. This finished piece is 30 cms long and probably as wide. The integration of gravel-concrete with the lime mortar and broken stone directly on floor is confirmed by a stray green river pebble only 2 cms from floor. The indication is a roof surface consisting of usual broken lime-stone and mortar concrete with a cap of gravel concrete between it and the usual pure lime finishing plaster. Immediately above this surfaced piece is another running down to the right (in picture) from the No. 2. The gravel concrete under this surfaced piece is about 7 cms thick, and below this also is crushed limestone and mortar. There is a sherd imbedded below the surface of the other and lower piece, and these occur on roof surfaces over medial wall and sanctuary. Loose gravel and sherds extend 40 cms left and 20 cms right of the No. 3. A small deposit of gravel extends 20 cms left from the No. 20 (a mistake in this number), the top at the level thickness about 5 cms. The only deposit to right (rear) of No. 4 is a small one at the No. 5, well above floor. The material on floor to right of No. 4 is small slabs & plaster without other stone. This is probably from ceiling, as medial wall and probably most of its vaulting is still in place. Gravel (loose) noted either side and below the No. 6. Apart from this there is no gravel left of the No. 1 deposit.

, but isolated pebbles occur ~~ran~~ more or less in a line from No. 2 to 6, thus passing above small slabs, as was noted in the cross-section of 34-136&137.

The positions of the numbers in this picture can be located from the following components, bearing in mind that heights are above floor, which descends slightly toward the front (left in picture):

No.	Distance from medial wall.	Height above floor.
1	1.68 m	.14
2	1.68	.30
3	1.15	.40
4	1.23	.00
5	.45	.42
6	2.60	.50

5. Smooth upper surface of piece of gravel concrete, taken from the larger one in the cross-section of 34-138, which see. This is from the lower finished-surface piece of that plate. Pebbles 2 to 3 cms below the surface of finishing plaster.
6. Piece of same, on edge. The finishing plaster, white, is about 1½ cm thick.
7. Sherd, with white mortar adhering, from "roof" of right medial wall.
8. Loose pebbles from deposits of this concrete (taken from the pieces numbered 5 and 6 above). Max. diameters here run from .013 to .04 m, but larger (not much larger) ones occur.

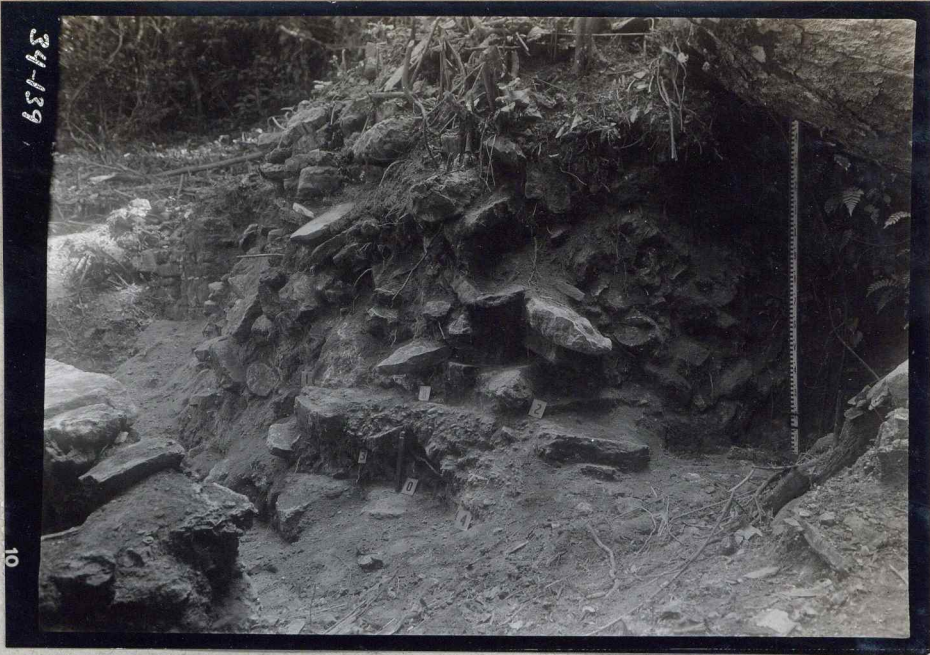
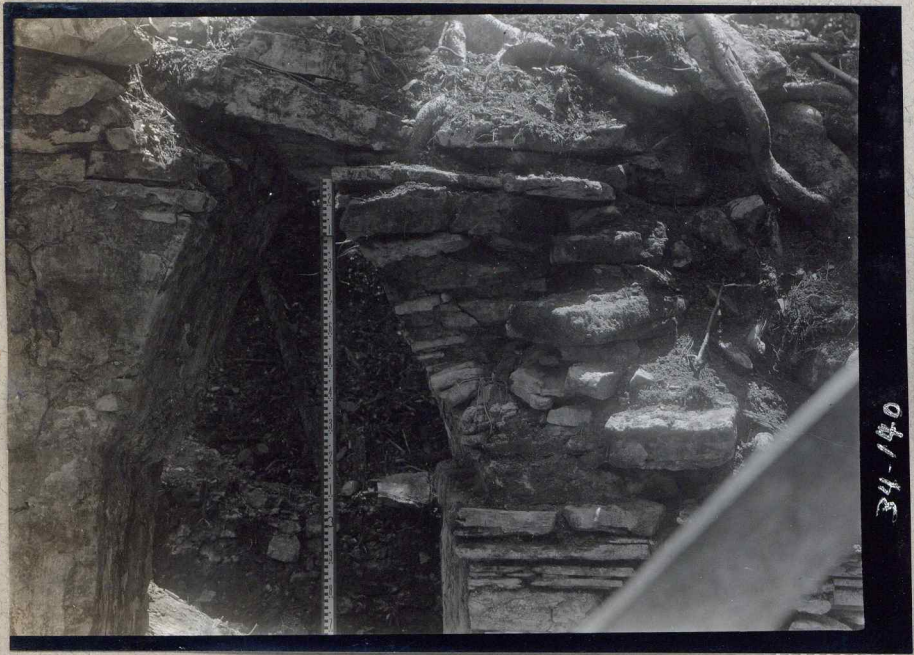
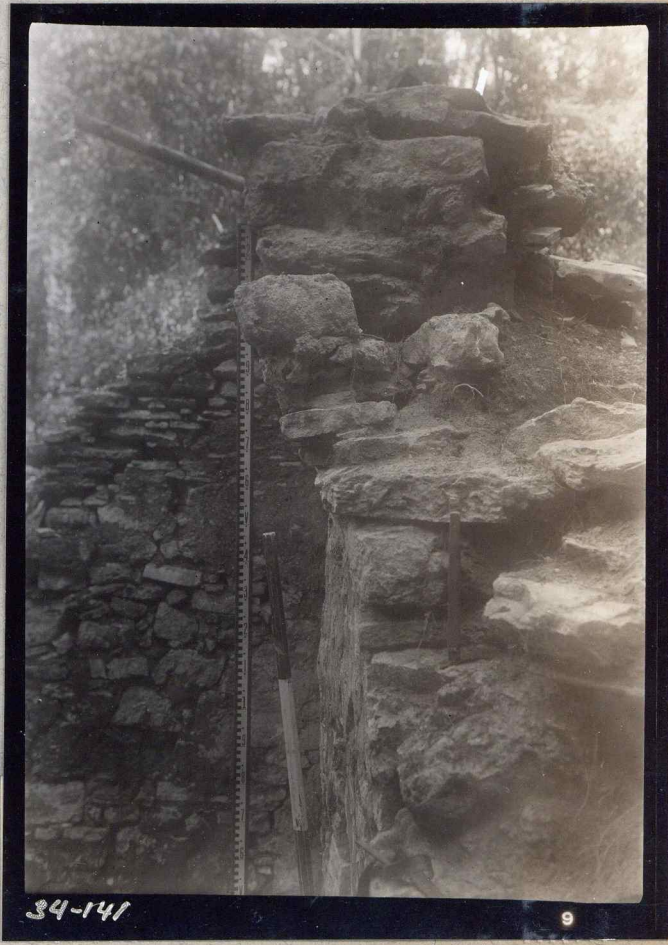
139 - cont'd.

Cut section of debris, right rear room, taken from doorway leading to front room. We look at the corner of a cut out from rear wall to the No. 2 and thence (to left in picture\* roughly parallel with rear wall, the rod, at the back of the front-rear cut, has its base at the level of the bottom of the rear wall, which is hidden in shadow. This is more or less the floor level here, about 39 cms. above zero (which is the floor level at the rear of the front room). The No. 2 is 1.20 from rear wall, and 1.60 from the No. 1, which marks the other end of the longitudinal face of the deposit.

Note the deposit of gravel and mortar which runs from No. 1 to No. 2 (1.60m). The number 8 rests on the surface of this deposit near the center. Finish plaster could not be found (as in the front room \* see 34-136 to 138) but this is a much longer and nearly level deposit. It over-ruled a couple of blocks and a small slab. The block under the No. 1 rests on a fallen slab. No 0 is at about the floor level here, though plaster finish of this floor is not found here. Below this level are building blocks and broken stone, a fill. We have checks on this floor level along the m arby altar, the corner 8 which appears at left.

The left half of this deposit, from No. 1 to 8 runs from 2 to 4 cms to 15 cms. in thickness. There is no gravel below, the deposit being crushed down on fallen stone below. To the right of No. 8 the thickness of gravel increases until a little to right of the No. 4 it is present to about 10 cms above the floor, but here there is also stone, and light yellow to white mortar.

Note that the gravel deposit brushed out quite level, despite the lack of the (probably) former finishing plaster surface.

Gravel does not appear in the cut from ~~ran~~ No. 2 to the rear. But the failure of the other cut to be truly parallel to rear wall, indicates the No 1 -2 deposit was above 40 cms in front-rear width - i.e. began about

80 cms in front of rear wall, and extended an unknown distance to front.

There is no gravel directly on the floor; and none above the surface of the Nos. 1 - 2 deposit. Above this level are slabs and wall blocks, ordinary mortar.

For the height of the gravel deposit see meter stick extended to 28 cms., the bottom on approximate floor level - i.e. the surface is about 30 cms above floor, the bottom of the deposit running from about 25 cms to only 10 cms above this level.

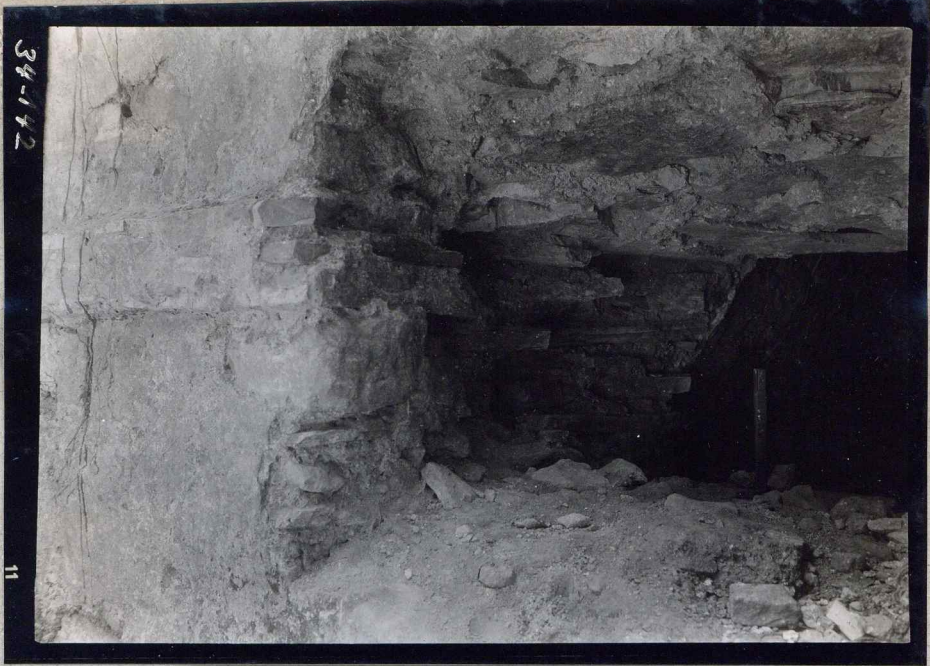
144 P-7 NE Jamb of right wall doorway; medial wall and vaulting from rear; and receding fallen cross-section of right and wall. Note use of blocks in combination with slabs - that many extend in from surface to point beyond center. There is nothing like a separate core - and no observable tendency of the stones from one face to fall away from those of the other - some bending, though probably accidental. The two projecting slabs at right are lowest and highest courses of the medial cornice, shown close-up elsewhere. And see sketch notes. Big slabs such as appear in this cut section (cornice apart) appear but rarely in surface examination.

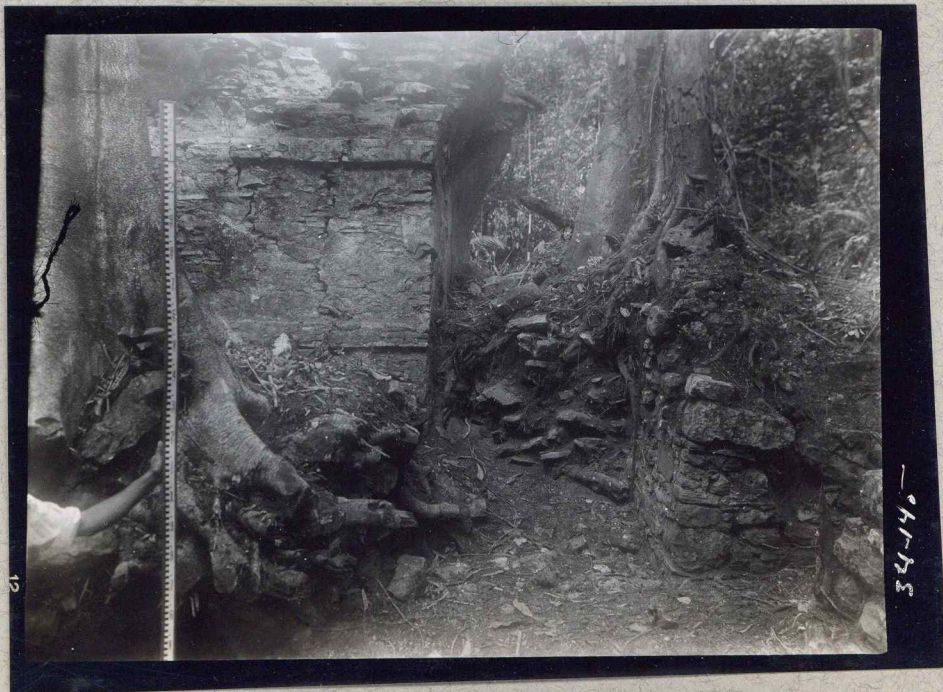
34-140

- 140 P-7 SW Fallen section of Sanctuary vaulting, cap stone to right medial wall, from the front. Rod is on floor, extended to 2.28 m.
- 141 P-7 NE Fallen section of vaulting on right end wall of front room, and of supporting wall. Note slab construction at base of vault only, giving way to blocks and block-like slabs. The steep angle of the soffit slope (see drawings). Rod rests on debris at this end.

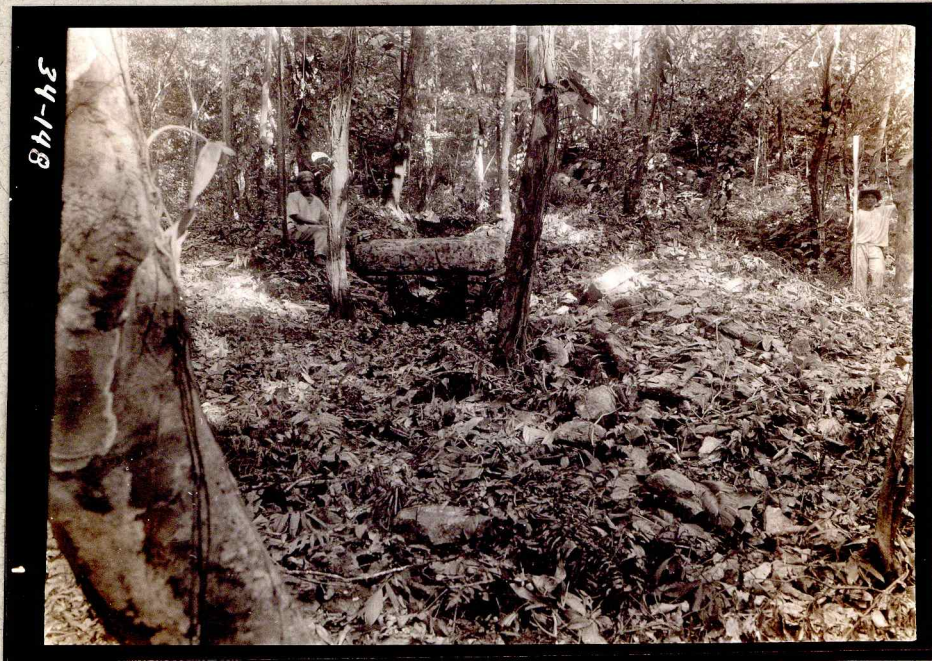
149 S-18 NW After clearing bush, without excavation. Range pole at front is on basal front platform, on cross-section ~~sign~~ line of drawing. Boy at left is behind rear right corner of the pier on this line, on the general level of debris surface between rear wall and piers. Other boy holds rod on general surface level behind rear wall, also on cross-section line. Note ( can't see much) tumbled blocks and small slabs all along rear wall ridge; and in the humps formed by the fallen piers at the front. Range pole at right is behind pier next but one to that of the cross-section. It stands behind that pier, on the lowest level between pier and rear wall ridge.

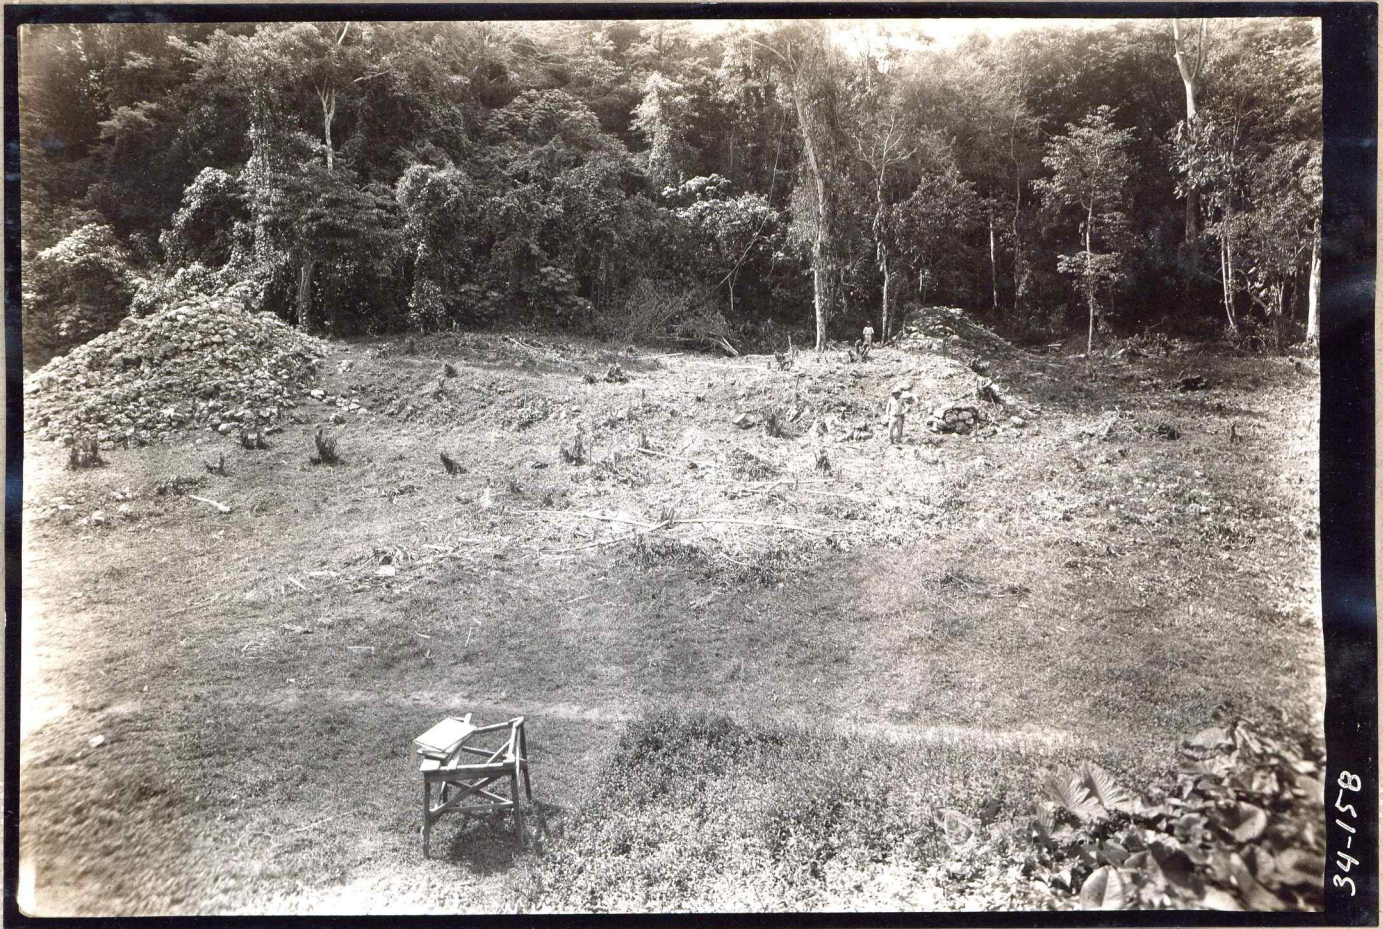
34-158

- 158 F-2 & SE Mounds of F-2 (left) and F-3 (right center) from tower in  
F-3 plaza of Northeast Section. First boy on plaza level,  
second on mound in front of right end of F-3, probably  
of a non-vaulted building. Well, cleared, no excavation.
- 159 F-3& SE Mounds of F-3 and F-4 (left and right, respectively).  
F-4 The stone sliding down F-4 mound is from excavations.  
From tower in plaza.
