1933

P.N. 1933 P.3

Photographs

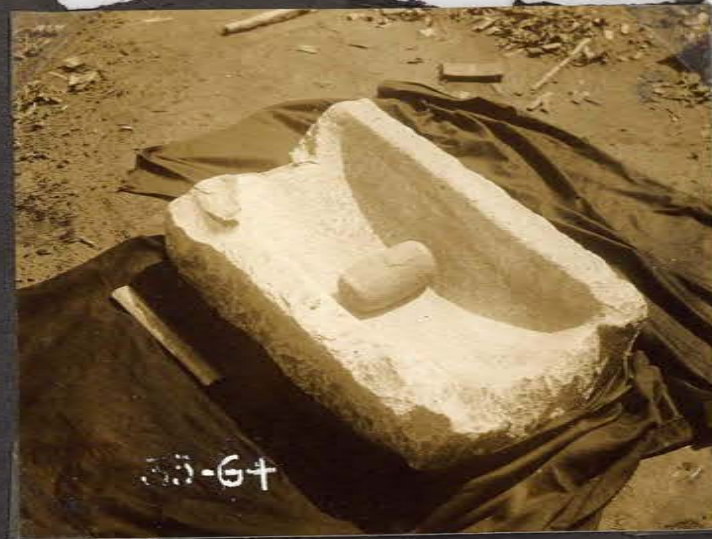
33-64

- 64 J-2 Metate from Debris of J-2, on SE side, SW of doorway to Room 5; mano stone picked up by architect in survey, location not noted. Both left at camp, casa principal.

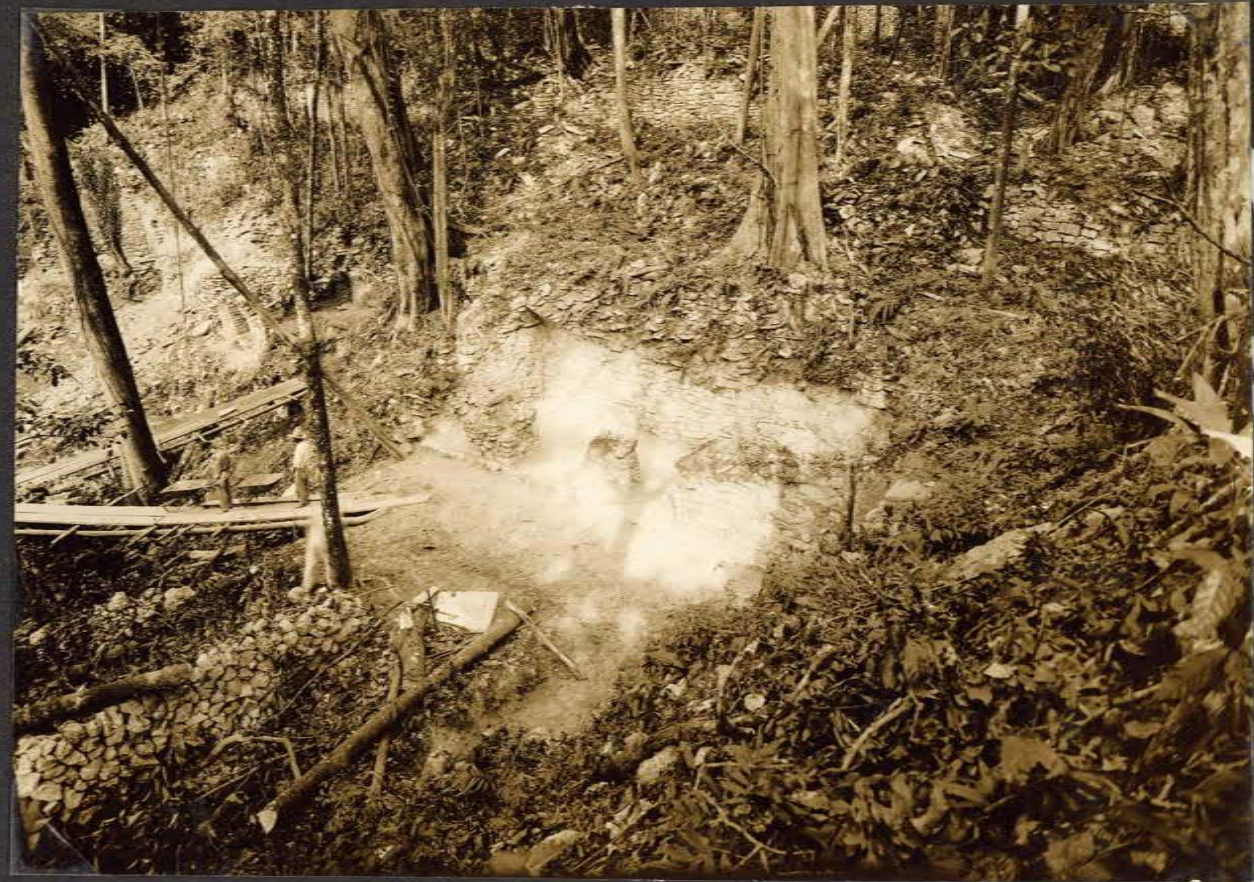
33-67

- 67 J-6 E Room 3 from Sly corner of J-4, second terrace from top. Right upper background terrace below J-8 shows plainly; left center, big tree in Room 2 (see its stump in 33-84) Floor of the platform terrace Str J-7 is cleared for a short distance in front of Room 3. The wall at left foreground is our old, holding dump from 1932 trench beyond it. 33-70 shows continuation of this trench where it enters the tunnel. Note "bridges" for wheelbarrows.

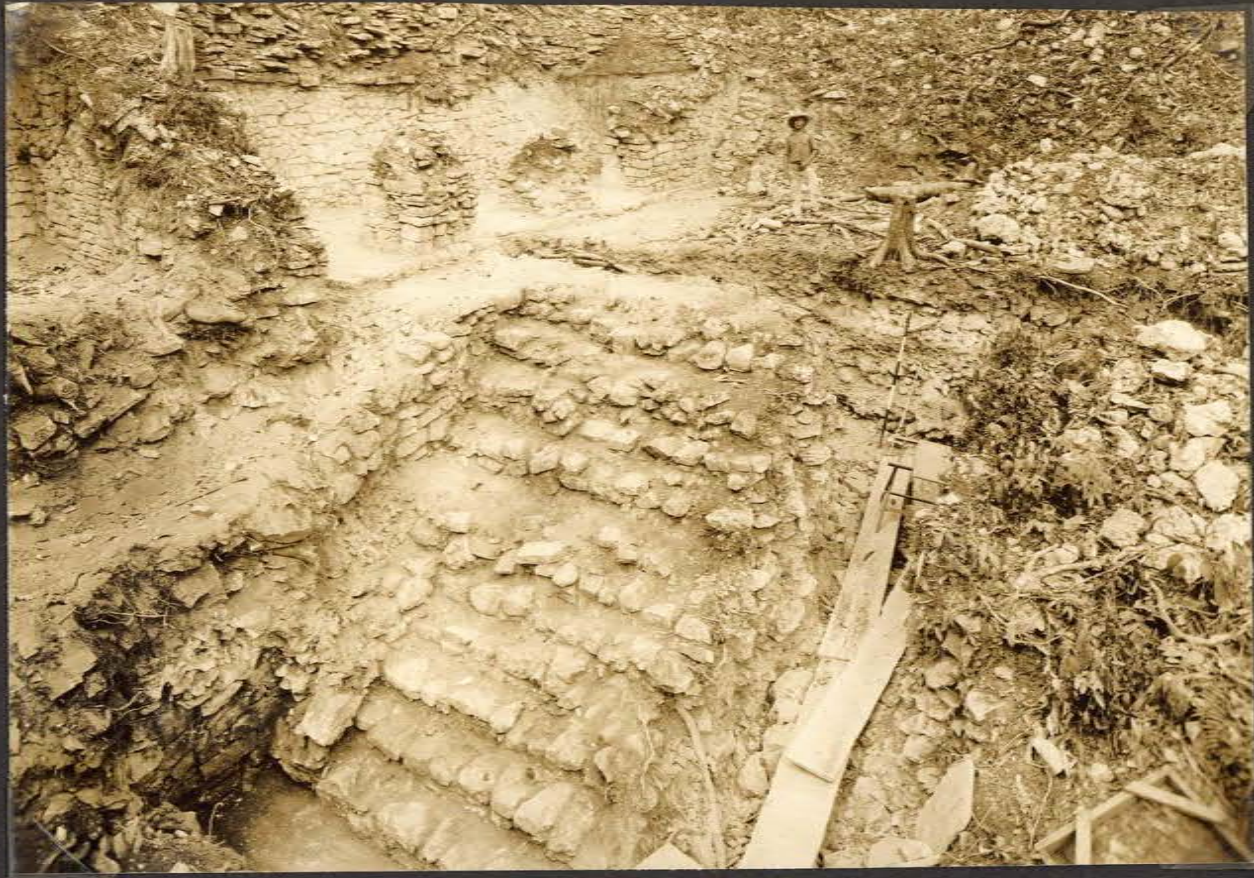
33-68

68 J-6 S From large dump (see 33-77 for location of dump); juncture J-7 (right) ^{with} Room 3 of J-6. Boards lie in trench connecting main trench at range pole. Note stairway of J-7, remnant of terracing front of Room 2 of J-6, rising from stairway.

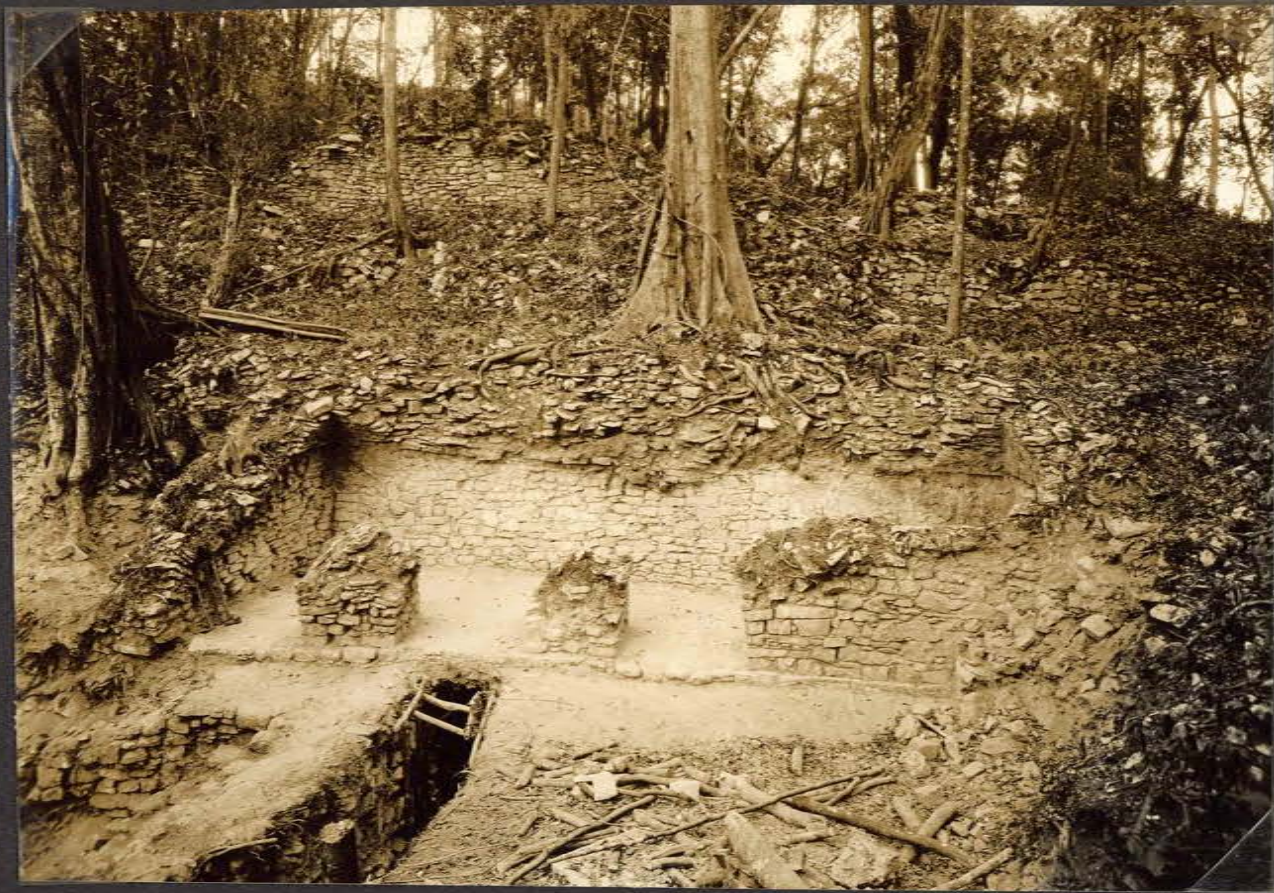
33-69

69 J-6 Same from tower on dump, showing more of Room 2 (left) and relation to Str. J-9 (extreme upper left) and to Str. J-4 (upper right). Note two men for scale. Boards at left are on bridge, 3.00 above Court 1, floor of which is visible at foot of stairway from J-7.

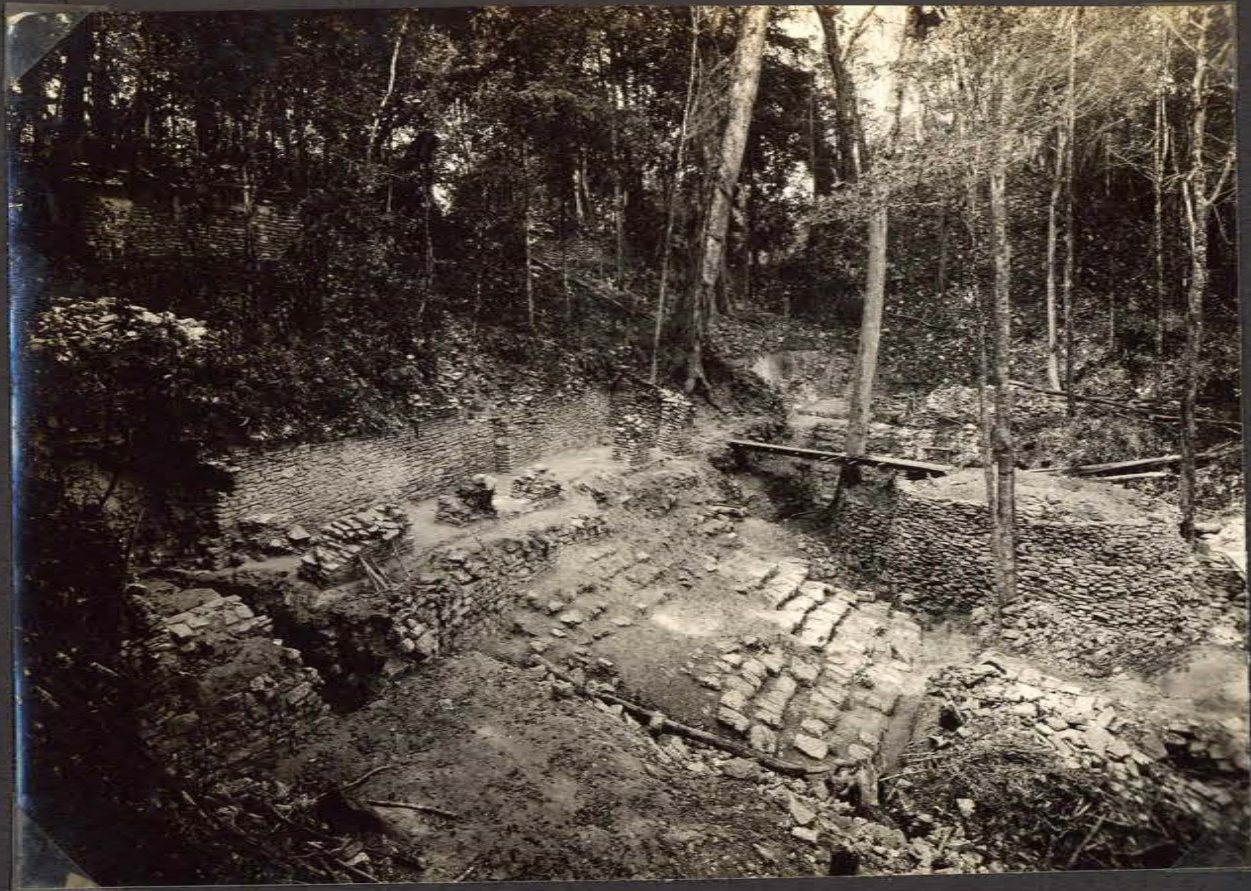
33-73-a

- 73-a J-6 S Main stairway lower center; left foreground to right center, Rooms 1, 2 and 3. Room 1-a has been almost entirely removed, the lowest steps only being seen from behind; the lower part of the rear wall of room 1 shows the original end, which was buried by the foundation of Room 1-a; Trench through J-6-2nd at extreme left. The round construction reached by a bridge is our dump, and dumps surround the stairway (foreground). See 33-77, better, later photo.

Same as 73-a, later. Room 3 now completely cleared ,
including felling of large tree. See notes under 73-a..

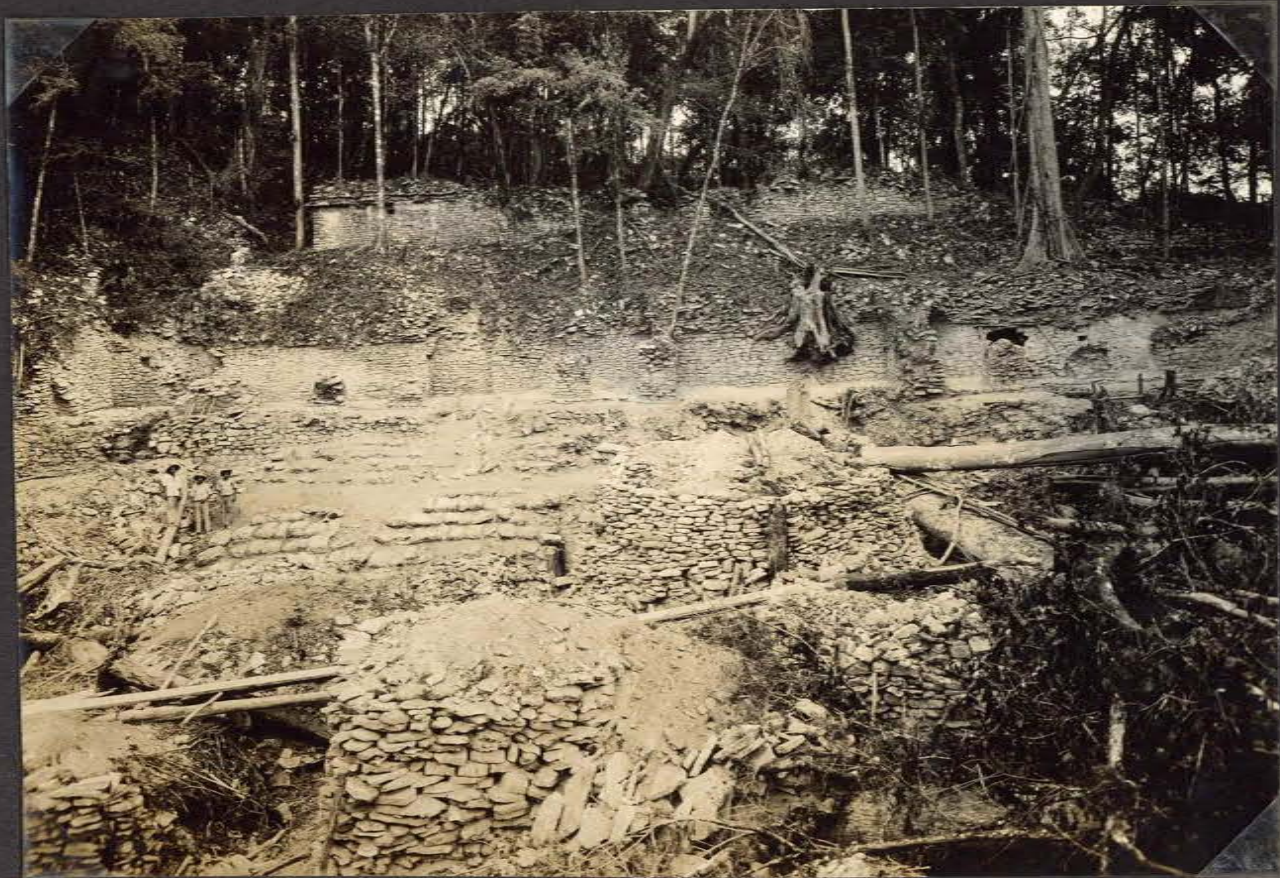
33-75

- 75 J-6
J-6-2nd
J-8 From tower near NEly end of Room 1 in Str. J-2. Foreground would be the flat surface of Court 1 were it not for our dumps. Note megalithic stairway rising from court the Room 1 (niche of Throne 1 behind it); Str. J-8 running along edge of Court 2, above and behind. (see Map and Section). Wide angle lens.

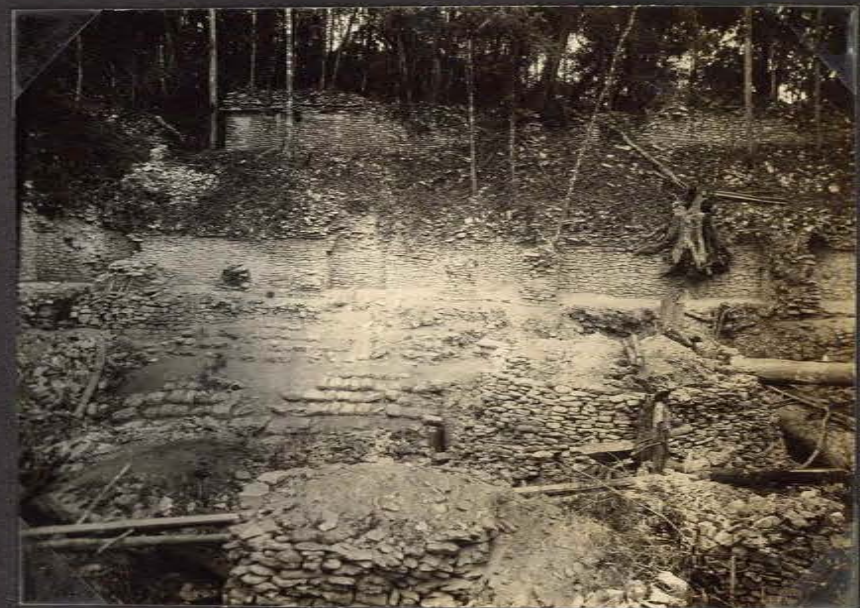
33-76

- 76 Same as 33-75, with small camera, wide angle lens. Good comparison of width of angles of the two lenses.

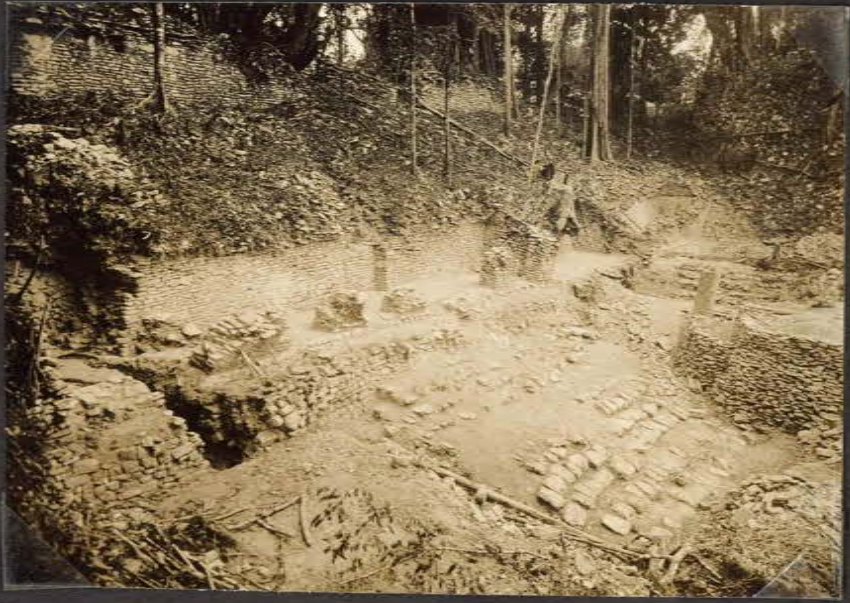
33-80

Same as 33-77, small camera.

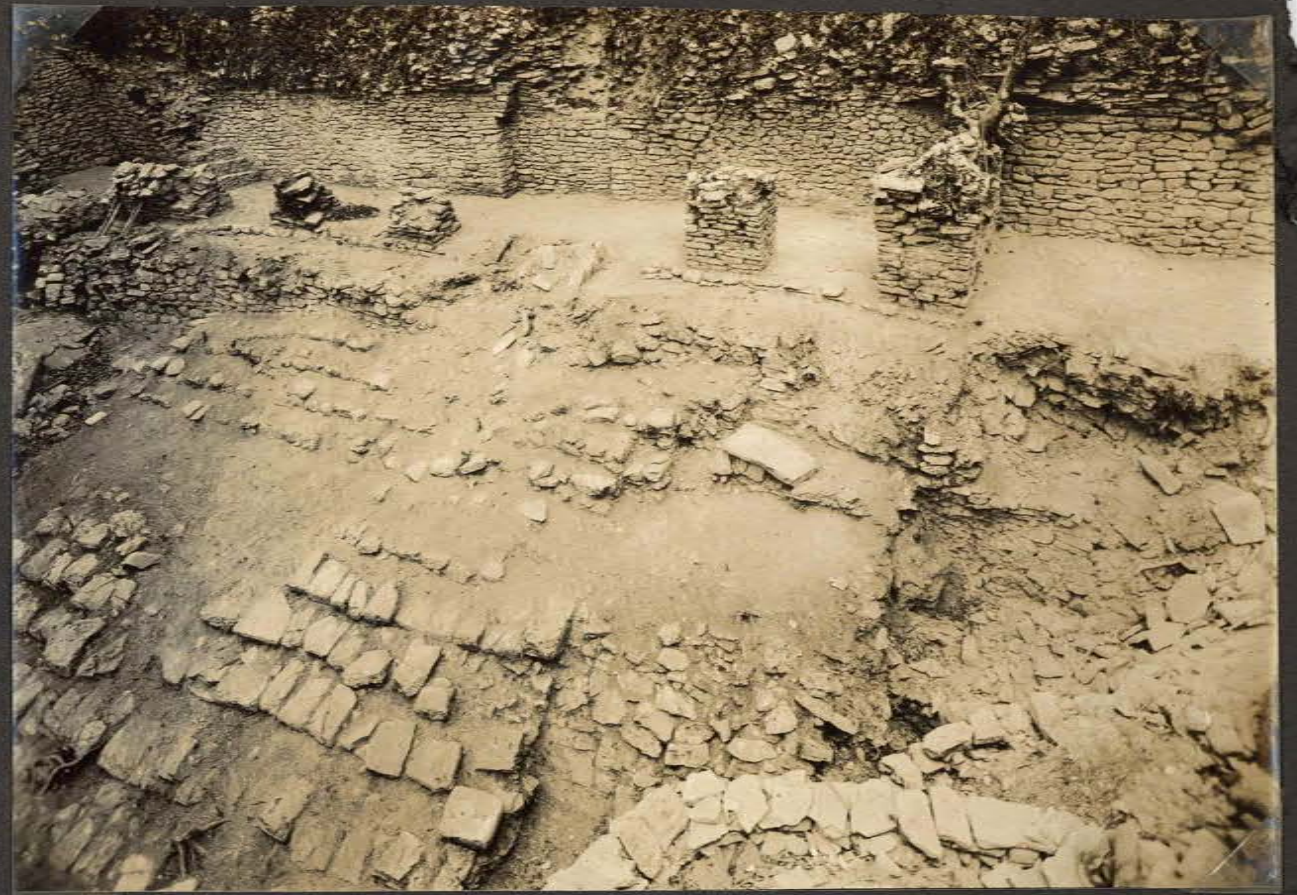
33-83

- 81 J-6 SW Similar to 33-77 & 80, but from point closer to the building (further to NW)
- 82 Same as 33-81; not printed for us.
- 83 J-6 E General view from tower on large dump (i.e. from height of about 6 meters). Stairway is shown somewhat distorted by the wide-angle lens. Note three steps of Room 1-a (upper left) which we have left in place; the now excavated but formerly buried ruin of the end of J-6-2nd, extreme upper left. There were probably piers at the front of Room 2 (upper right) but they had completely fallen before excavation.

Room 3 during the cavation, from the other direction; the same large stone, in position, at right, with two cap-stones for comparison. The two typical capstones were found also on edge just this side of the large one; note its upper right corner, in place, but broken by the fall - it probably is also a capstone. Cp with the large (and thicker) stone of Room 1 (33-83 & 84)

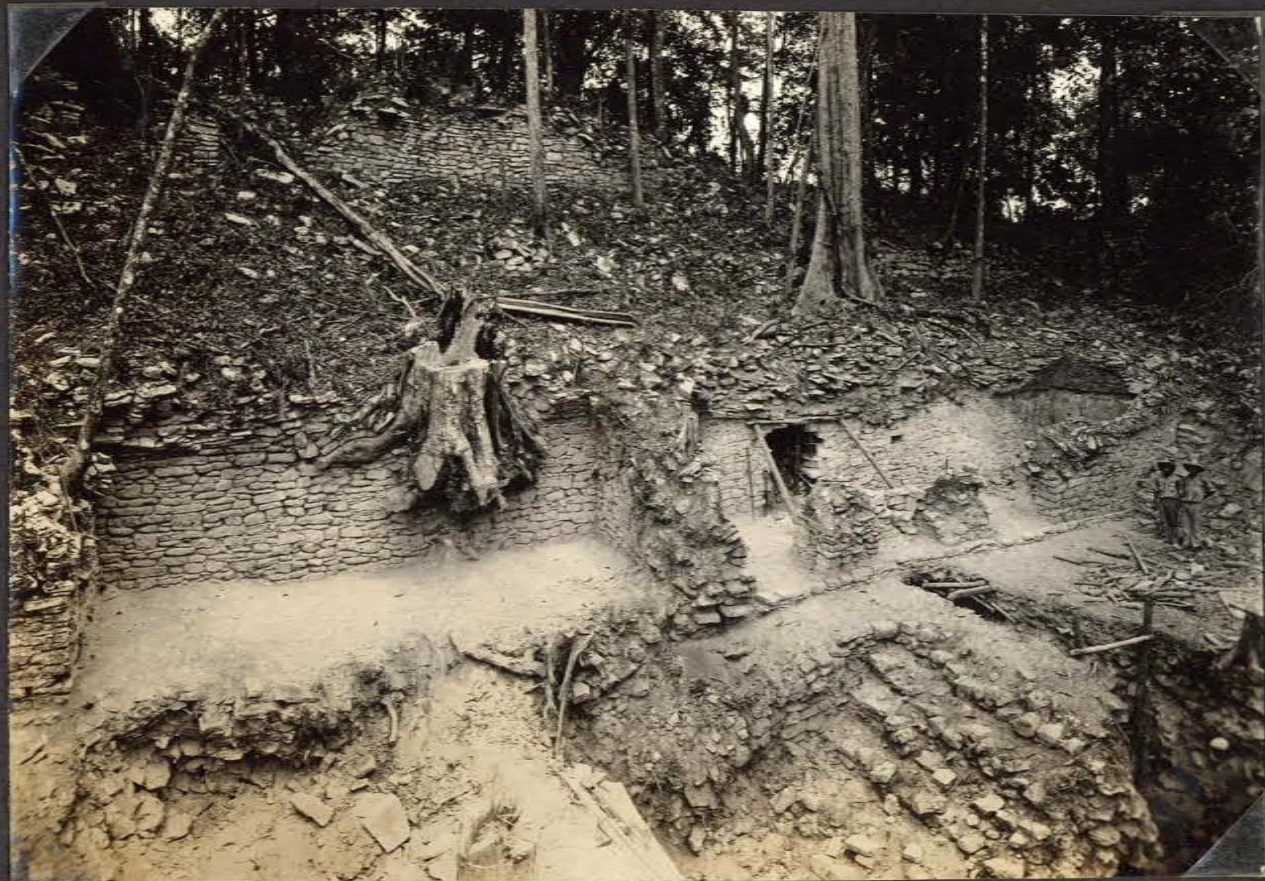
33-84

- 84 J-6 SE From tower on dump, same position as 33-83; Rooms 2 and 3. Note trench in J-7 from which tunnel follows under floor; also opening of upper tunnel, beginning at rear wall. This one is immediately over the lower tunnel, with only a concrete floor between.

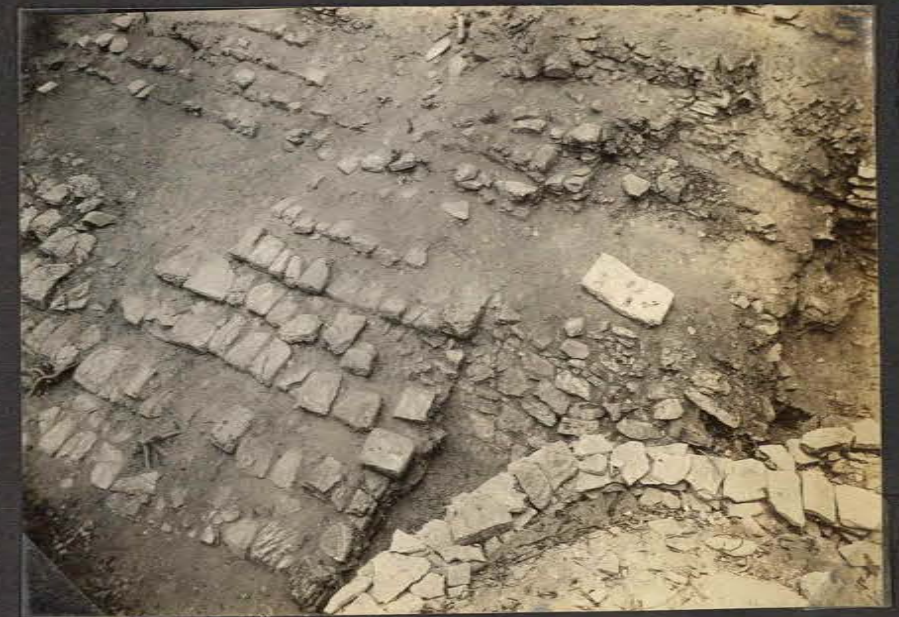
33-85

- 85 J-6 E Same as 33-83. The large heavy slab in each of these pictures is meaningless were shown: it was found on the floor at NE end of Room 1, immediately in front of small bench at that end. Purpose unknown - heavier and more rectangular than any other cap-stone, but obviously fallen or thrown there.

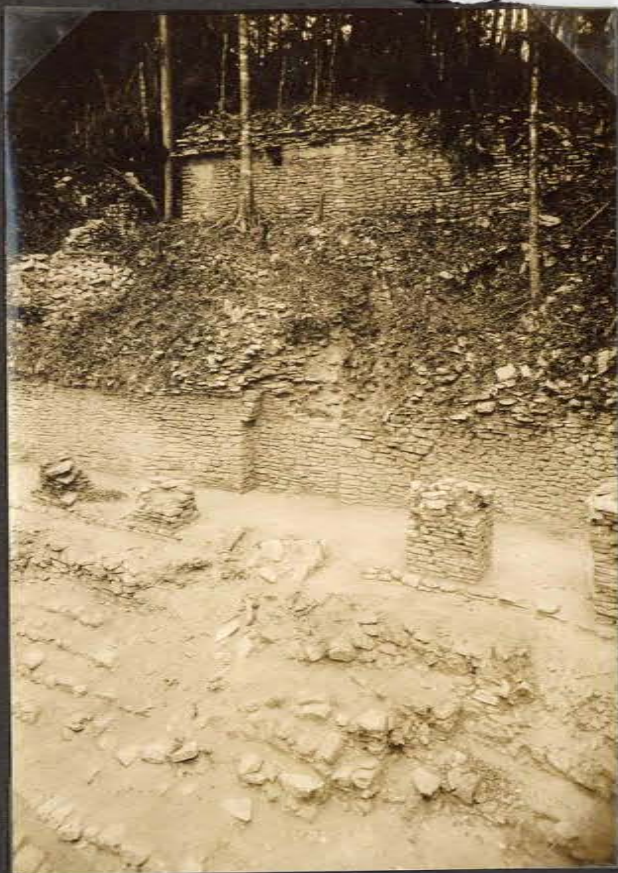
33-86

- 86 J-6 E Similar to 33-83, but showing Str. J-8 above and behind; niche of Throne 1 in center; note fallen pier.
- 87 J-6 SE West of Room 1, and Room 2, to show masonry; from dump in Court 1.
- 88 J-6 SE Room 1 and megalithic stairway before it, from tower in Court 1. Note predominance of irregular stones in right (NEly) part of rear wall, note observed close to and left (SW) of niche. Is this Room 1 a single construction, or is the NEly part of the rear wall an older one, fallen or torn down except at the NE?
- 89 J-6 E SWly end of J-6, and J-6-2nd beyond (left), from tower in Court 1. Note terrace retaining wall in front of both, upper stones of megalithic stairway lower right; dump lower left. Here at the left original contours showed that terrace system descended, at right (here left) of stairway to court level, as on the other side.

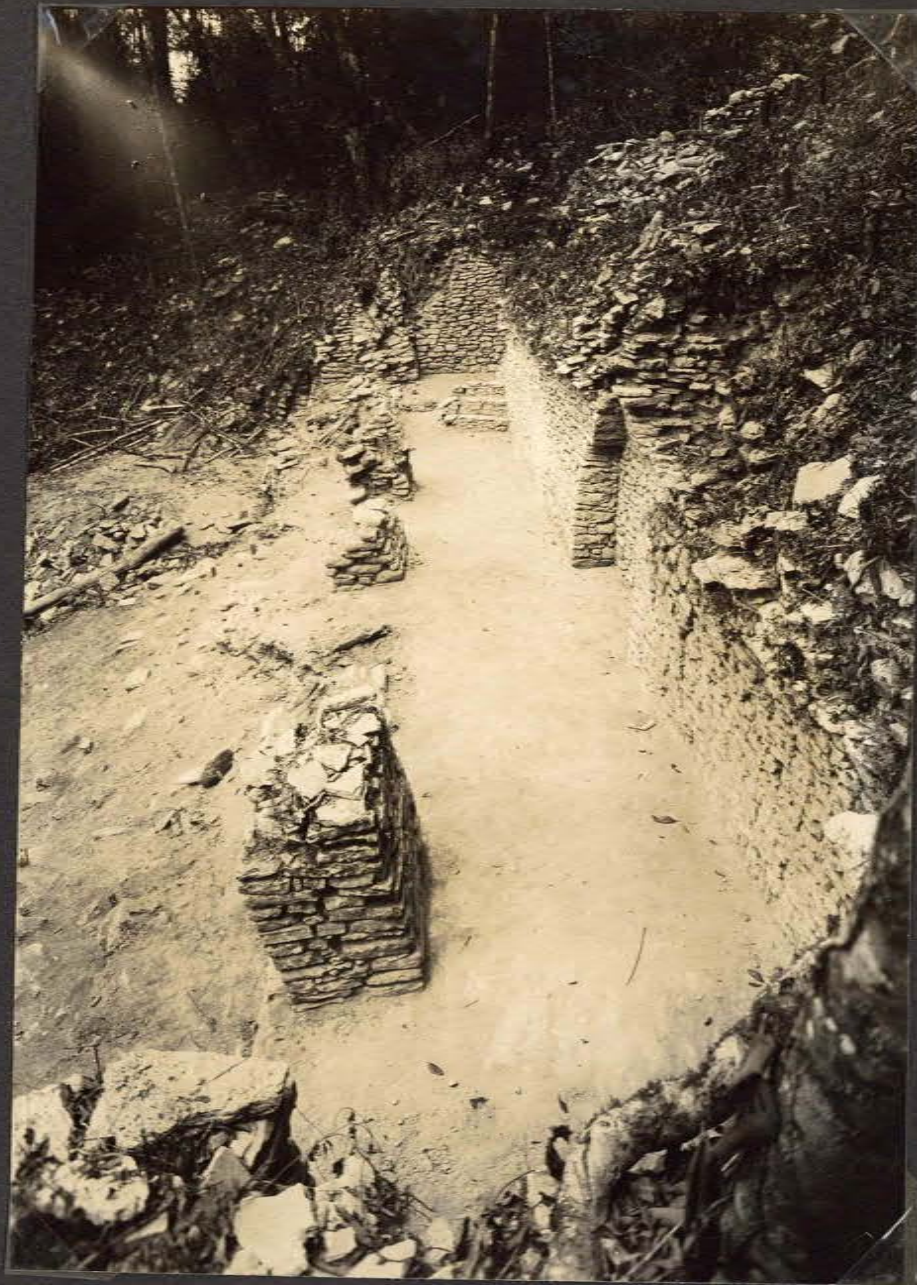
33-90

- 90 J-6 NE Room 1 from tower in Room 2; J-6-2nd beyond remnant of three setps which led to elevated floor of Room 1-a.
- 91 J-6 S Room 3 from outside, on floor of J-7; note terraces (only about 50 cm high) rising against (or part of) the pyramid J-4, the ends against J-6; the highest remaining risines up under a big slab which seems to be remnant of medial cornice slab of J-6. Should have gone in here for possible preserved portion of upper zone and relative dating.
- 92 J-6 E Room 1, niche of Throne one (bench removed); note slabs of broken-off vault above; masonry.
- 93 J-6 S Same as 33-92, but from other side, closer; note large single slab, right side, which carried the side off-set (in position and unbroken on left side - see 33-92.

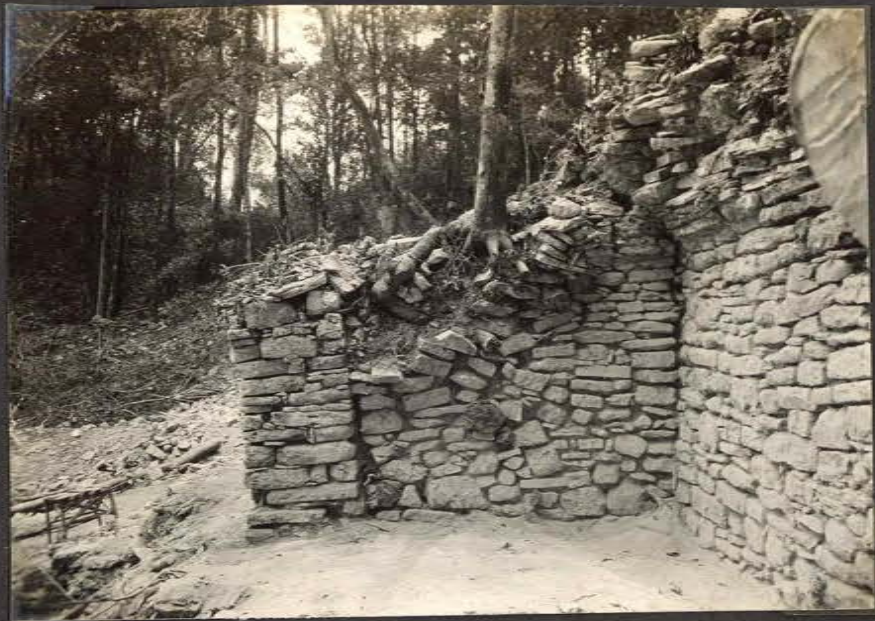
33-94

- 94 J-6 NE Room 2, SWly end wall, running from rear wall to pier. Note that it was placed after pier and rear wall (including vault) were in position p may be secondary in period as well as constructional sequence.

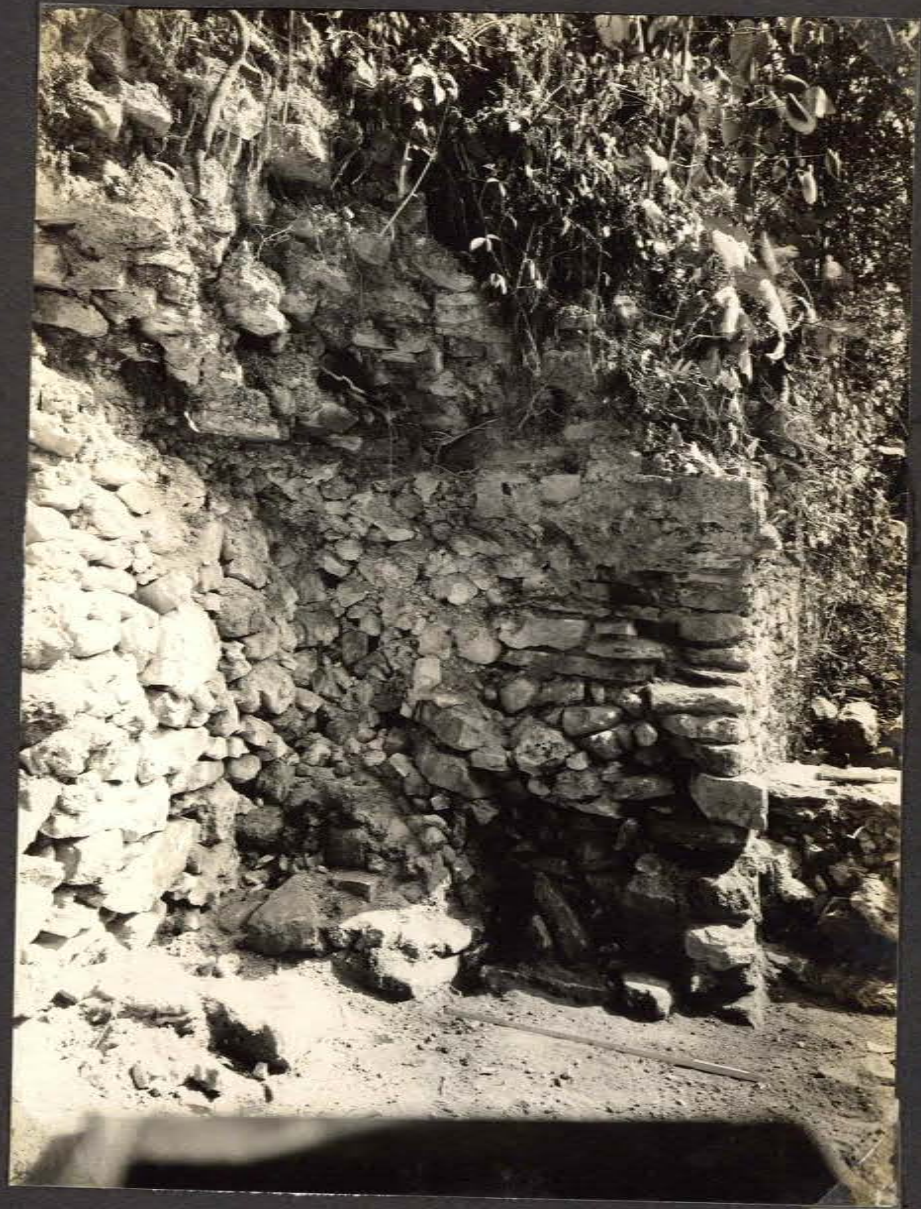
33-95

- 95 J-6, SW End of rear wall of Room 1, Str. J-6, as left by the builders, except at top, at and above level of elevated floor of Room 1-a, where we have removed it and left a cut-section; tread of third step of the stairway of Room 1-a shows at right, seen from behind, a cut section of the fill under it; Note fill behind the rear wall of Room 1, running (here left) to a fill wall paralell to rear wall (runs out of picture, toward camera, at left); this fill wall is curve-battered, very crude, its base just behind (NE) of the lowest courses of the nearly removed rear wall of J-6-2nd, at which the ruler points; A trowel, visible if one looks for it (left center) marks the junction of our cut section of fill with the fill wall mentioned above. Above all this is a masonry core. Compare this picyure with 32-S-140, taken from the front, in 1932.

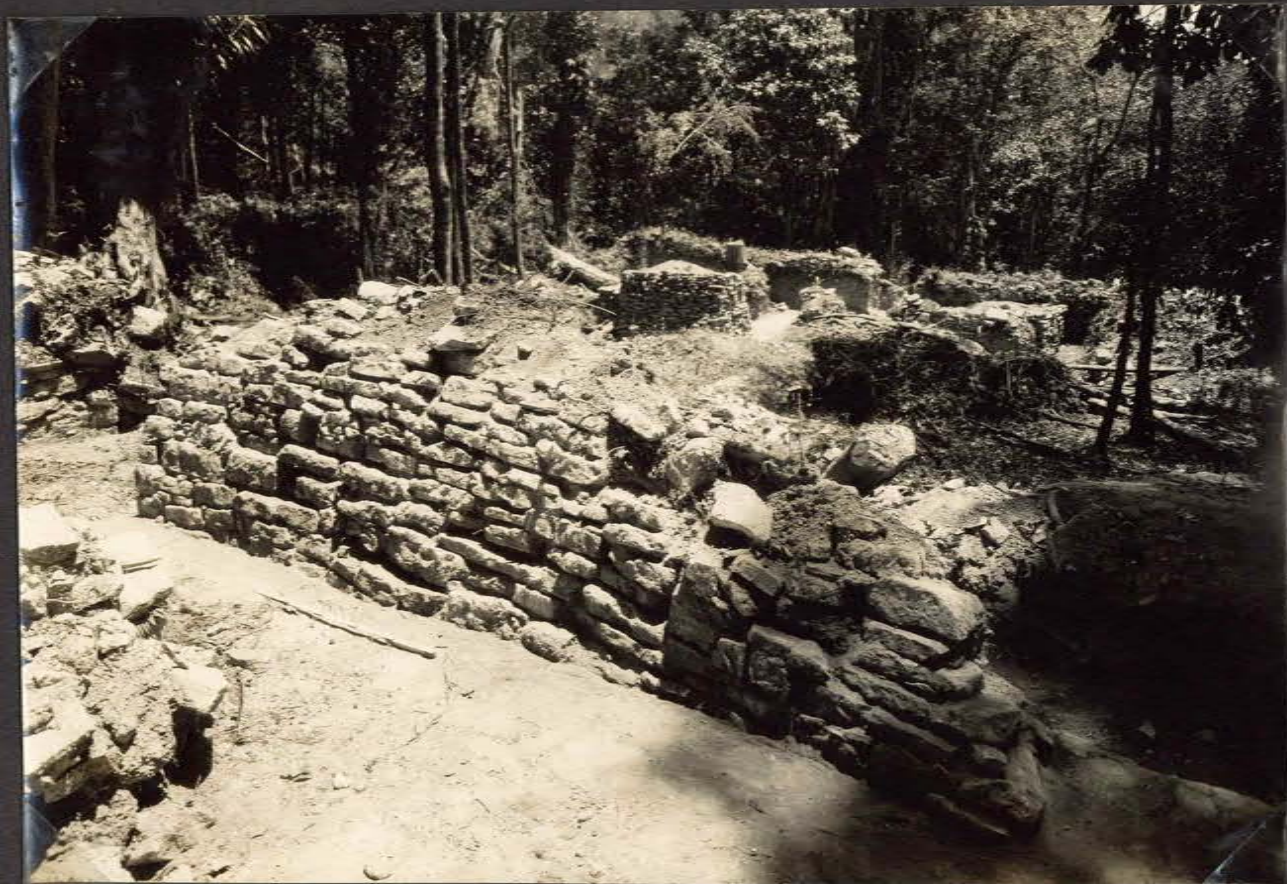
33-96

- 96 J-6, W Room 1, inner side of outer wall, common (apparently) to both earlier and later buildings. The break at right is due to our excavations; a doorway at left.

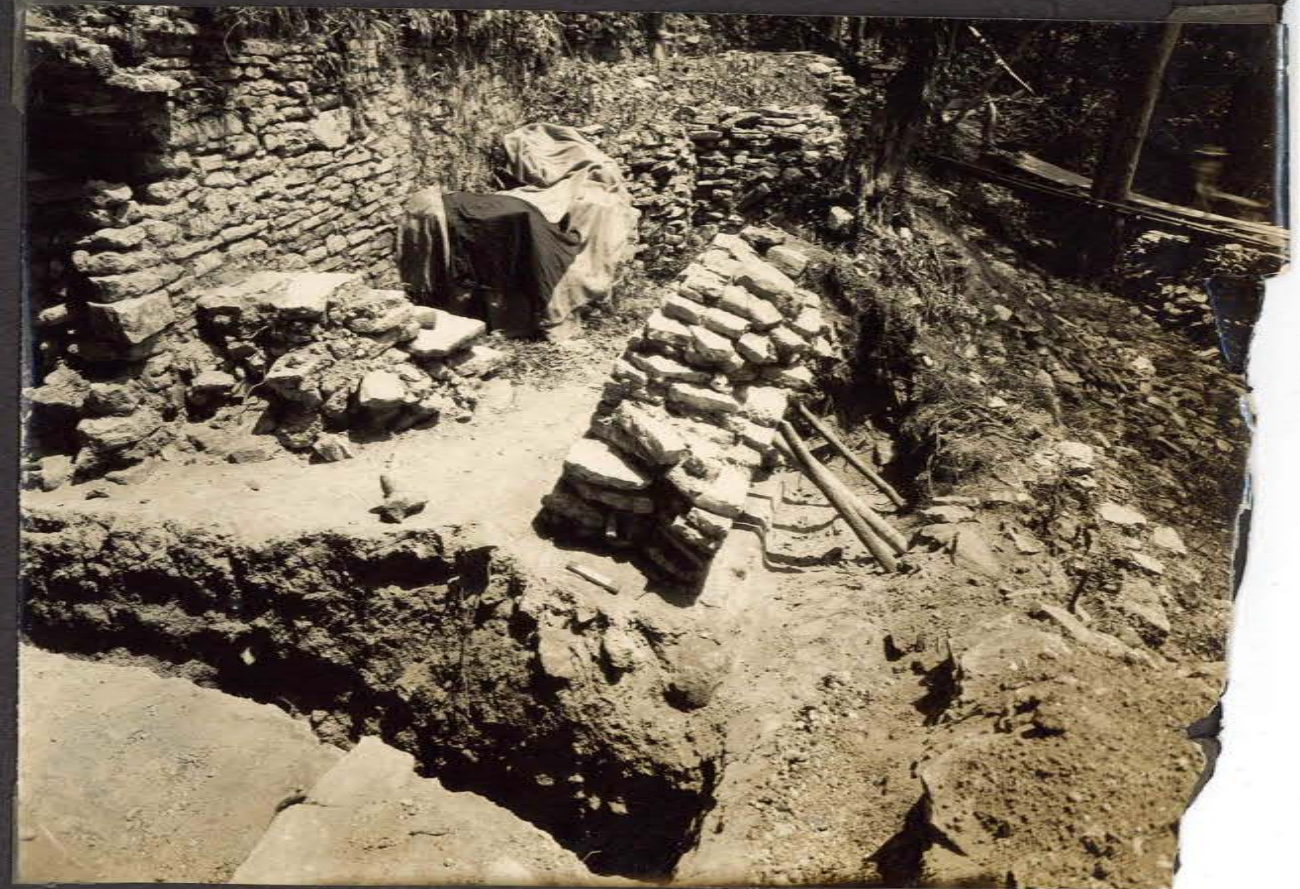
33-100

- 100 J-6 SW Cut section through outer wall at Sly end (see
33-99 also); Pencil, in shadow, points to finishing
plaster running under the wall; trench in foreground -
note tight solid fill here; fragment of stalactite
from this trench lies on floor of J-6-2nd, which
was buried under Room 1-a; note plinth at right.
Notice flat slabs in wall, partly overlapping at center.
To be compared with 33-43, but that is a thicker wall.

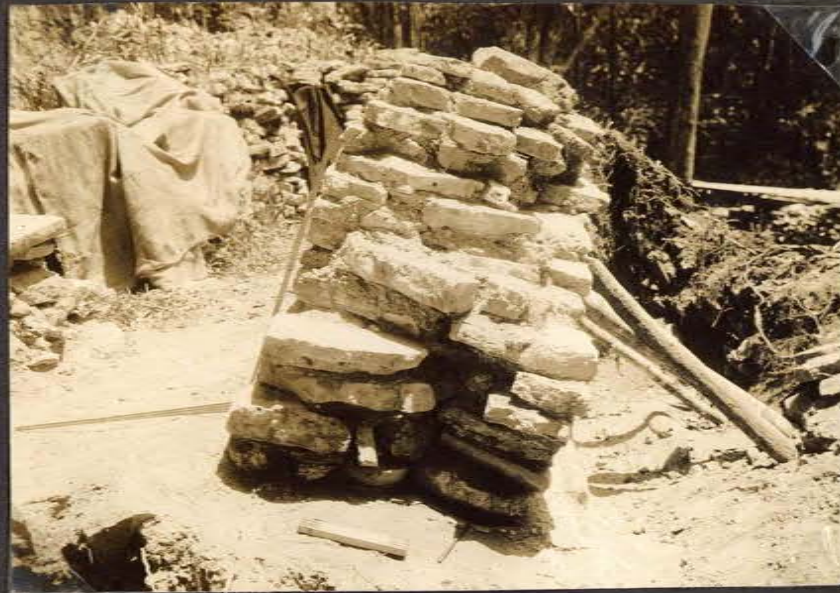
33-102

- 105 J-6, SWly end; J-6-2nd at left, with secondary partition (retaining) wall still in place. Outer terrace in foreground runs before both, apparently continuous.

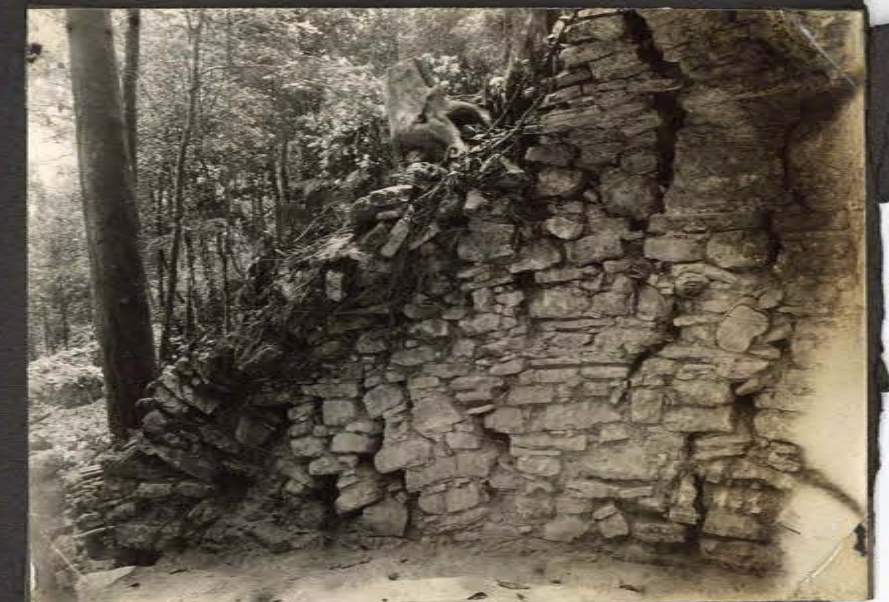
33-106

- 106 J-6 NE Room 3, SWly end wall. On this side, this end wall runs into (across) the rear wall. The wall is badly damaged by roots and actually pushed, more or less intact, a considerable distance forward.

- 112 J-6 SW Room 2, NEly partition wall (i.e. end wall of this room). Note disturbance by roots. For other side of this wall see 33-106.
- 113 J-6, NE Room 1, "partition wall" across J-6-2nd in background; J-6- SWly doorway of this room at left, remainder of steps 2nd to Room 1-a at right. Compare this with 32-S-65, which shows what was originally left of Room 1-a from about same point of view.

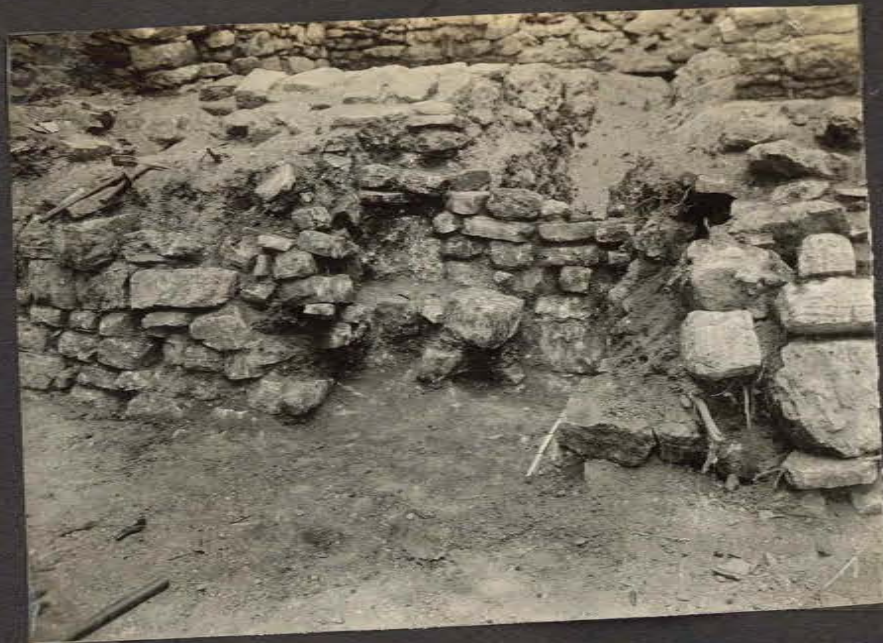
33-107

- 107 J-6, SE Terrace at SWly end (for position see large stone at
J-6- extreme right, in 33-105 at right center) showing
2nd crude earlier (or constructional) terrace 1 meter
behind, in trench. The trench is 1.60 M from end of
J-6-2nd room (before removal of transverse partition
retaining wall.)

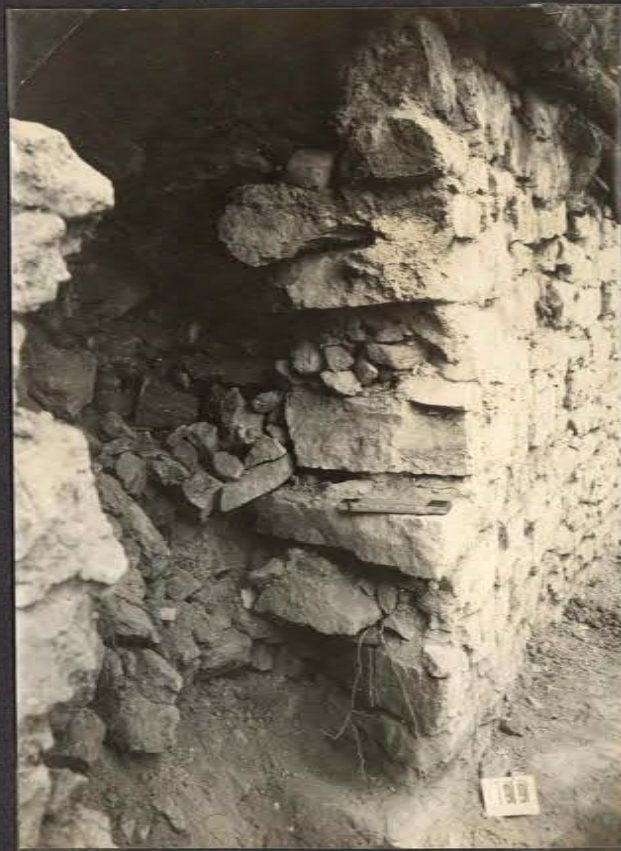
33-110

- 110 J-6 S Cut section through rearwall of Room 3 (entrance to
upper level tunnel); note heavy slabs, blocks from
stratified deposits - parallel upper and lower surfaces -
laid in mortar; pure rock fill behind.

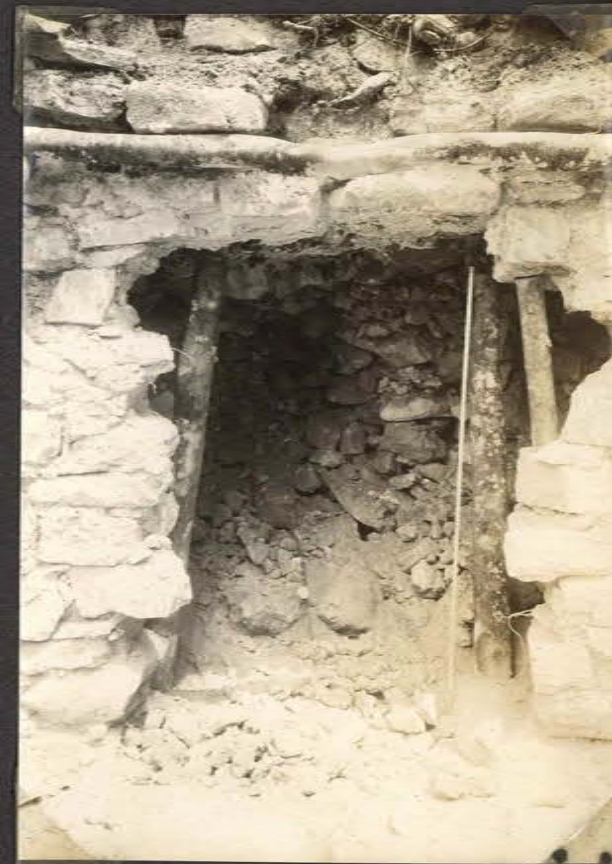
33-111

- 111 J-6 SE Entrance to upper tunnel, through rear wall of Room 3,
behind center doorway; notice pure loose rock fill
behind wall to height about level of vault-spring -
then slab masonry laid in mortar forms a "natural" roof
to the tunnel. Plenty of small stone mixed with medium
sizes in the rock fill.

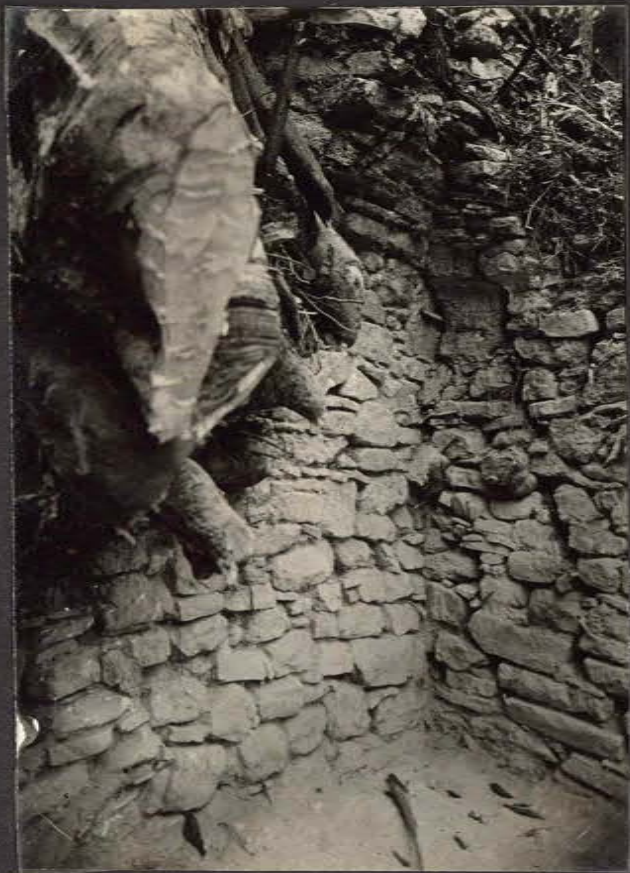
33-114

- 114 J-6 S Junction of partition wall between Rooms 2 and 3 with rear wall. Note that walls are tied, while vault appears to carry through across end of partition wall. This is actually an inside corner, against the outside of which the rear wall of Room 3 was added (See the other side, 33-123). At least parts of wall and vault of Room 2 were in existence before Room 3 was erected.

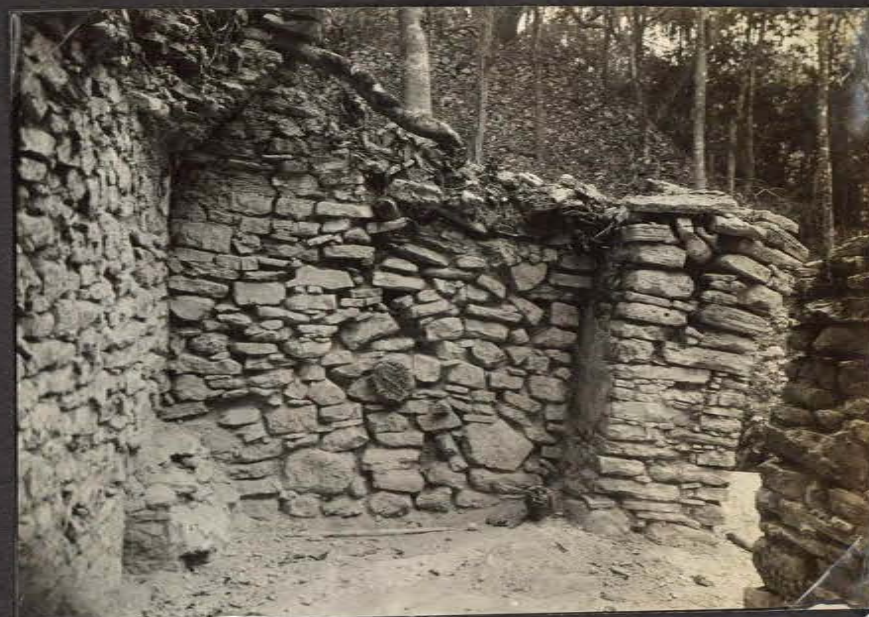
33-115

- 115 J-6 SW Partition wall between Rooms 1 & 2, from Room 1 - remnant of bench at left; Note plaster on pier at right. Both pier and ~~wall~~ vault, run across this partition wall (see 33-94 for the other side); Indications therefore are that Room 1, or part of its rear wall and vault, were contemporary with Room 2, which preceded Room 3 (see note/ under 33-114); But on ~~taxa~~ tearing out upper part But the rear wall itself has a thin portion of this partition wall let into it (see 33-122 and ~~taxa~~ field notes. Present conclusions; consid ering also the differences in masonry of the rear wd 1 of Room 1 (see 33-88 & note), probably Structure J-6 with its three rooms was conceived and built as a unit, but built over older structures, parts of the walls and floors of which were allowed to remain standing and utilized in Rooms 1 and 2. However, there is no positive evidence to show whether Room 3 may not have been part of the earlier complex in its entirety or a later addition to Rooms 1 and 2; Modification of this note; it is probable that this partition wall was built as a unit in its entire thickness, covering up the mere stump of an earlier thin wall (hence the note under 33-94 that rear wall runs across the partition, which is fully justified by the external appearance on both sides. It does run through, but includes this stump. This is further evidence that the rear wall of Room 1 includes masonry of two periods. We should look for the base of the J-6-2nd rear wall behind the NEly part of Room 1, and behind Room 2 - if there, we have three instead of 2 building periods in Rooms 1 and/or ~~taxa~~ 2.

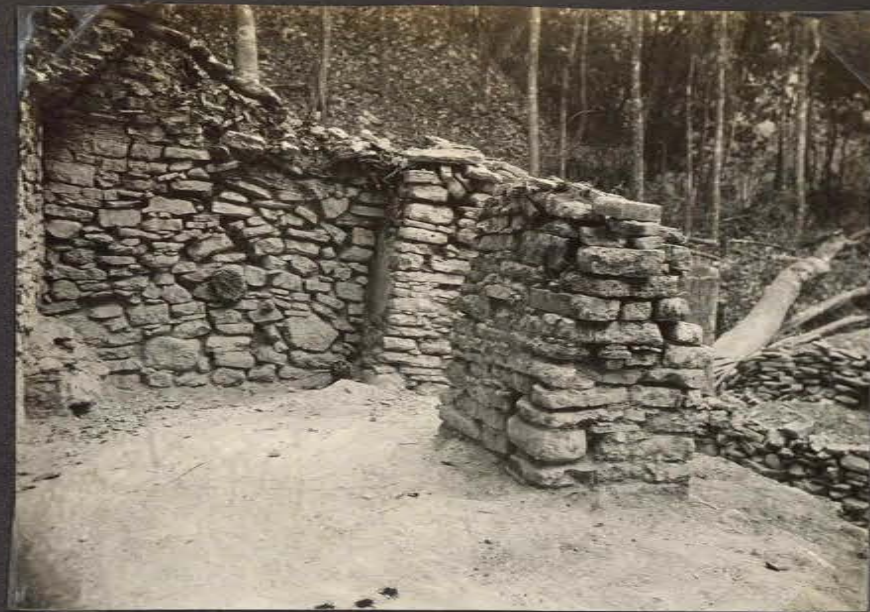
- 116 J-6 W NEly pier of Room 1, from inside, with partition and final pier (here forming a sort of pillaster) beyond.
- 117 J-6 W The above pier and, in foreground, the two SW of it, the first badly fallen (Room 1).
- 118 J-6, SW Similar to 33-104 - same note applies to both.
J-6-
2nd
- 119 J-6 N Room 1, NEly doorway at left - the same pier as 33-116, from the other inside corner.
- 120 J-6 S Room 1, same pier (center) as 33-116 & 33-119, outside corner, with pier at partition beyond.
