1933

P.N. 1933 P.3

Photographs

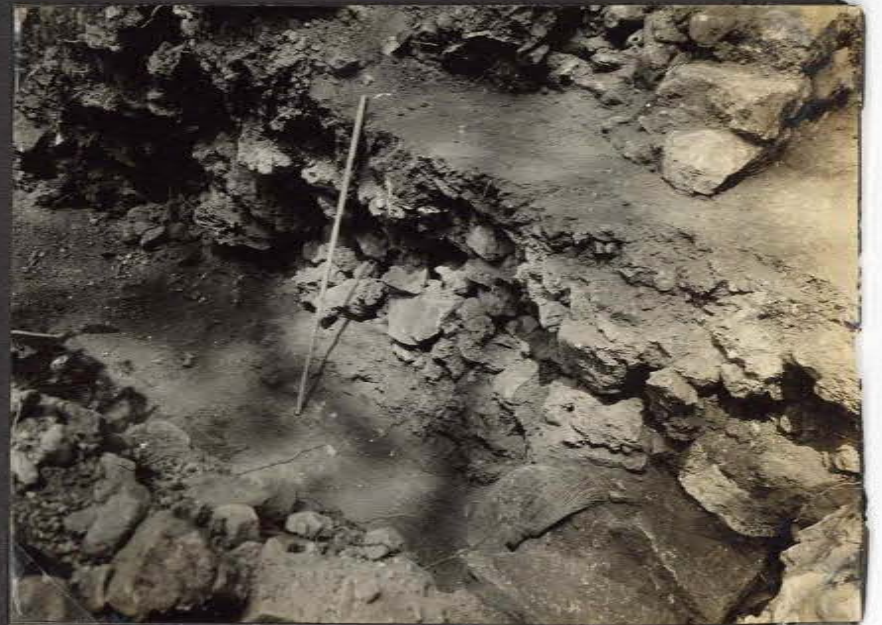
33-126

- 126 J-7 E Looking at NEly side of connecting trench from Court 1, the end of which was shown in 33-125; whisk broom in same position on largely removed wall of third level house, ruler against cut section of fill which buried it and supported floor of the low terraces of second level; bottom of ruler on floor of the house.

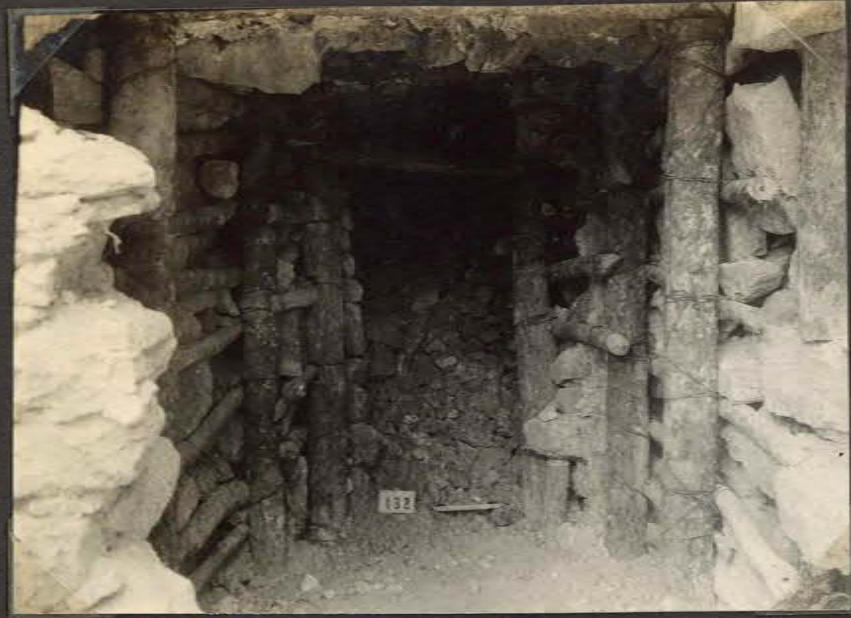
33-133

- 133 J-6 SE Upper tunnel, Room 3; pure loose rock fill behind dry wall shown in 33-132, and against side wall of independently standing left (SW) portion, the corner of which shows at left, beyond post;

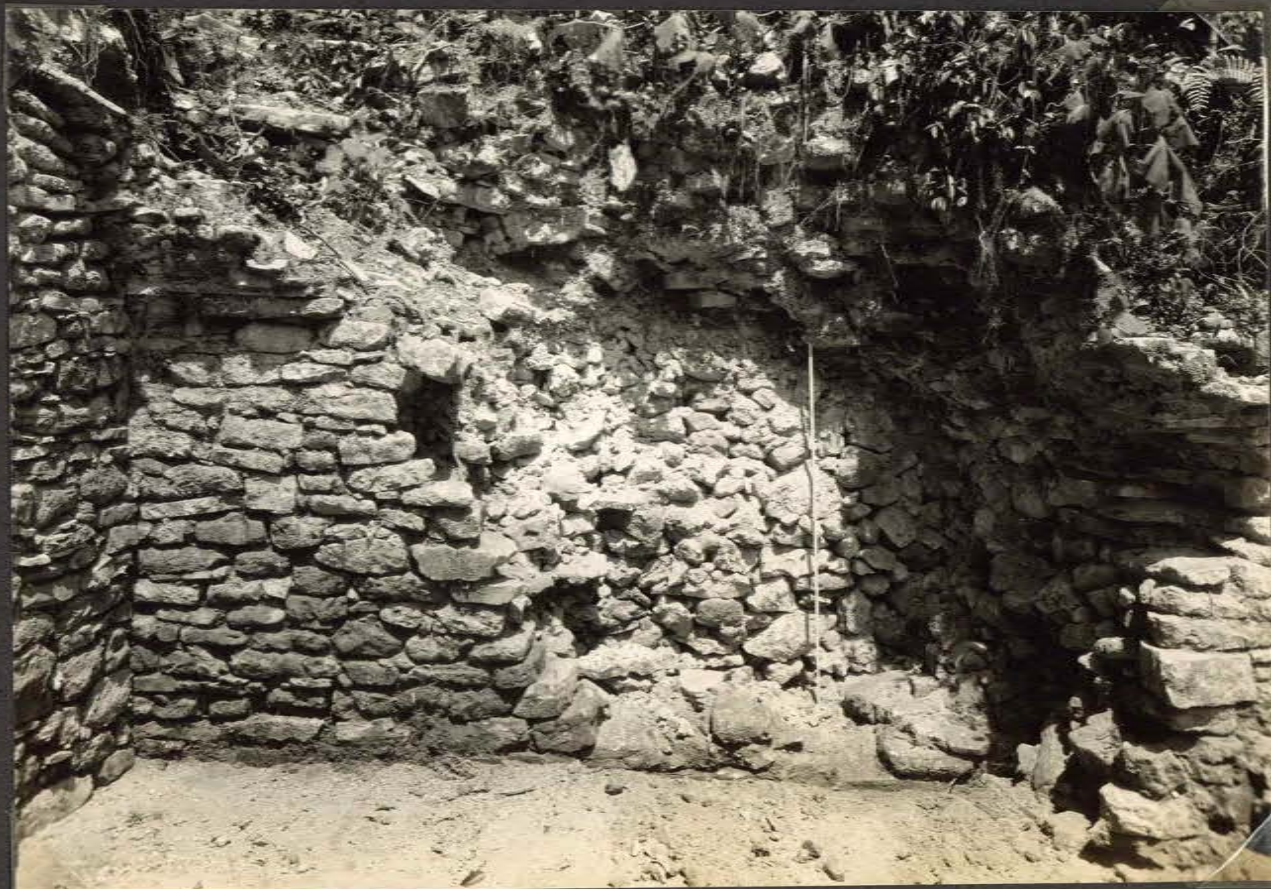
33-145

Rear wall of J-6-2nd, from front; It was found in this
ruined condition, being reduced to lowest two or three
courses at right; the secondary "partition" wall is still
in place (left); Meter stick rests against a crude fill
wall. End of Room 1 wall of J-6 at extreme right in foregro
ground, from which our cut section runs back to meet this
fill wall, the junction marked by a trowel, in shadow;
The fill wall probably extends to the right behind the
latest fill, which is placed over the ruin of the J-6-2nd
wall; & probably also to left behind J-6-2nd rear wall,
in which case the fill wall is an early one, part of
J-6-2nd; note beginning of vaulting on rear wall of
J-6-2nd; also the masonry hearting above, which rises
to surface. The only real masonry hearting seen yet at P.N.

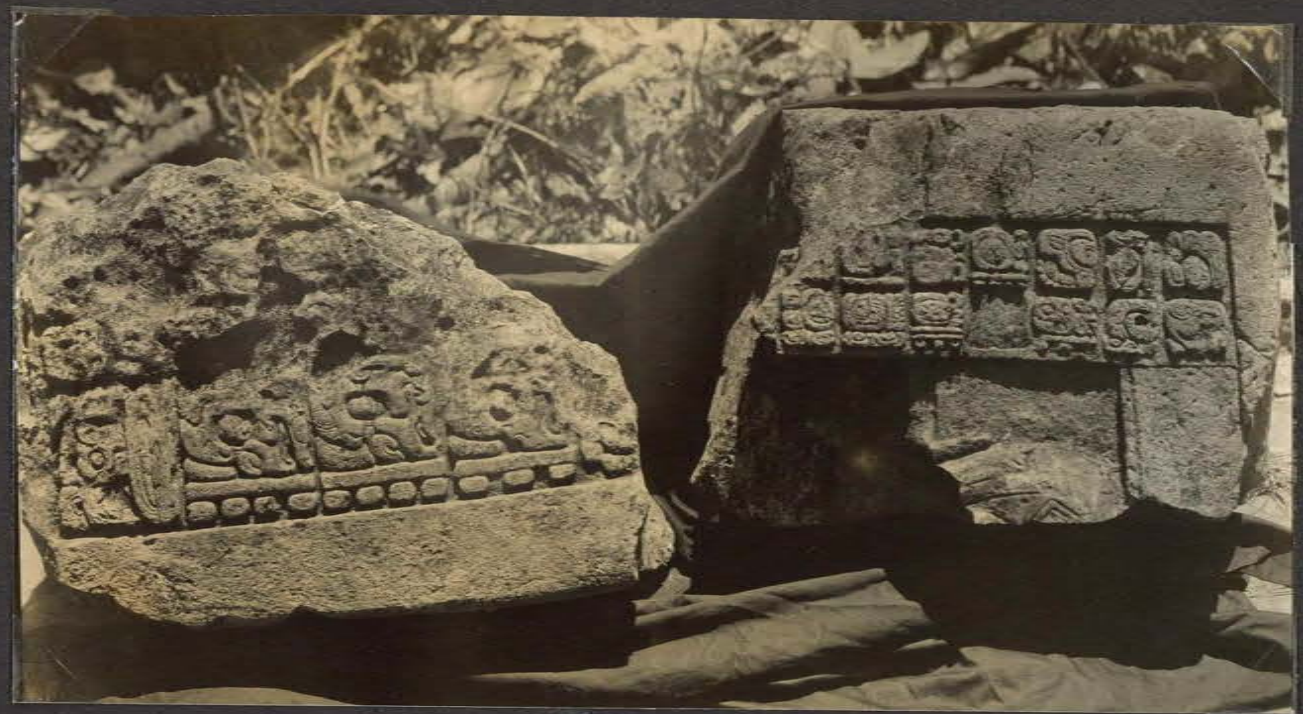
33-151

- 151 K-5 Two fragments of Lintel 7, re-photographed (see also 33-153) Upper left corner (left); lower right corner (right).
- 152 K-5 Fragment, probably of Lintel 7, found on front slope, over left (SEly) edge of stairway, about in line with front of terrace of the upper stucco mask (see 33-157), about 1.50 higher, near surface. It is certainly not from right (NWly) doorway of K-5, but might be from left rather than center.

- 153 K-5 Same as 33-151, smaller picture.

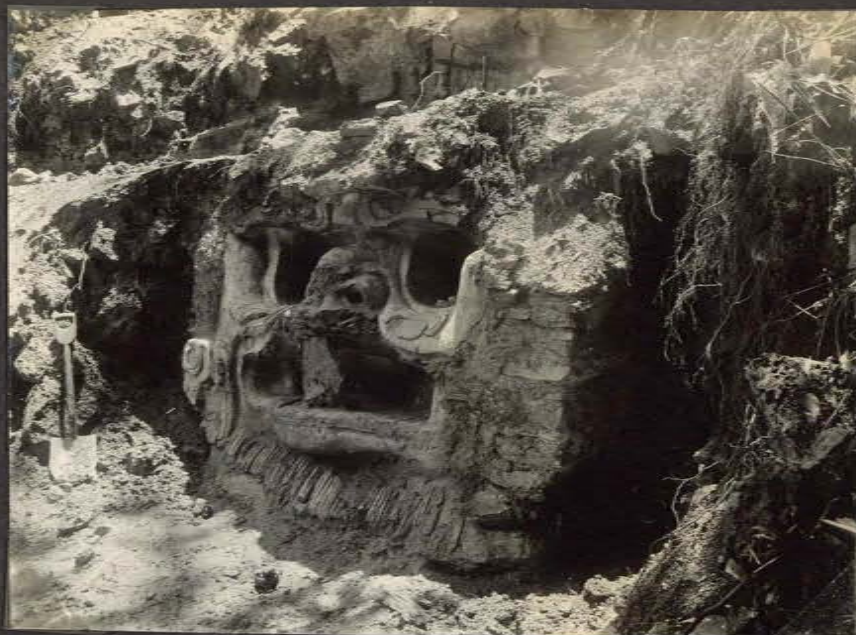
33-154-a

✓ 154-a K-5 SE Large stucco mask (lower, on second terrace, of the two found in 1933, with remains of the upper, on third terrace, above and behind.

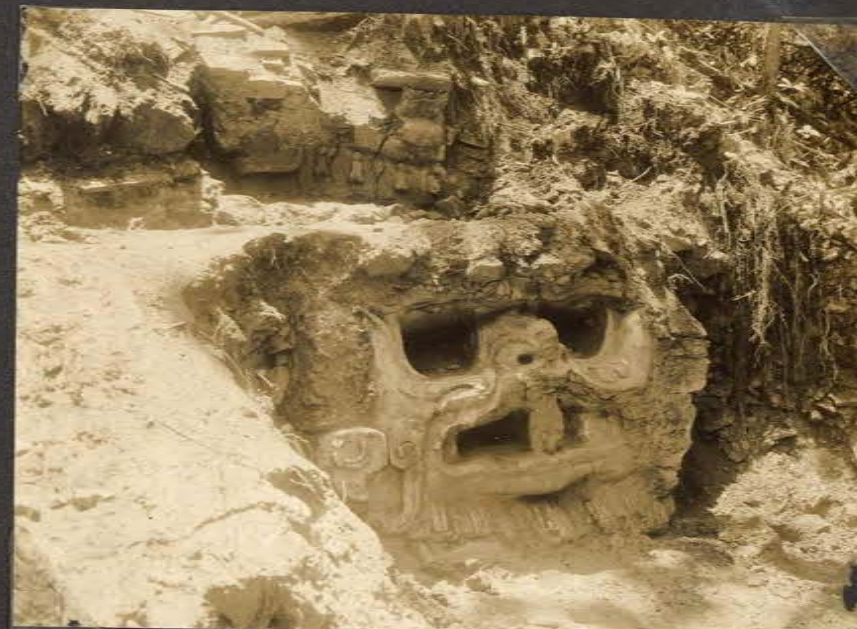
33-155

155 K-5 W Same masks, from the other side (the masks' right).

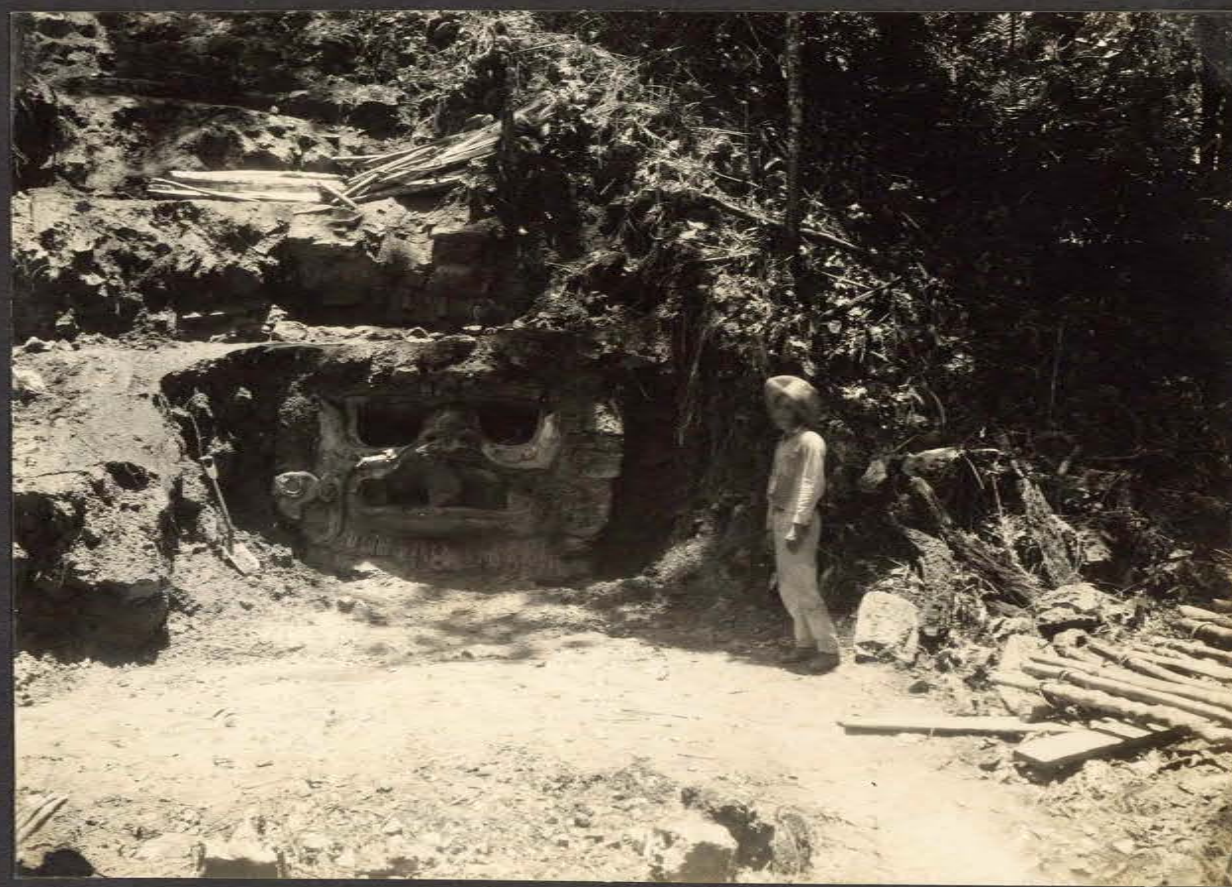
33-156

156 K-5 SW Above mask - note that the lower portion of another on third terrace seems to be in line; Benjamin, who discovered it, at right.

158 K-5 SW Same as 33-156, in stronger light.

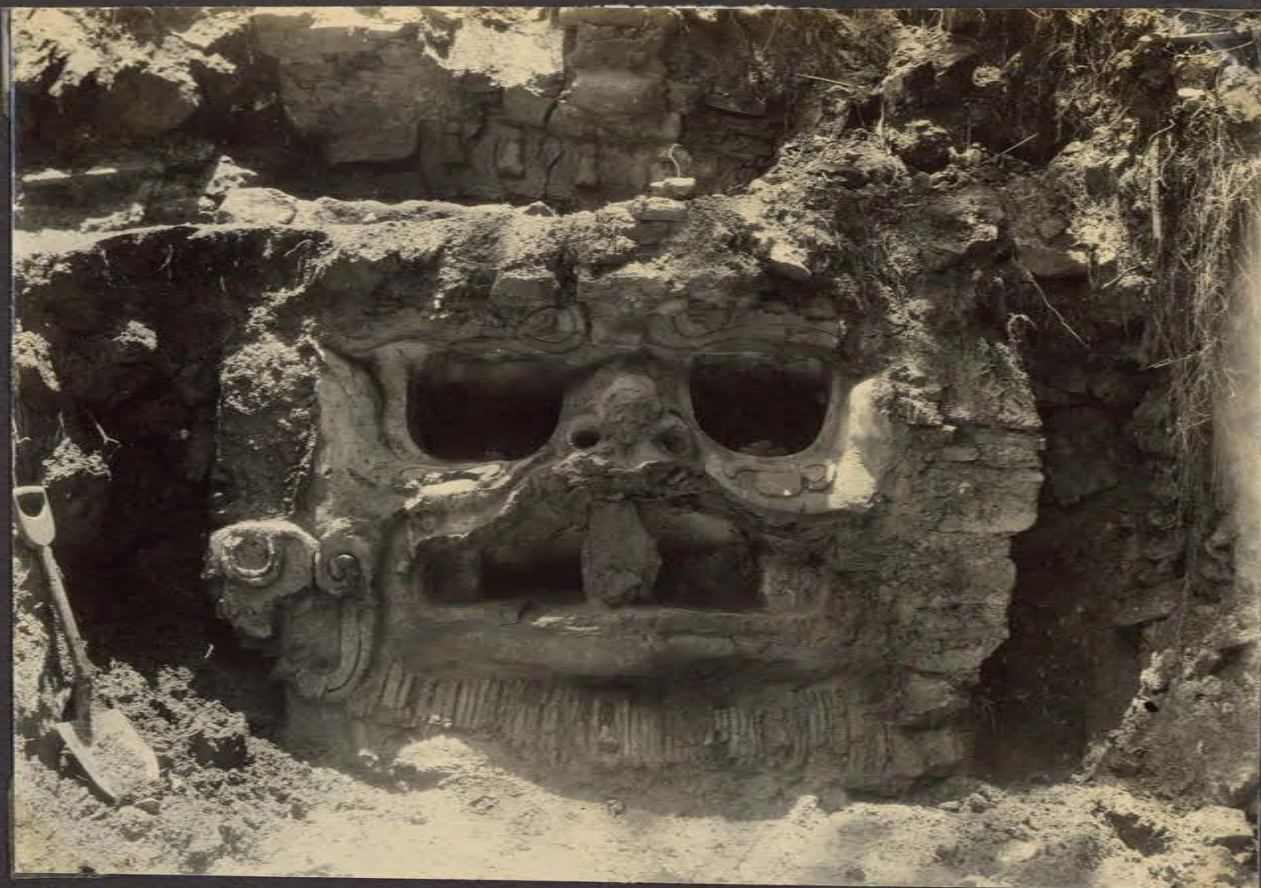
33-157

157 K-5 SW Same view of masks, close-up, in shadow.

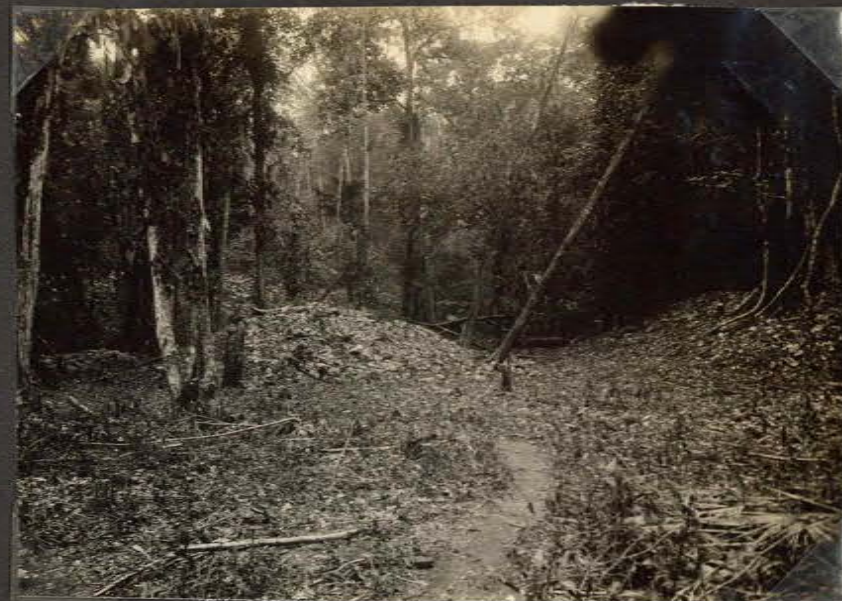
33-164

- 163 K-6 SW West Group Ball Court before 1933 excavations - no part of the slight 1932 clearing, or the Carnegie digging, are visible - the natural appearance of the ruin after clearing bush rather thoroughly. Sixto Perez stands on debris on inner bench of K-6-b, about 4 meters this side of the far end. From table only.
- 164 K-6 SW Same, small picture, partly fogged.
- 165 K-6 SW Same as 33-163 after partial excavation, from tower. Note vertical walls of the benches fronting the central alley, and at the rear of these benches. Secondary wings at the rear of this end are visible, the reverse, in plan, of the wings of South Group Court.

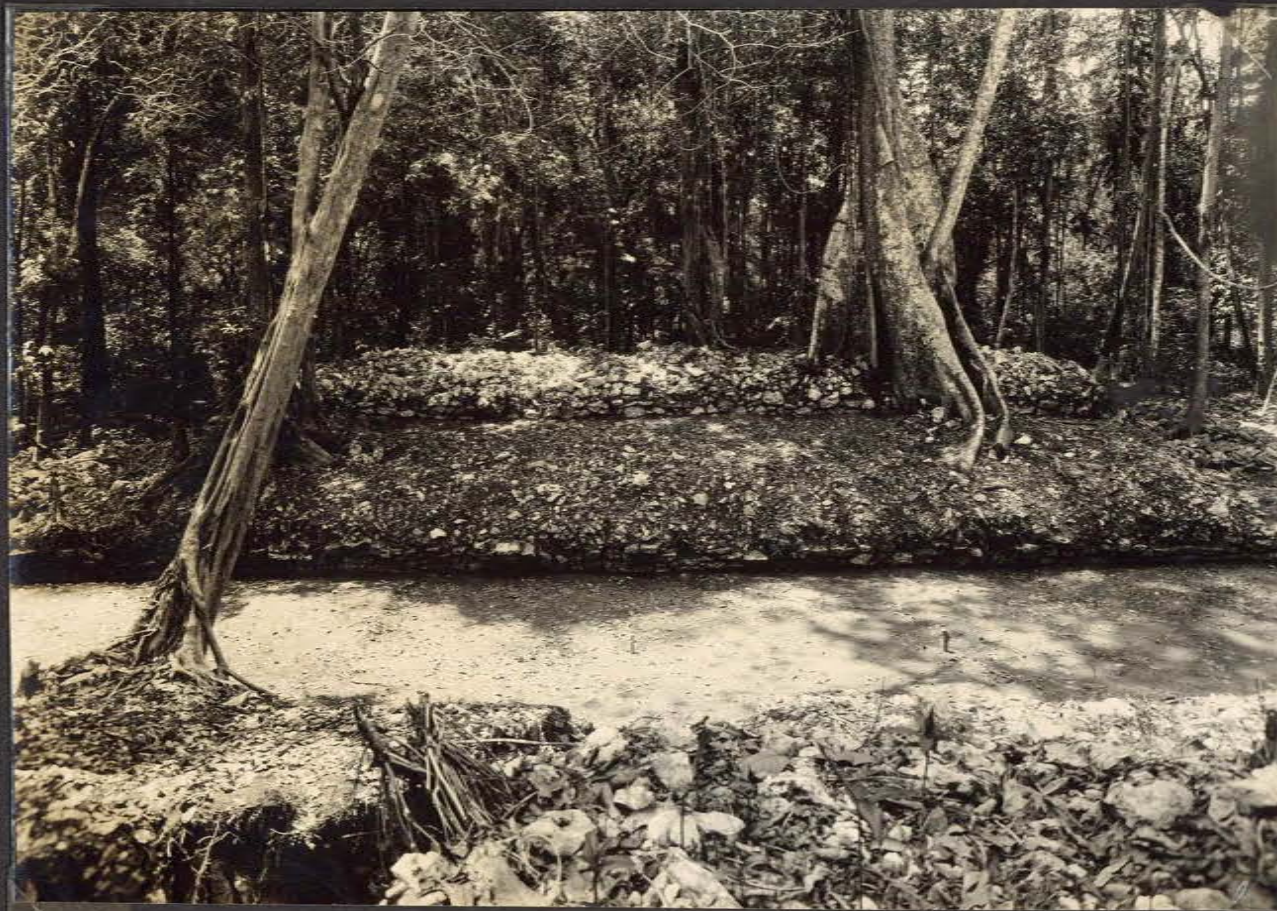
33-168-a

168-a K-6 NW Str. K-6-b from center of K-6-b

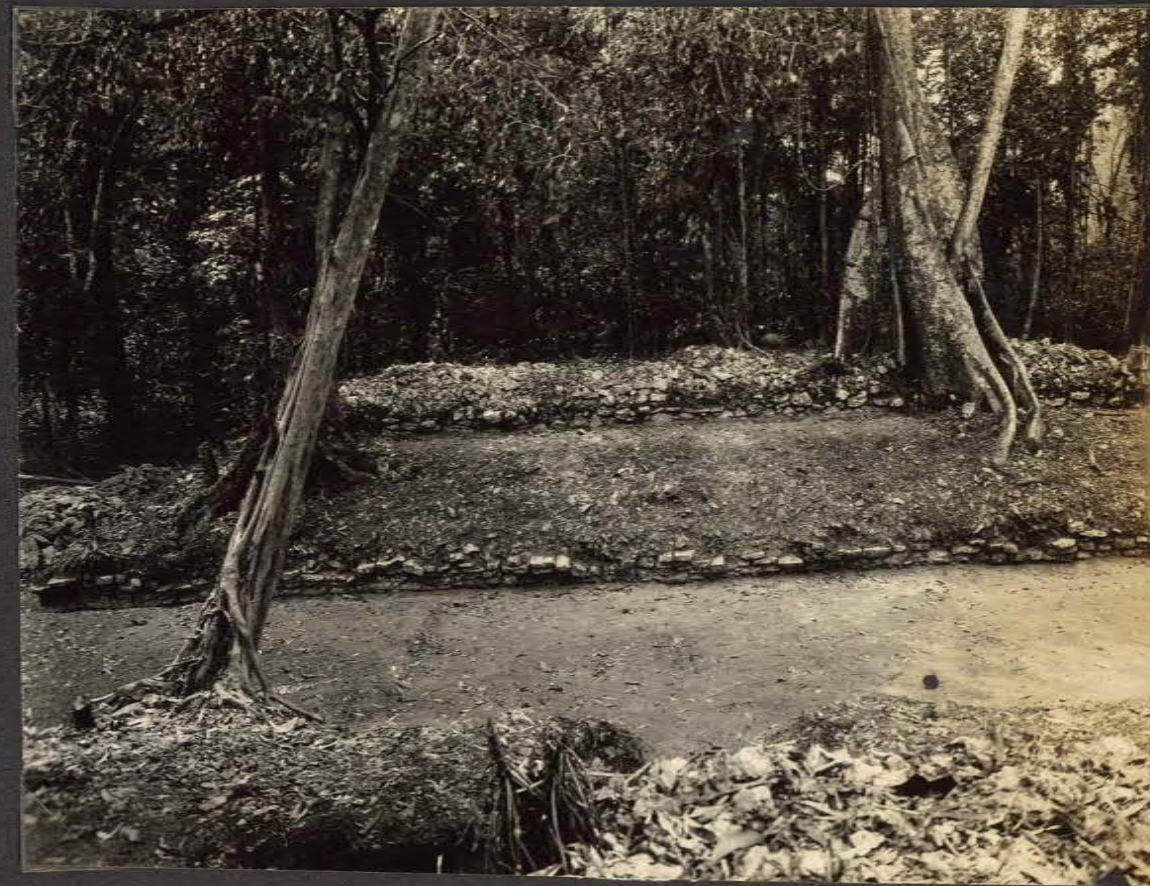
33-168-b

168-b K-6 NW Similar to 33-168-a, retaken - shows NEly end.

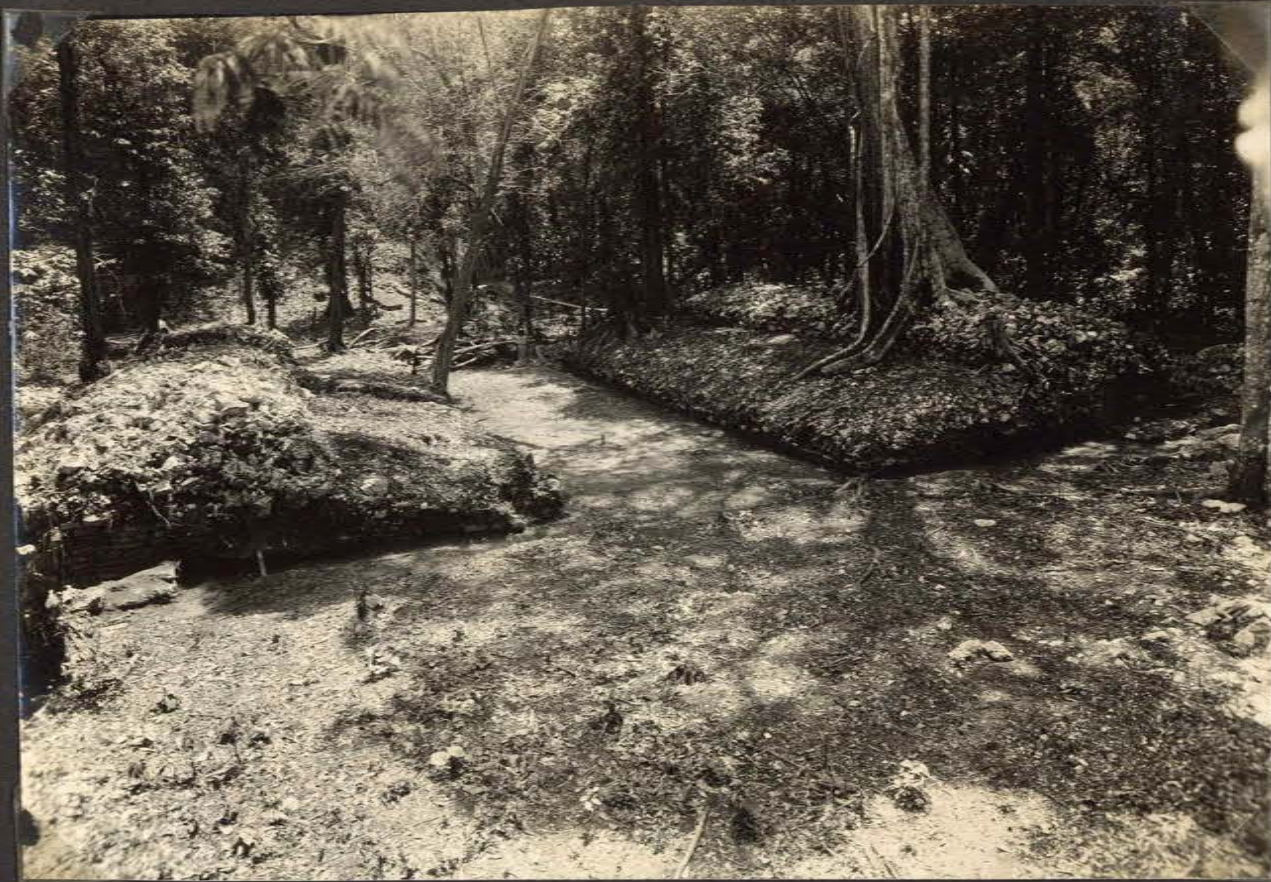
33-169-a

169-a K-6 SW Same as 33-165, with all but bottom course of secondary wings removed.

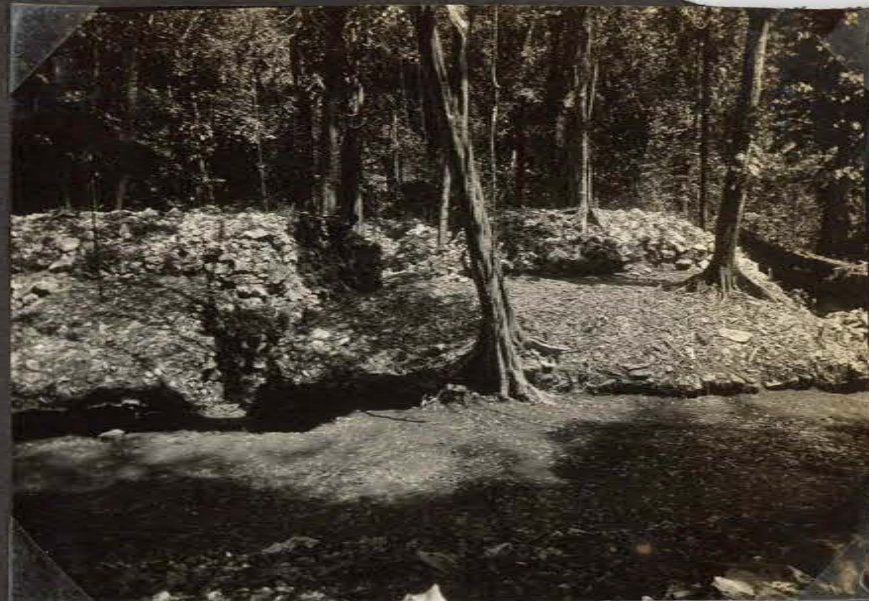
33-170

170 K-6 SE K-6-a from center of K-6-b, looking a little to right. Note curved trench (incorporating Carnegie digging).

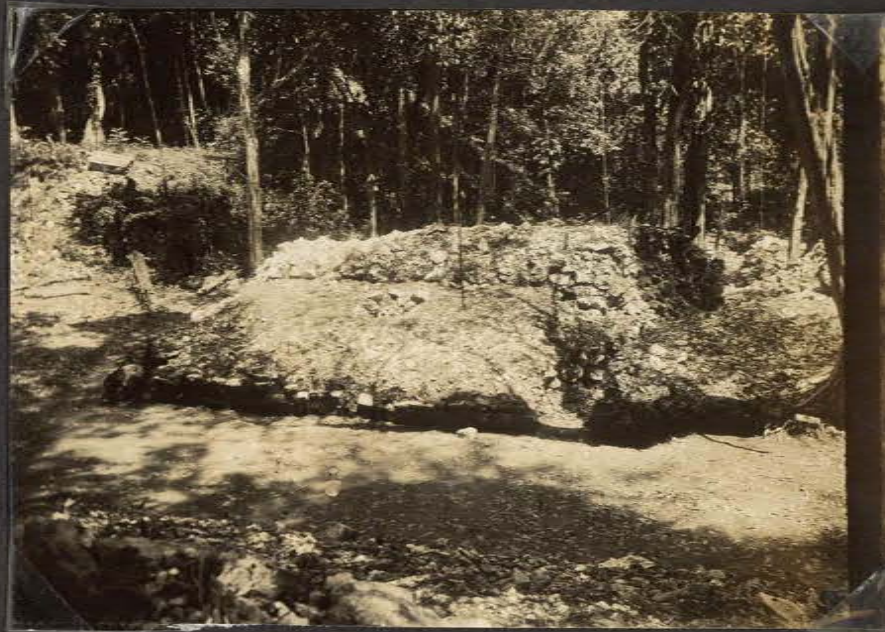
33-171

171 K-6 SE Same as 33-170, but looking a little to left.

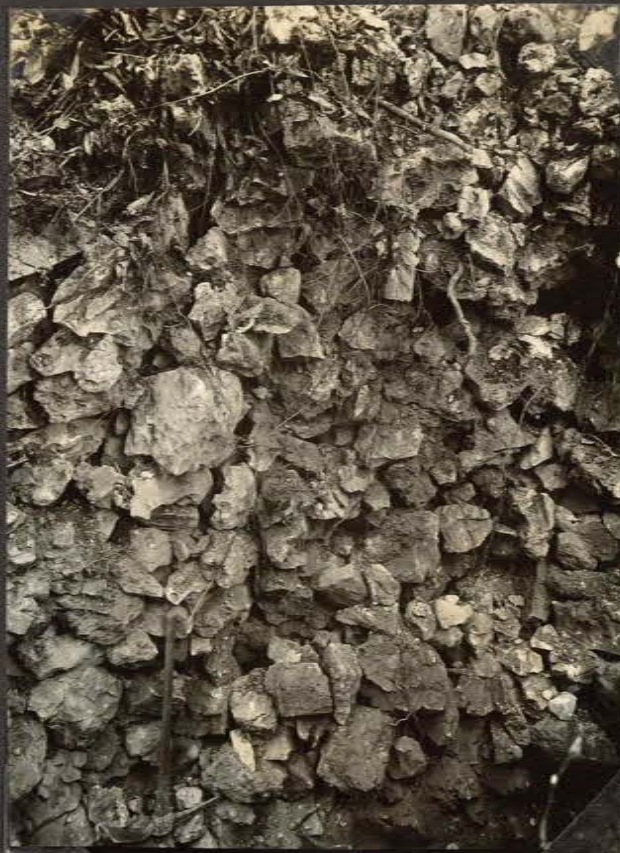
33-172

172 K-6 S Looking somewhat down on cut-section of fill of K-6-a; pick rests on floor under this building, surface is at top of picture. Pure large and medium rock fill, homogenous, with no remaining signs of the top floor - a mass of rock except for outer walls at base.

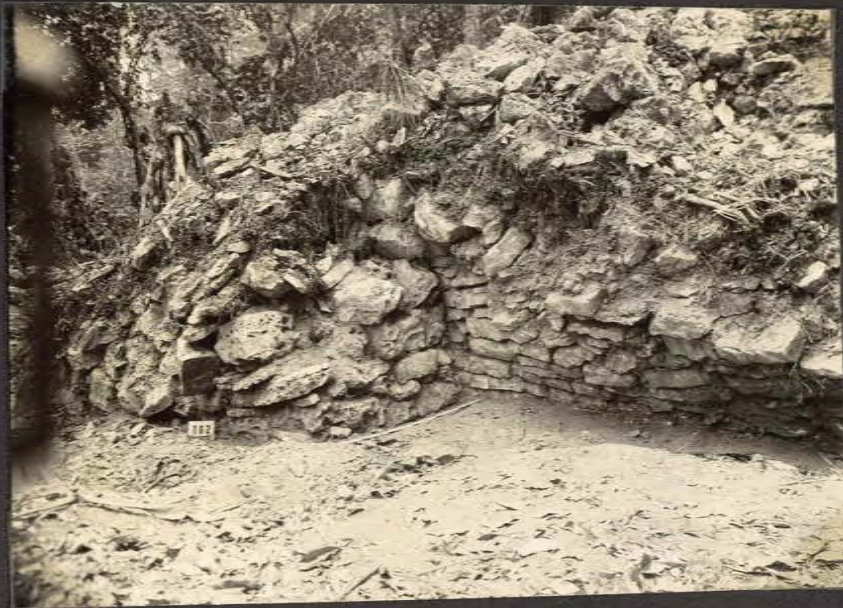
33-174

174 K-6-a S Same feature as above, at SWly end of the other structure.

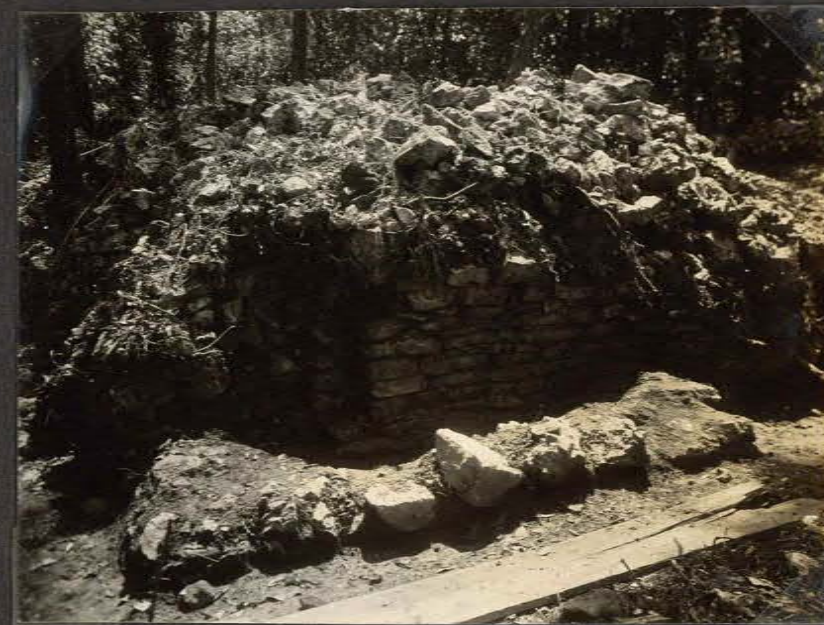
33-175

175 K-6-a SW The original corner (SW) with the secondary wing removed to lowest course, which see in foreground; note that the wing is merely a turning of the corner by an addition (possibly full height) at the rear. Masonry of original wall well preserved, but was probably better than the addition in the first place; the rear wall seems to have been double at the corner - here stones are removed to show this. See also 33-176.

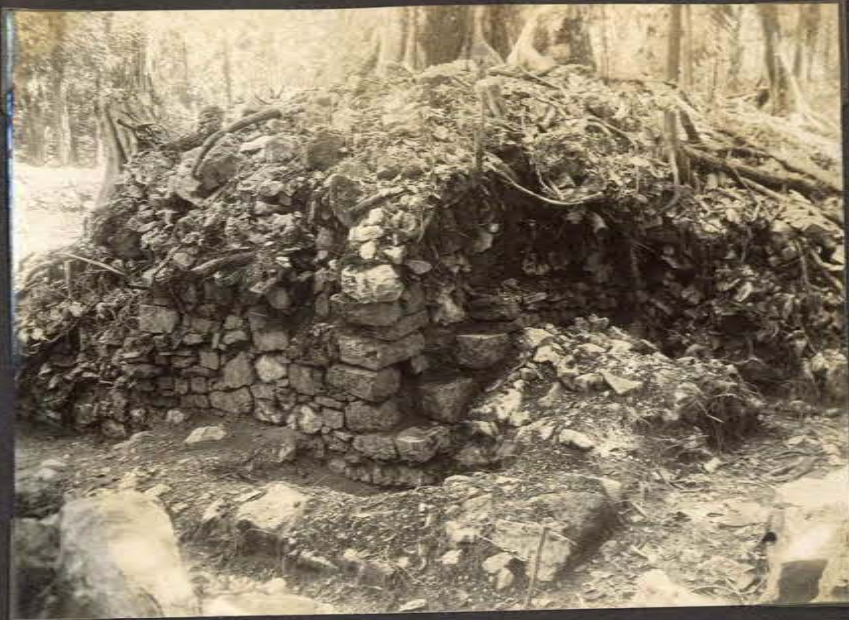
33-176

- 9
- 176 K-6-b SE Corresponding view of SEly corner of K-6-b, showing all fakkur features noted under 33-175 about K-6-a.
- 177 K-6-a The exposed face of Miscellaneous Sculptured Stone NO. 9, probably a fragment of another throne (No. 2), re-used in SWly end wall of K-6-a. Morley reads (9.11.10.0.0) 11 Ahau 18 Chen. The & 11 Ahau 18 (?) Ending Sign are clear here, at the extreme right. See also 33-179, 180, 187, 188, 189, 190, 192 & 193; also cast in museum; & 181. Film of 177 sent to Morley. See also 33-183.

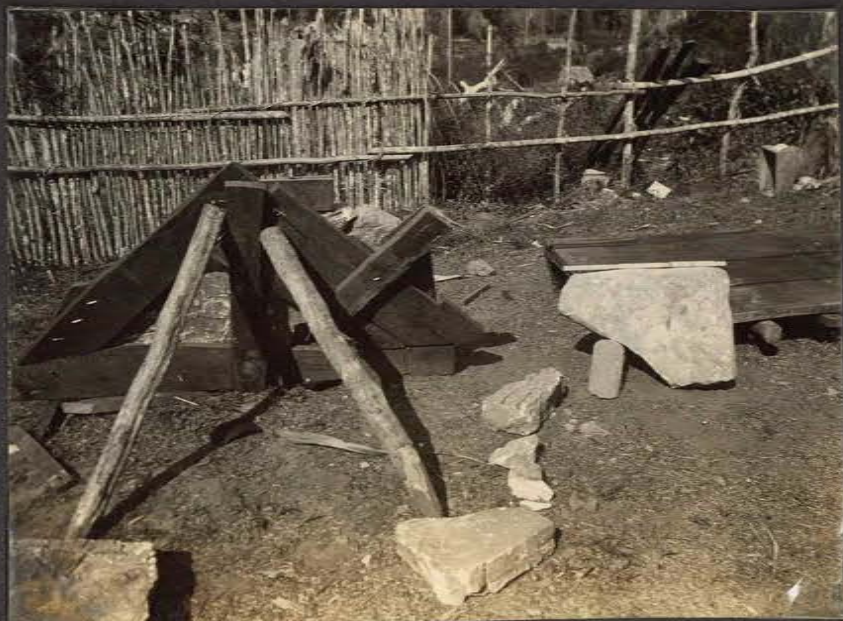
33-183

- 183 K-6-b The same (M.S.S. No 10) from rear, to show frame, and at the right, M.S.S. No. 9 on edge, top view, to show shape and size (stick at 62 cm rests on front (exposed) edge. Axkakkar

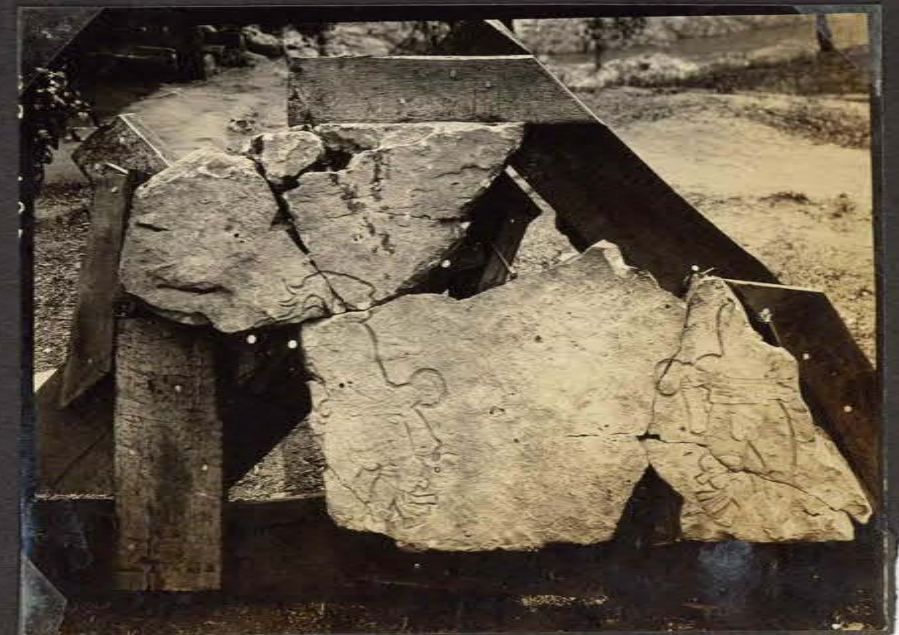
33-182

- 182 K-6-b Misc. Sculptured Stone NO. 10 - a single-stone panel found at back of bench, center, almost certainly a panel let into the vertical wall rising from the rear of the bench. Here set in wooden frame for photographing. Six fragments, the others destroyed or carried away. Photo is in shadow, under bright sun. Beeter view - 33-184-a

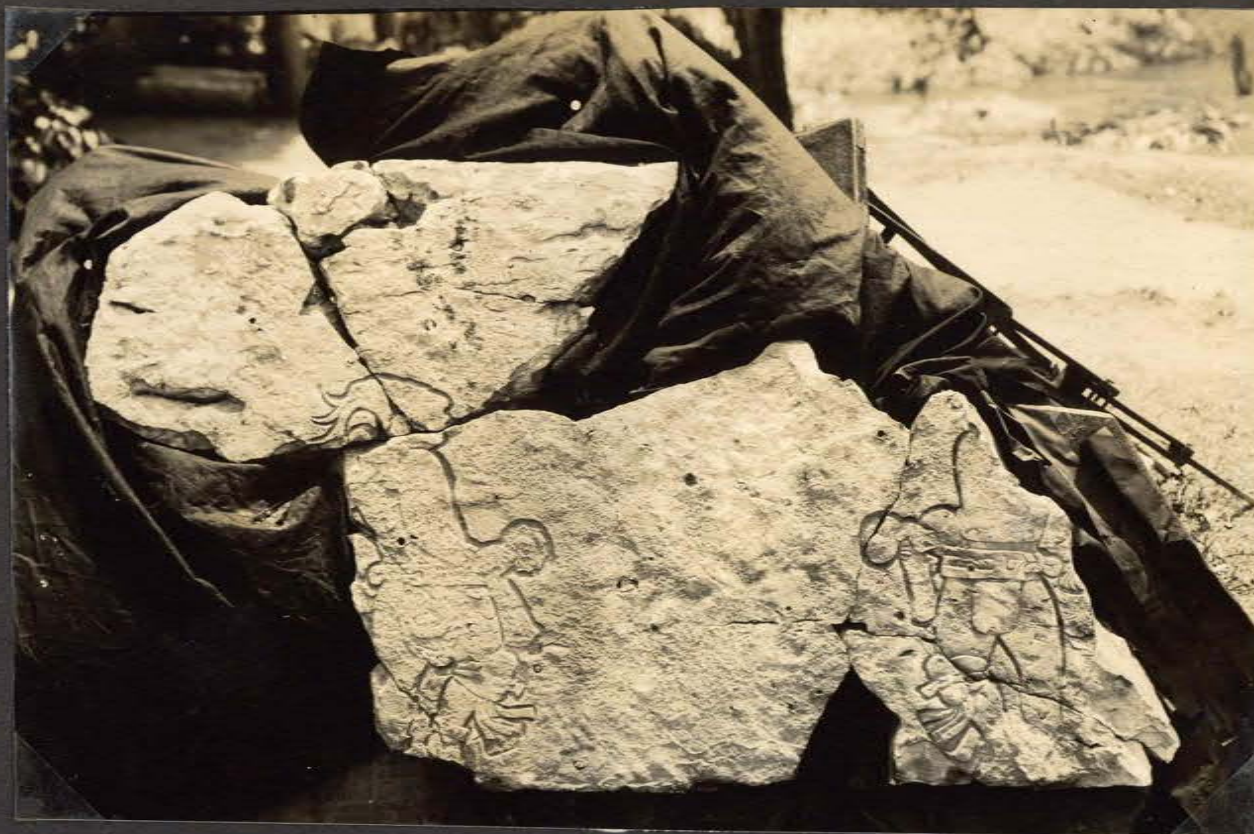
33-184-a

- 184-a K-6-b M.S.S. No. 10, in sunlight at sharp angle, almost in line with surface. Figures face each other (dancing with feather-tasseled rattle in right hand?) - note knee pad on right knee of each - practical absence of headdress. See also 33-186, and the original tracing-drawing.
- 184-b There is no film for this number, assigned by mistake.
- 185 K-6-b M.S.S. No. 10, in frame, with paper stretchers over figures for rubbings (not an entire success).
- 186 K-6-b Tracing from rubbings, carefully checked and corrected by measurements. For this degree of accuracy, a straight scale drawing would have been easier.

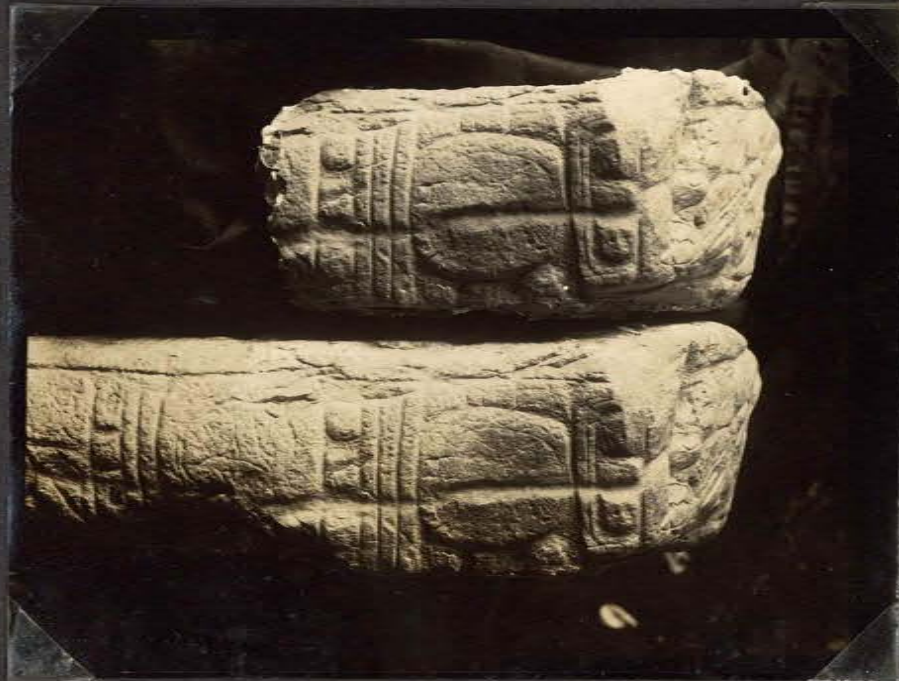
33-192

- 11
- 187 K-6-a M.S.S. No. 9 (see 33-178)
- 188 K-6-a M.S.S. No. 9 (see 33-178)
- 189 K-6-a M.S.S. No. 9 (see 33-178)
- 190 K-6-a M.S.S. No. 9 (see 33-178)
- 191 K-6-a Same as 33-192, not printed.
- 192 K-6-a Right end of M.S.S. No. 9 (below) with cast of same (Above).
The exposed face is toward the camera, the protected
end (i.e. buried in the wall) to the right.
- 193 K-6-a M.S.S. No. 9 (see 33-178)

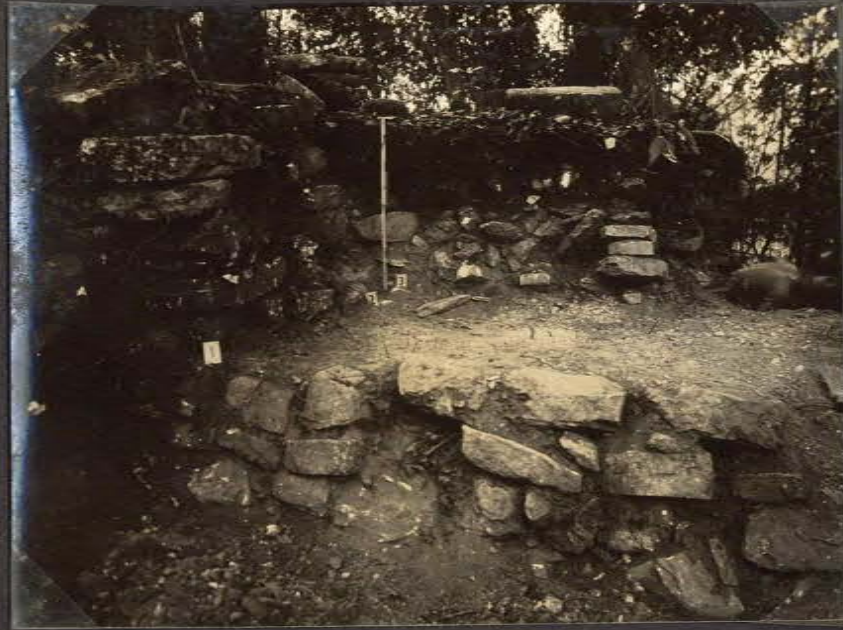
33-194

- 194 R-1 NE Ruler rest on floor, front terrace in foreground descending from this; The No. 1 is at front corner of apparent doorway, No. 2 at rear, the doorway apparently being a right (NEly) doorway, rather than a central one. The No. 3 is in line with 1 & 2, at floor level and base of our cut through debris; the slabs at right were isolated, and apparently fell in this position fortuitously; Depth of debris is about 80 cm; note that it includes small slabs and remains of mortar - but they are too sparse and too small to be the remains of fallen vault - there were no slabs of vault size. At the right a trench cuts through to the rear (see 33-195 for side of this trench). The section of debris to the left of this trench is parallel with front & 30 cm behind inner side of front wall or pier (i.e. behind the No. 2). The section shown in 33-195 joins it at right angles, at the left of that picture. Much crushed stone in debris (little in vault debris)

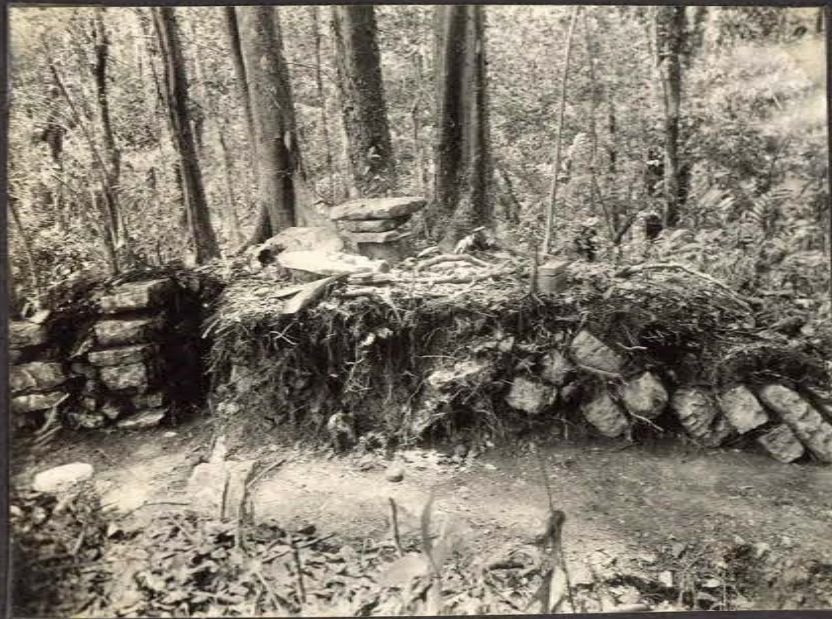
33-196

- 196 R-1 SW From same point of view as 33-195, with further clearing. Note the fallen worked blocks - they are in line (front to rear) with the inner side of the right doorway (which see at left. There was nothing like them in the debris until this line of them was reached. We failed to find an end wall (more digging might show it). Possibly the whole thing is a matter of piers.

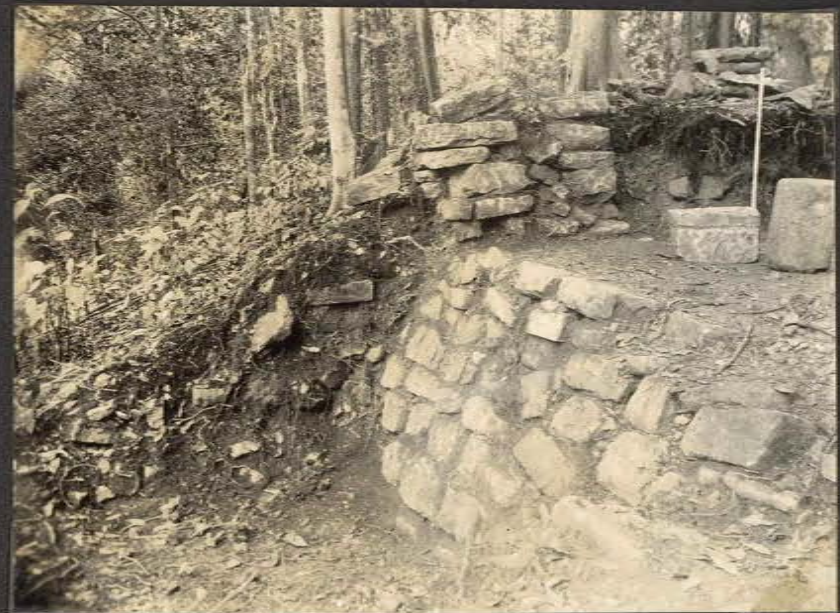
33-197

- 197 R-1 W The front upper terrace (probably here under a ruined stairway) showing the jamb of the supposed right doorway. The position of this (and central pier - see plan in notes) plus the quantity of stone debris, precludes theory that the top was open. But the type of building is still to be worked out (1933). On the floor at right is the stone column, to left of it, crudely worked rectangular stone with groove - see field notes for positions found.

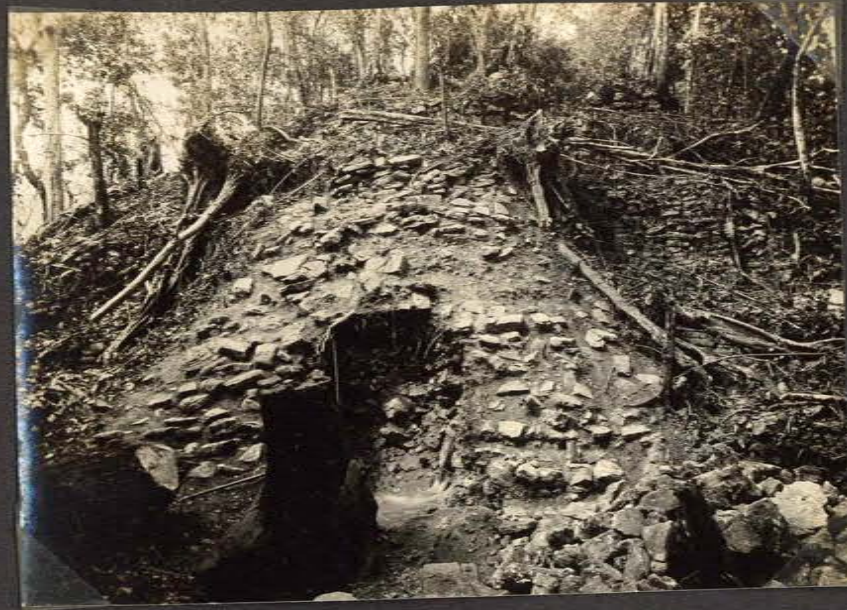
33-198

- 198 R-3 NE Ruin of front stairway, with beginning of trench, in center. Stairway is cleared of bush only (though thoroughly.
- 199-a R-3 NE Central trench through front stairway, terrace walls buried by stairway at end of trench. At right, first terrace partly buried by debris from 1932 operations, second and third terraces above - cleared of bush and loose debris - little real excavation. Ruler in trench rests on floor understairway.

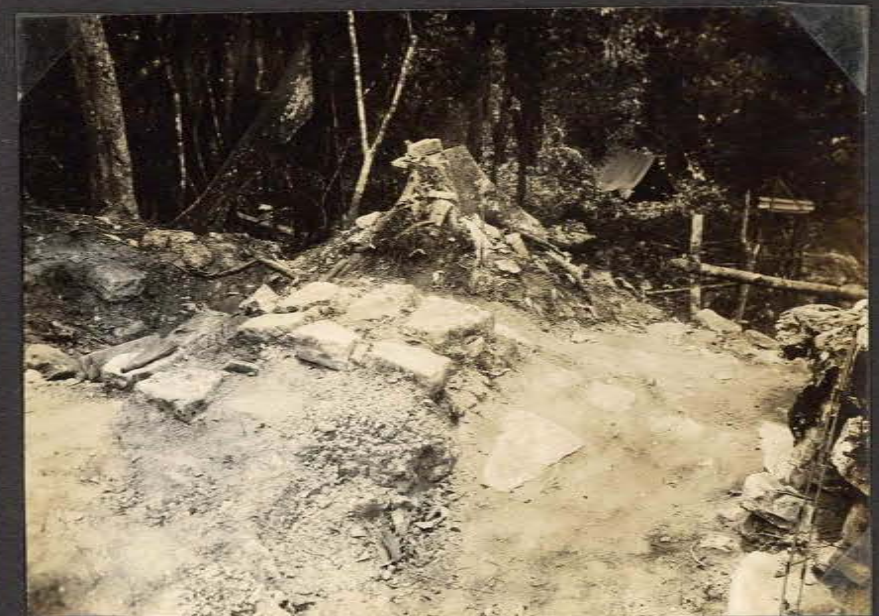
33-201

- 201 R-3 SW A picture at right angle to the above, the ruler in same position in right foreground; the central pier in left center. Lintel 11 came from the right of this; and all probability Lintel 14 (old Stela 29) came from the left of it.

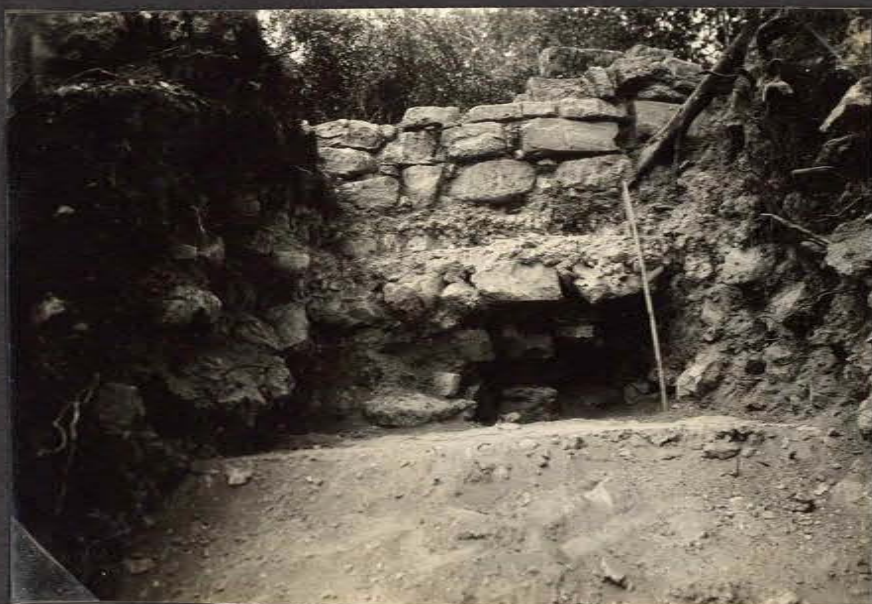
33-204

- 204 R-3 NE Looking at head of trench, same time as 33-203; ruler ~~rests~~ rests on floor of R-3-3d (eye-level); broken-off floor of R-3-2nd between this and R-3 plinth.

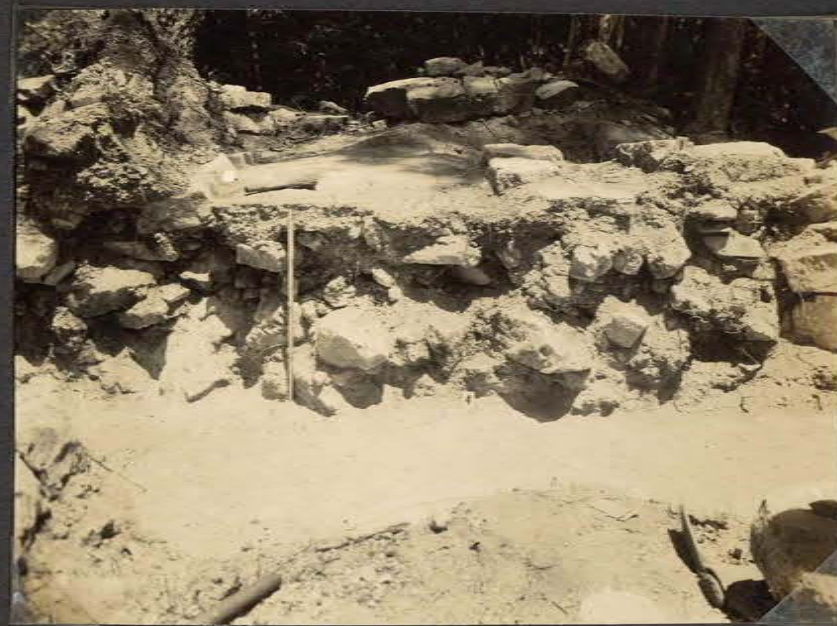
33-205

- 205 R-3 SE Side of trench showing superposition of R-3 over R-3-2nd (Periods 1 and 2, respectively); Ruler (and No. 4) rests on R-3-2nd floor; No. 2 (and whisk broom) on R-3 plastered floor, the former against the rear sill of R-3; No. 2 is on two westerly stones of supposed central pier; Fill of R-3 is loose at top (in part) tight at bottom. Note concrete under pier and wall at right, but extending back in the fill only about 1 meter. The No. 3 is supposed to be on front terrace (plinth?) wall, which was buried by an extension to the front. Can't see the No. in picture.
