1933

P.N. 1933 P.3

Photographs

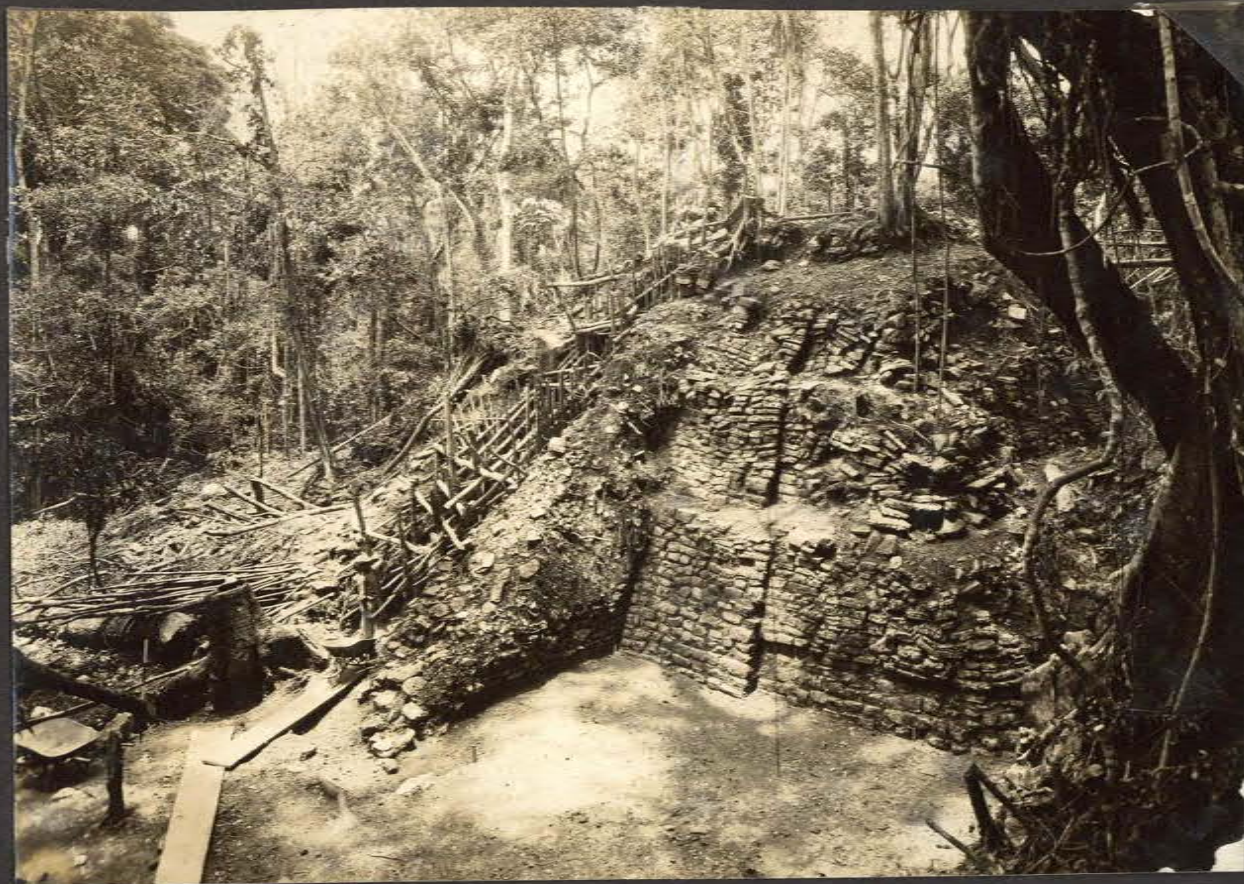
33-206-a

206 R-3 N The north corner of pyramid, front stairway at right, from tower. Note three main terraces, the upper badly ruined, with subsidiary platform or plinth of R-3 (1st and latest Period) above, indicated by a few stones; panneling to ~~right~~ left (right in picture) of plain central zone next stairway; round corners.

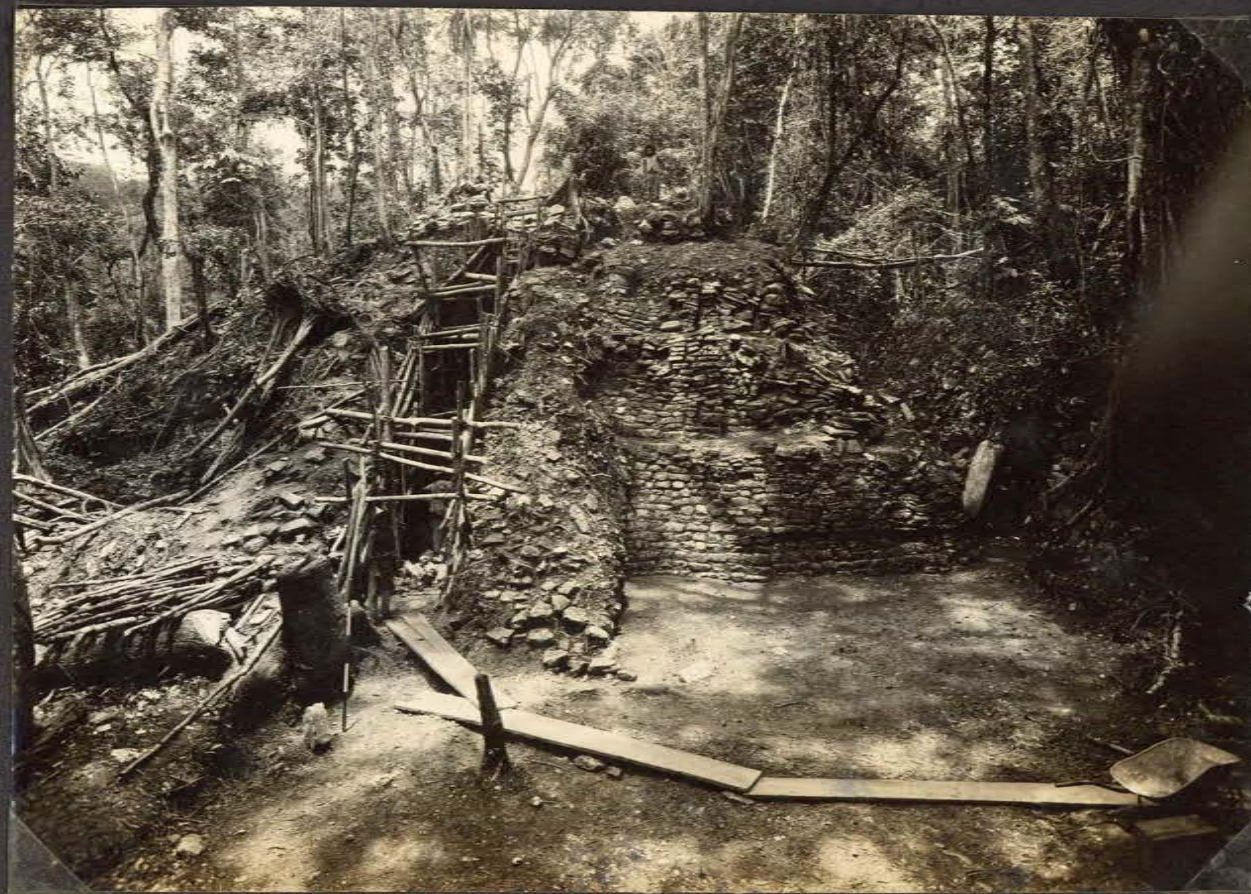
33-207

207 R-3 NE View of substructure (pyramid) from front; stairway with trench through its center at left; the right (left in picture) facade of the pyramid is covered with debris, though important points were picked out in 1932, and relocated in 1933, showing a symetrical front facade.

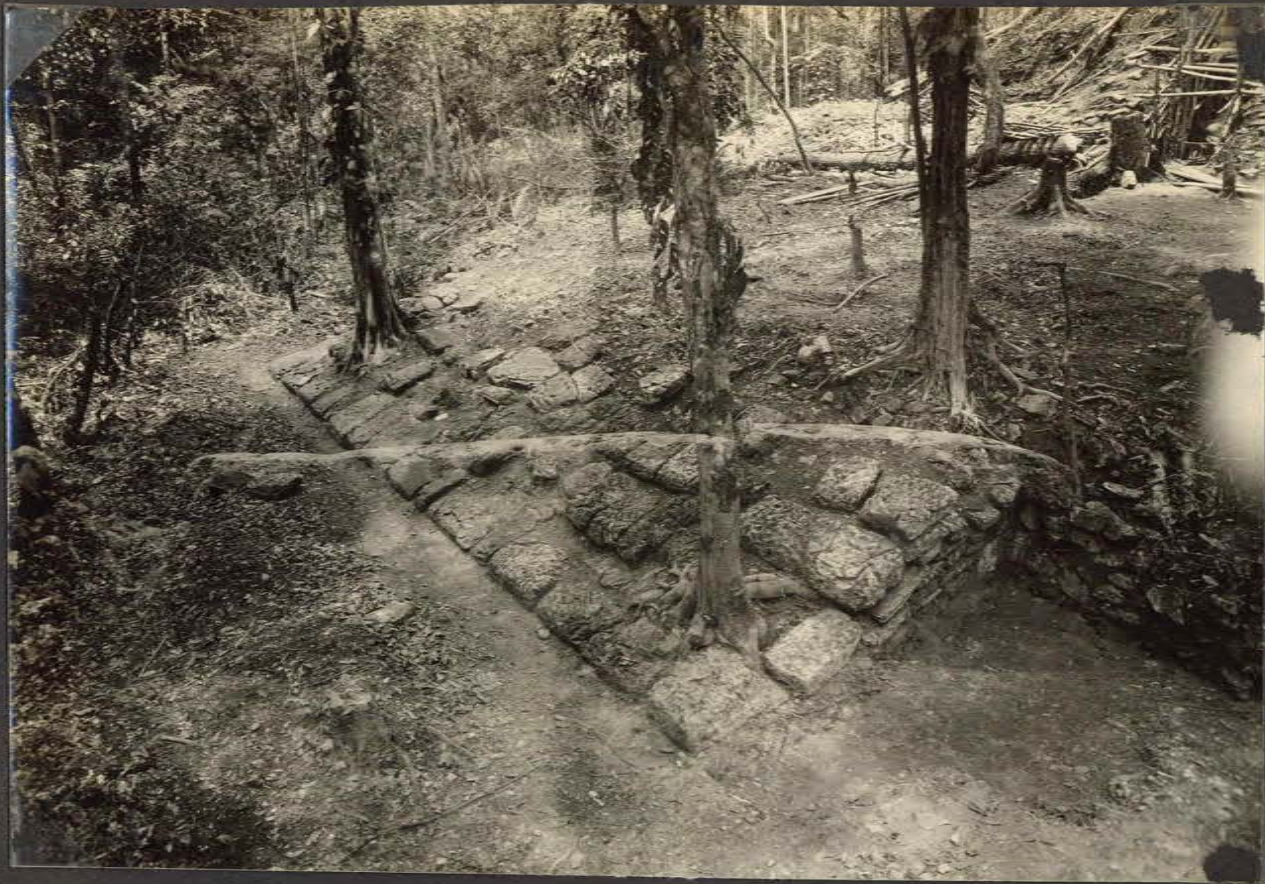
33-208-a

208-a R-3 NW Megalithic stairway, with sloping risers and treads
(see 33-209 & 2100 leading from South Group Court
to the broad low platform supporting Strs. R-3 and R-4.
The white line across center is result of a double
exposure.

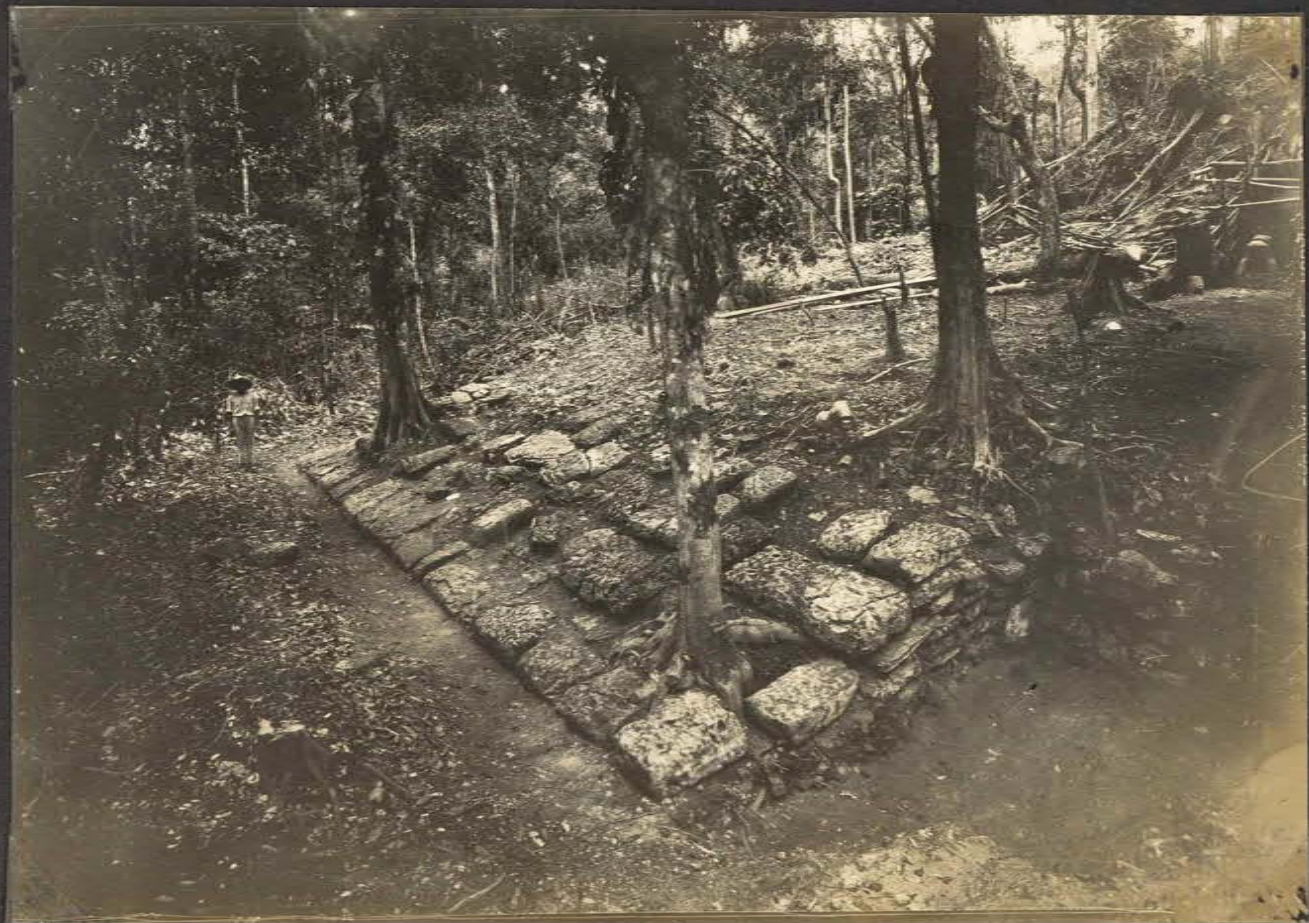
33-208-b

208-b R-3 NW Same as 208-a, poorer lighting, but no double exposure.

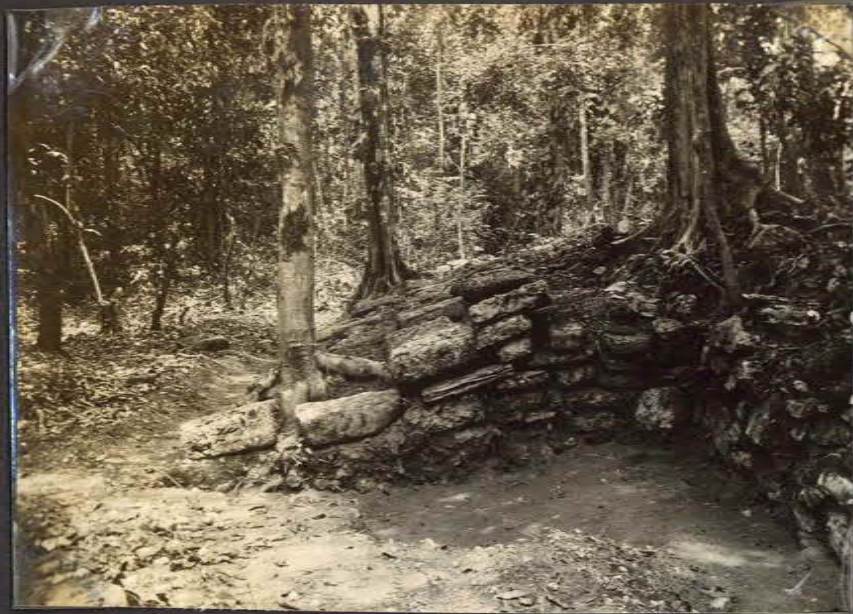
33-209

- 209 R-3 NW End of above megalithic stairway, showing sloping risers and end wall - no balustrade. End wall rests on floor material of slight depth, which is on bed-rock.

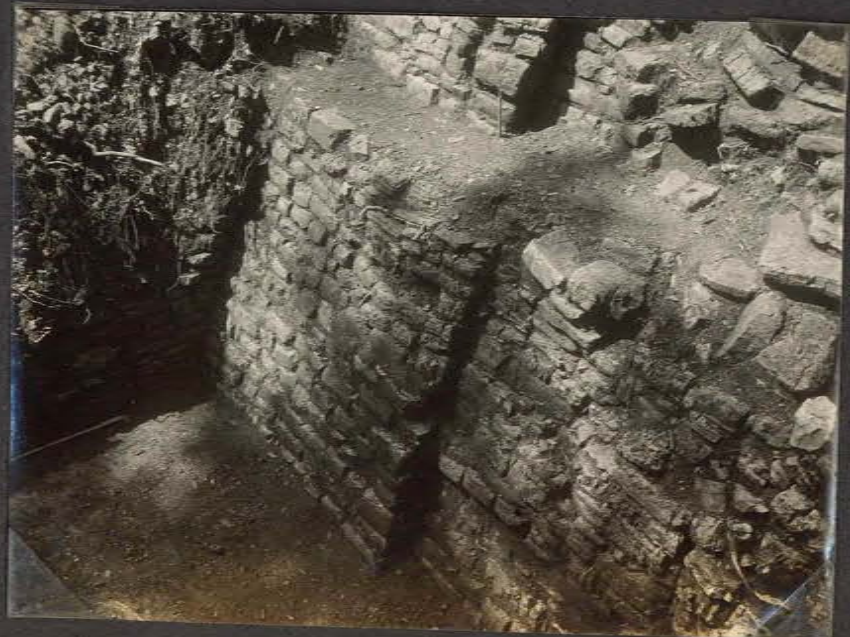
33-213

- 212 R-3 NW NWly side retaining wall of front stairway, Str. R-3, lower terrace at right.
- 213 R-3 N Looking down from tower at lower (1st) terrace) and beginning of second, stairway side wall at left.

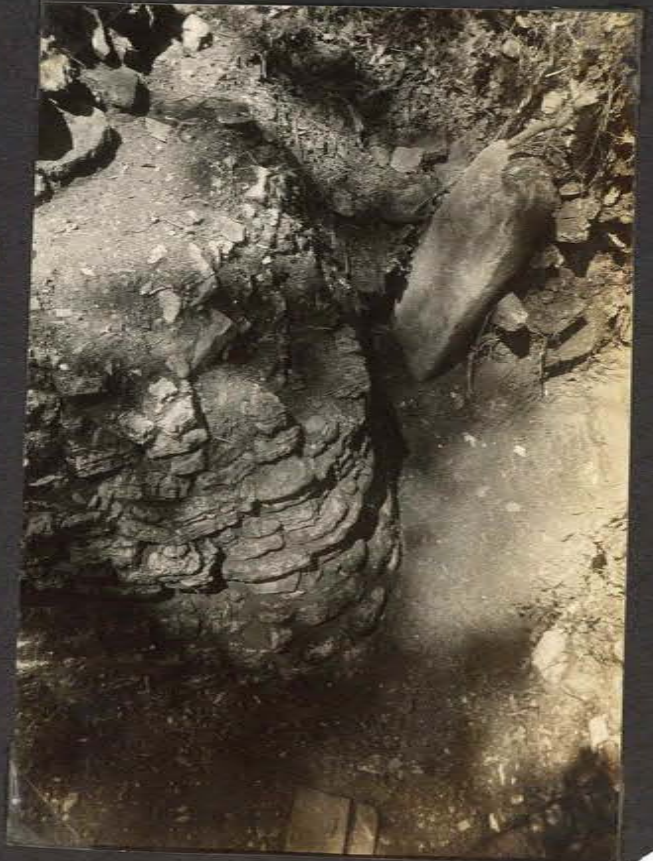
33-214

- 214 R-3 NE Looking down on rounded Nly corner of 1st terrace, with plain stela 44, moved from position higher up on R-3 by Amrem in 1932.

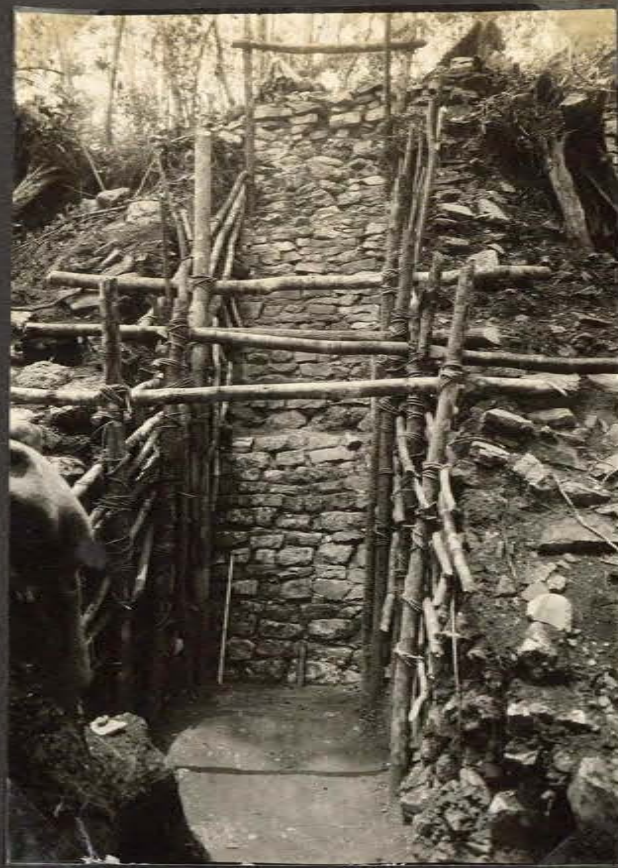
33-215

- 215 R-3 NE Center trench with terrace walls under stairway at end of trench; this is an early picture - same view as 33-190-a, closer, with small camera.

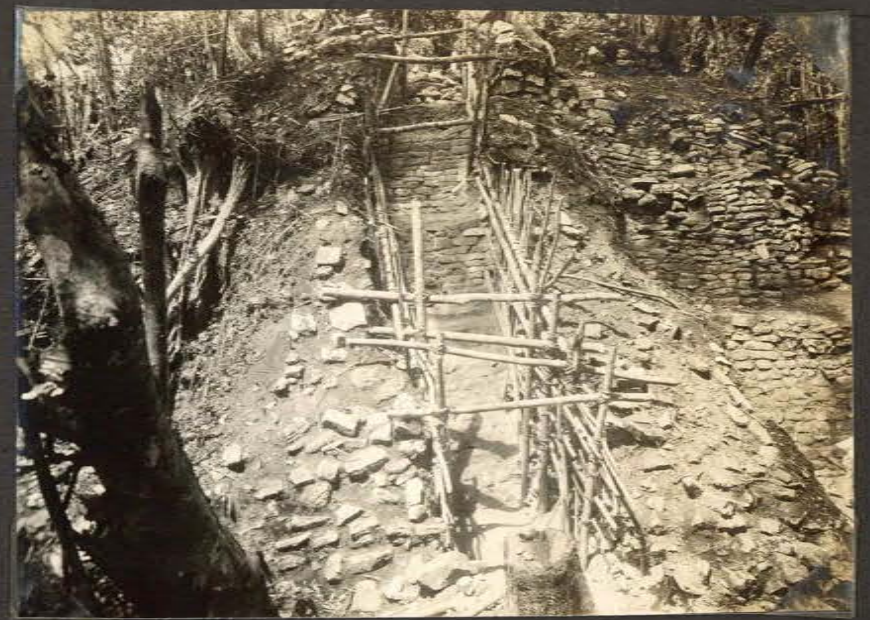
33-216

- 216 R-3 NE Center trench, after removal of crude construction over third terrace - showing third terrace of Period 3 behind, and continuous with 1st and second terraces of Period 3 below, which served for Periods 2 and 1 also, at least under the stairway. The floor of R-3-3d appears in broken-off section above this inner third terrace, which is probably minus a few upper courses.

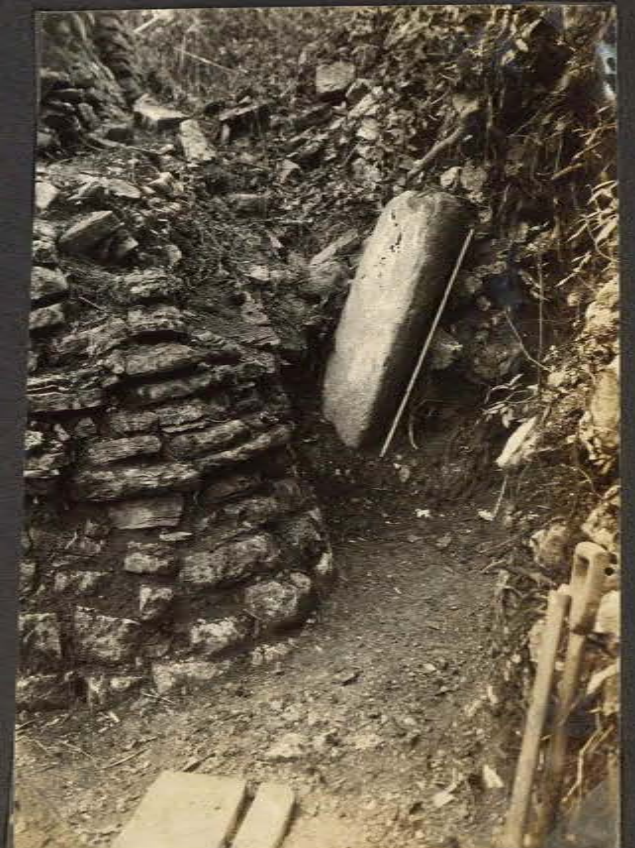
33-220

- 220 R-3 NE Same corner of R-3 as in 33-219-a & b, to the front. meter stick along Stela 44.

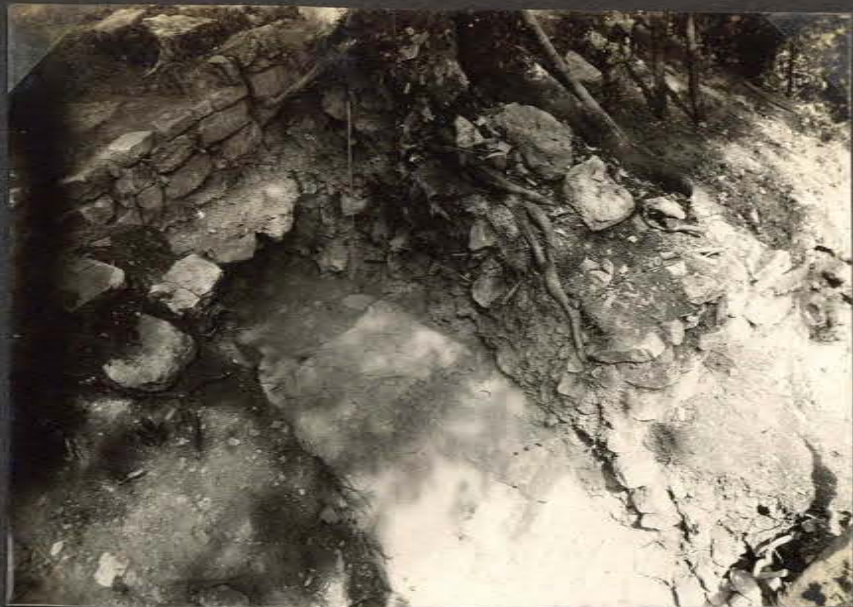
33-221

- 17
- 221 R-3 E Close up, same conditions shown in 33-203; Note sharp line where finishing plaster of floor of R-3-3d breaks off, though floor of the building itself runs on under R-3-2nd, on which is the plinth of R-3.

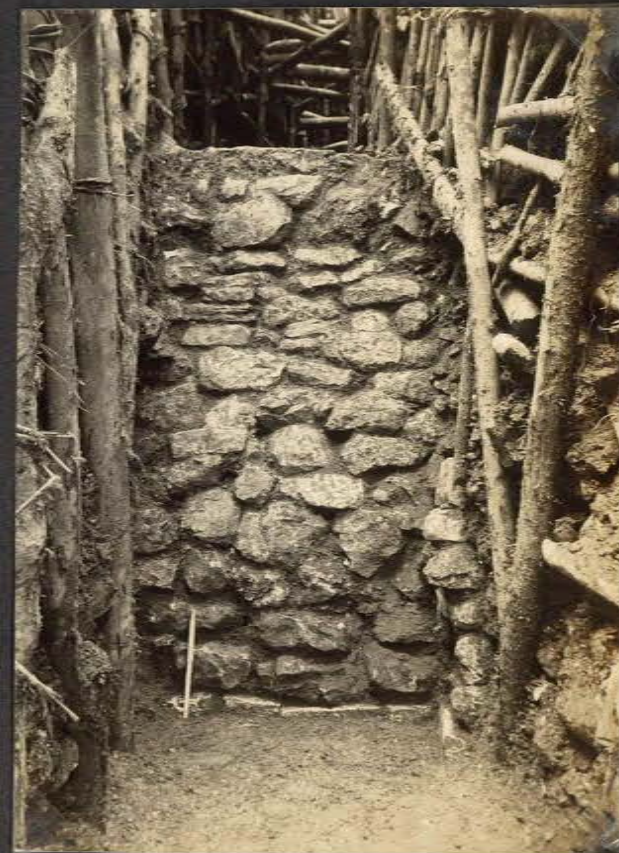
33-225

- 225 R-3 & NE R-3- 3d Center trench; crude but solid construction wall just behind the first terrace wall under the stairway. (same condition behind second terrace, but not behind third) Compare with same thing in substructure of J-9, behind rear wall of Room 3 of Str. 6. See cross section.

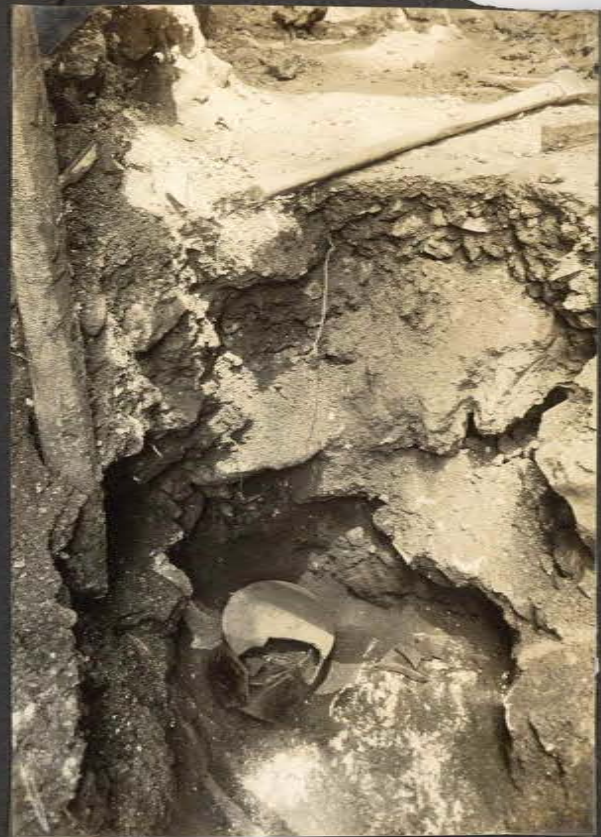
33-227

227 R-3-4th NE

Cache of two identical tripod bowls (feet removed) on bed-rock, in trench; cut section through floor of Kwxkx R-3-4th above (pick lies on that floor; note solid fill under same and over cache; Pots rest in slight depression in bed-rock, apparently hollowed out purposely; the sherds at the right rest on the general level of bed-rock here, and have been removed from the bowls by us; two pieces of unworked jade (green stone at least, poor quality) were found a cm or two in front of pots as shown, on bed-rock - they may have been in the lower bowl & forced out with the smashing of both by weight of fill; The covering pot, seen here bottom up, is No. S-2-63, sent to Guatemala; see field notes for scale drawings; the bottom pot is No. L-39-36 (field No. S-2-62) and was filled with earth (probably from fill, and contained badly disintegrated fragments of bone, including probable fragments of skull, and certainly human teeth. Skull was very thin, teeth those of a child. Probably a skull (of a child) was here cached, with the two pieces of jade, both in the lower bowl, the upper inverted over it as a cover. There is little question that this cache was placed during or before construction of R-3-4th; alternative: that in building R-3-3d, an excavation was made into R-3-4th, the floor of which breaks off at a point about over the pot. The same condition, however, exists in the cases of R-3-3d and R-3-2nd (i.e. front of floor is broken off). There was nothing in the fill to suggest such an excavation, but, since it is a solid fill, this is not conclusive.

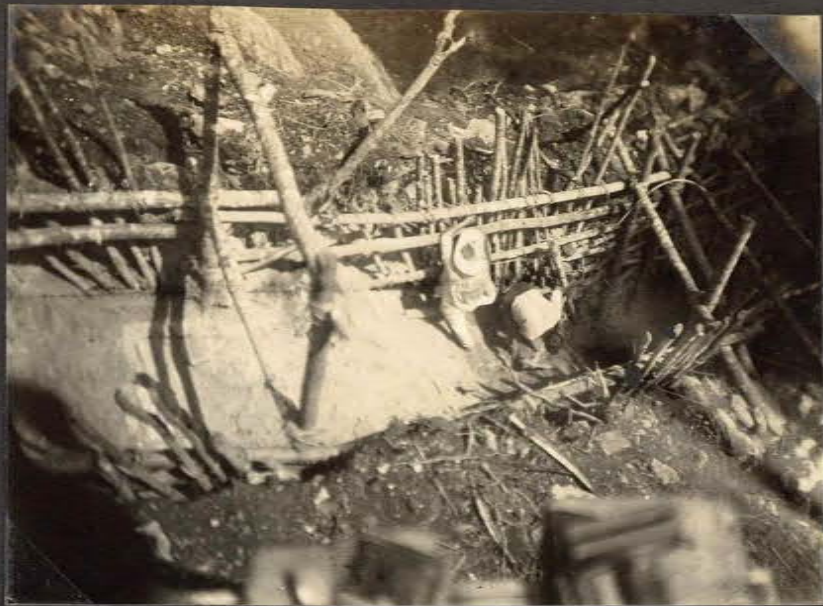
33-232

- 232 R-3 S Central trench from tower, showing method of shoring.
- 233 R-4 E Excavation of rear of top; ruler lies along the broken
(R-4) stone column, much larger than those found elsewhere;
column is in position as found, well to left of center.
- 234 R-5 N Central front pier; right doorway beyond, & right side
wall, all seen from within.
- 235 R-5 SE Rear wall seen from right (SWly) doorway); rear doorway
at right; the sill along rear wall is torn out by
us except at extreme right and left.

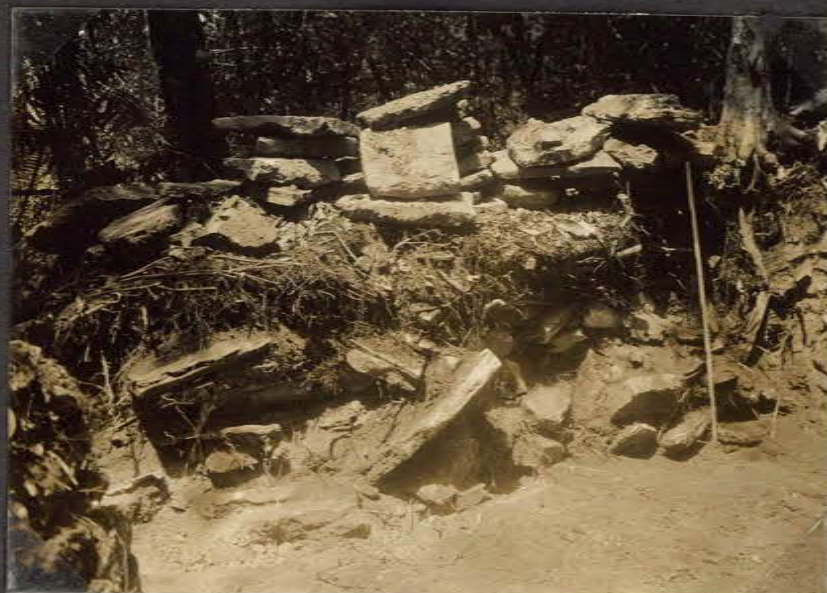
33-236

236 R-5 NE Cut section through debris on line from rear wall (right)
through center of right (SWly) doorway (left); Note
slabs, and depth of debris (about 1 meter). This is
the most typical cross section of debris - a center section
would have been the same. Cp with 33-237, which is
deeper, because it is close to the end wall, which is
without question partly standing. It was possible to
predict the front doorways and presence of a single
chamber by the contours of the debris, which was higher
along rear and side walls, and over central front pier,
than within the room, and outside.

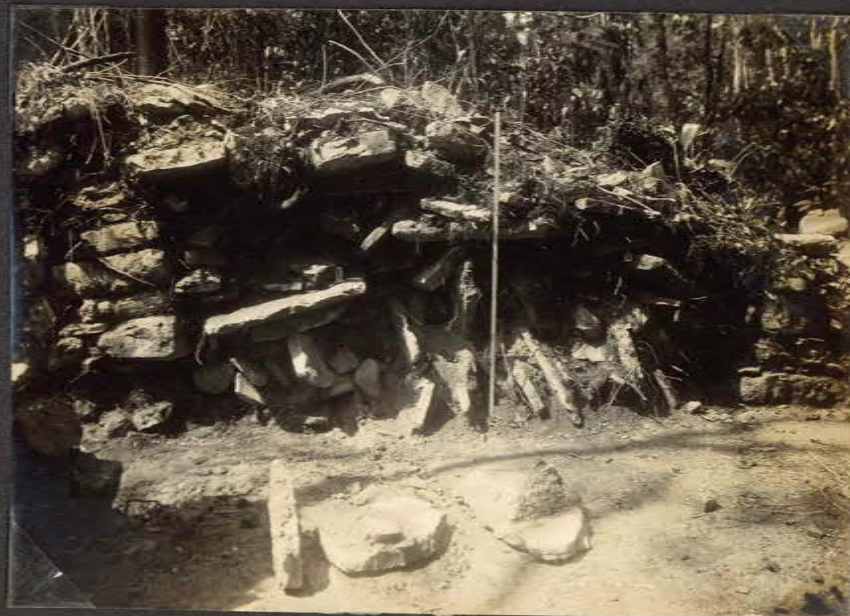
33-237

237 R-5 SW Cut section through debris from rear wall (left) to
front wall (right), on a line connecting NEly sides
of rear and front left (NE) doorways. That is, only
50 cm or so from the NEly side wall. Note the fallen
vault slabs on edge, at bottom. On the floor in front
is a section of vault - two slabs cemented together,
with the original plaster of the vault across their
edges (the left side of the right stone in the foreground).
Mortar and a piece of a slab adheres to the one in the
center. Gray mortar permeated the whole deposit of
debris, making the digging very dusty - more so than in
Acropolis vaulted buildings. The color was markedly
gray instead of cream-yellow.
Jambs of rear and front doorways show plainly.

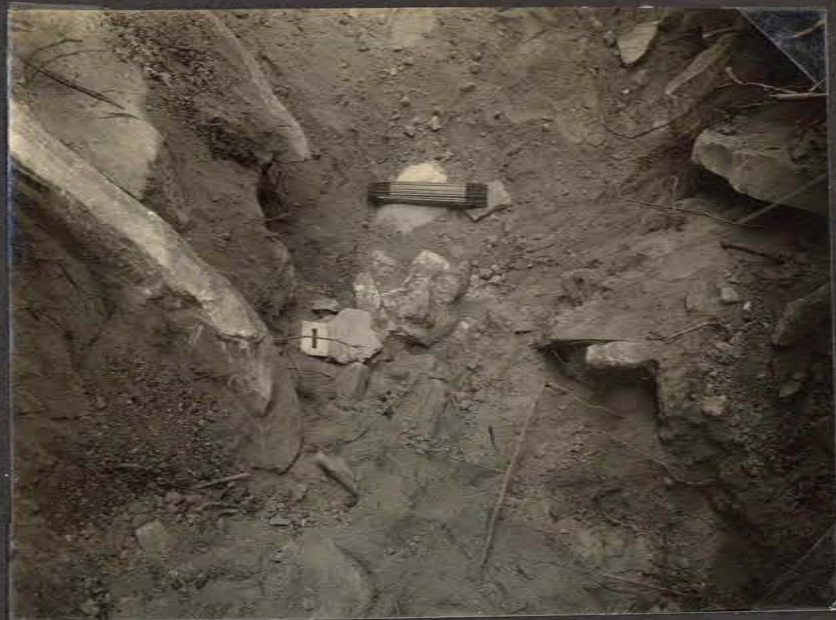
33-238

- 238 R-5 SE Stucco head (S-16-1, sent to Guatemala) in position under floor of Temple, R-5, between rear door and left (NEly) front door. Head and ruler lie on stones of pure rock fill below. The No. 1 is against a fragment of face broken off by our men, and other fragments had been removed before they realized what they had. Found by Carmen Acopa, capitas.
- (For 239 see 241)
- 240 R-5 Stucco head S-16-1, as restored in field, front view, left side of head only has been cleaned.
- 241 R-5 Same view of S-16-1, more light. Note the secondary coat of thin stucco (red painted) on the uncleaned right side of face. See field notes. ~~xxxx~~ 33-239 is same.
- 242 R-5 Same view, less light on right side (S-16-1)
- 243 R-5 Stucco head S-16-1, right profile view.
- 244 R-5 Stucco head S-16-1, left profile view.

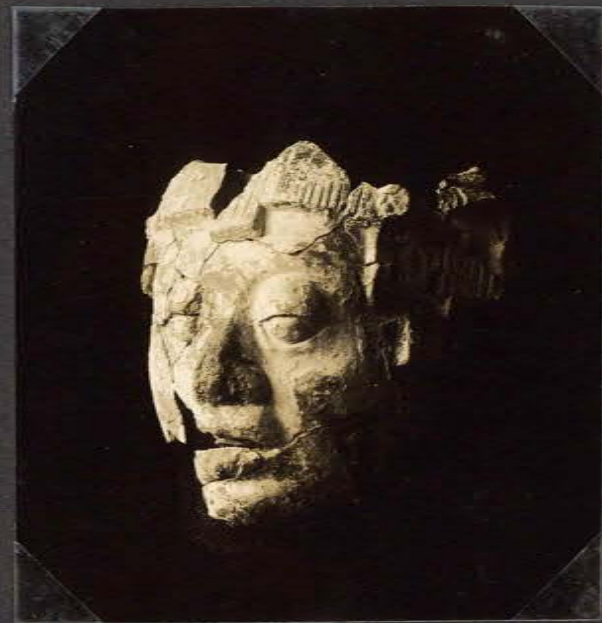
33-247

245 R-5 Same as 244
246 R-5 Same as 33-247, which see.
247 R-5 Stucco head, S-16-1, three-quarter view from left.
248 R-5 Same as 33-247, less light.
249 R-5 Stucco head S-16-1, three-quarter view from slightly above,
with principal fragments which could not be fitted - the
piece at right probably ear-plug, painted light green.

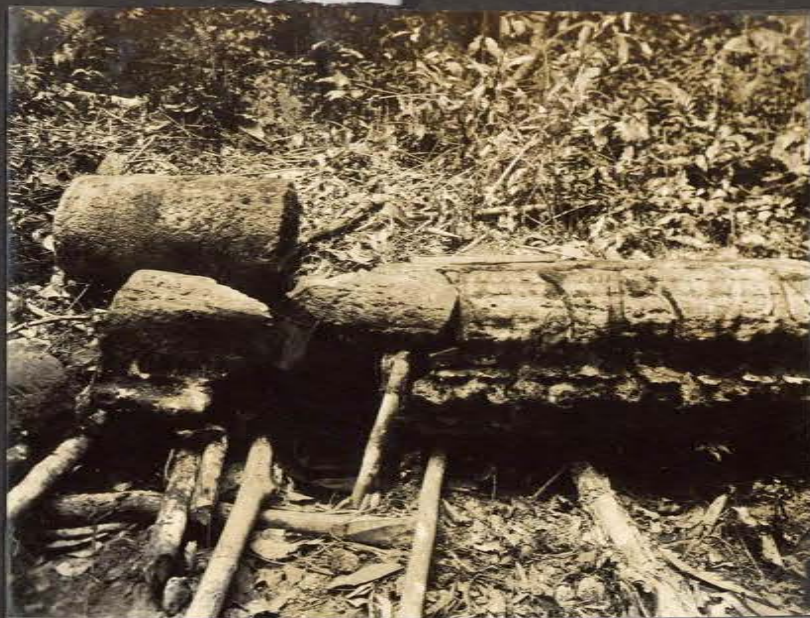
33-254

- 254 R-5 NW In foreground, Maler's "sacrificial column, Morley's "Alter 6", renamed Stela 29 (Maler's Stela 29 becoming Lintel 14) - all according to agreement with and desire of Dr. Morley - see correspondence re, 1932. The piece at right is the piece known to Maler and Morley. A small piece is fitted to it at left end. This plain piece, together with the butt (probably of this monument) were found on platform near center. The angle of the break on the butt, and dimensions, apart from location, make the conclusion that this butt belongs with this monument, though there is no actual fit. Behind - another butt of a round column-like stone, moved here by us from just NE of the NE end of the stela-platform, in front of Maler's "drain" between Strs. R-5 and R-6. It is a well-worked butt, plain, eroded on one end only - possibly not broken there in which case this is the entire length. Nothing else found near it, though search hardly was thorough.

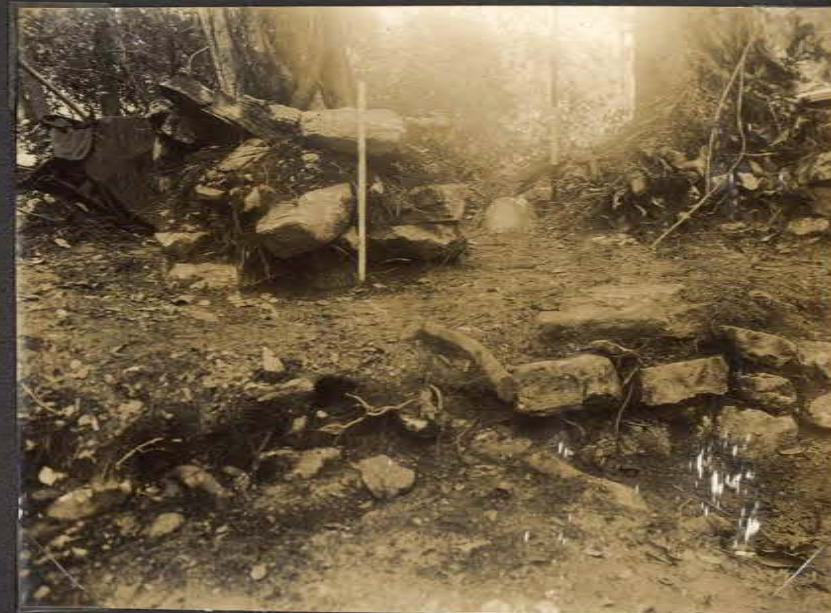
33-256

- 256 R-9 N The right (NEly) pier from right front, with stone column beyond, in position as found; meter stick is at floor level (as found clearly between piers) & extended to 62 cm.

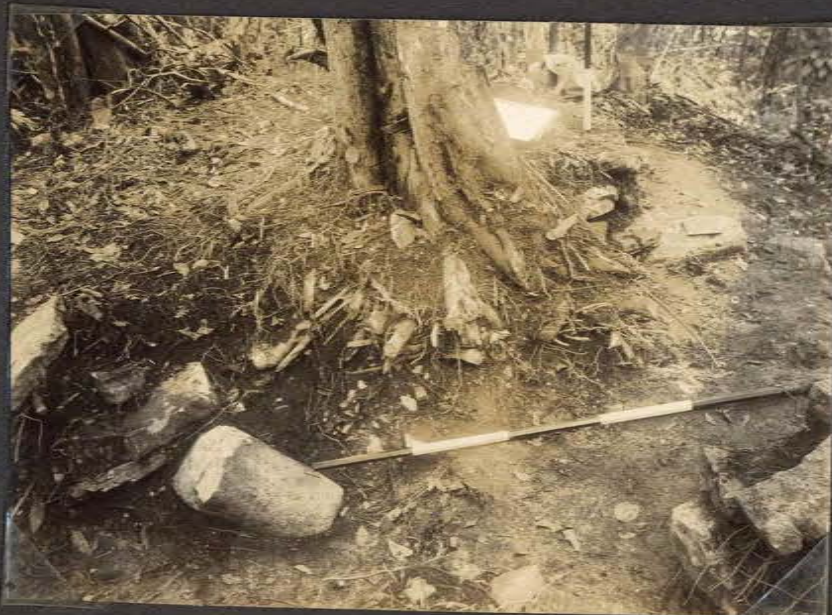
33-257

- 257 R-9 NW Foreground, top of front terrace or plinth; meter stick against right (NEly pier) which has cloth behind its inner right corner, & on that a pick, at surface level; Stone column is in position as found behind & to right (in picture) of pier, with range pole beside it. Its level is here clear. Meter stick is at 62 cm.

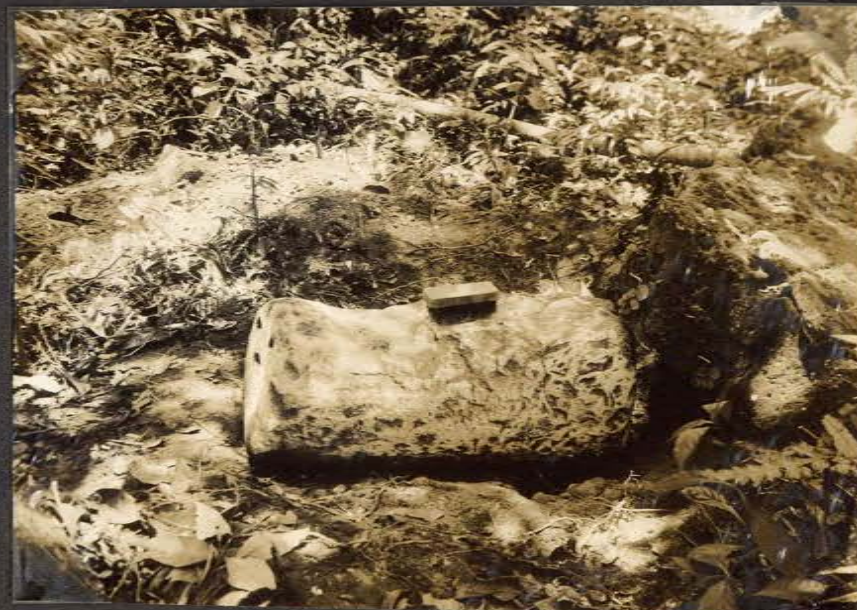
33-258

- 258 R-9 An apparently complete short stone column at right (NE) end of stela platform (on court floor in front of it, rather), found in 1933 to be partly under Stela 24; length 1 to 1.05M; Dia, .50 by .40 M; flat on one side and there questionable signs of carving. This side was up, is badly eroded. Butt end and sides worked (butt end is at left); top eroded; no signs of other fragments. Probably 40 cm were set in ground - not sure of thi

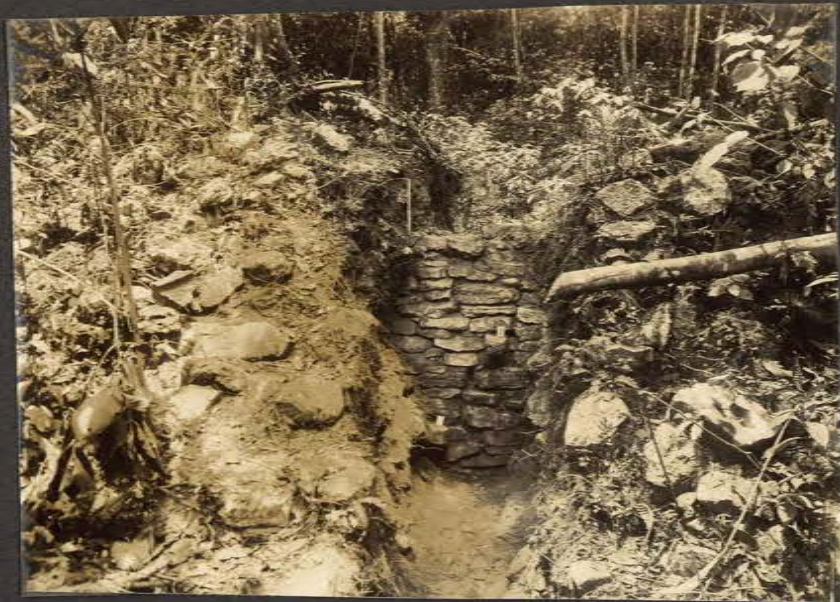
33-260

- 260 R-11-a NW Trench through rear stairway showing early rear wall of the ball-court structure; the numbers rest on two long stones, the ends set in the wall, and projecting 20 cm (upper) and 25 cm (lower) from the wall. Wall is apparently dry-laid, and thus corresponds with original rear wall of R-11-b. The projecting stones are apart 45 cm laterally and 70 cm vertically - climbing stones?

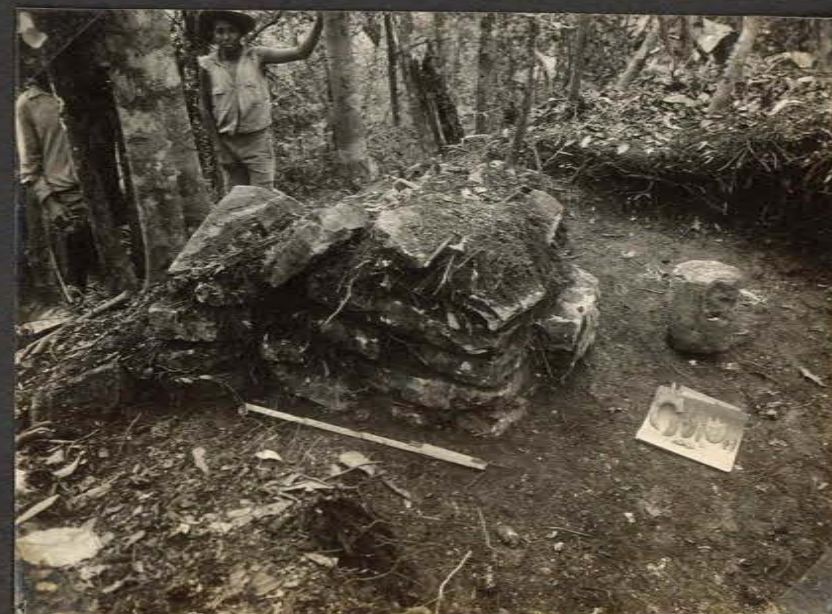
33-263

- 263 R-16 NE The one pier identified - based on contours here at the top, it is a central pier. The left (NEly) inner corner. The left outer corner is probably displaced. Note slight depth of debris (65 cm), better seen in 33-262.

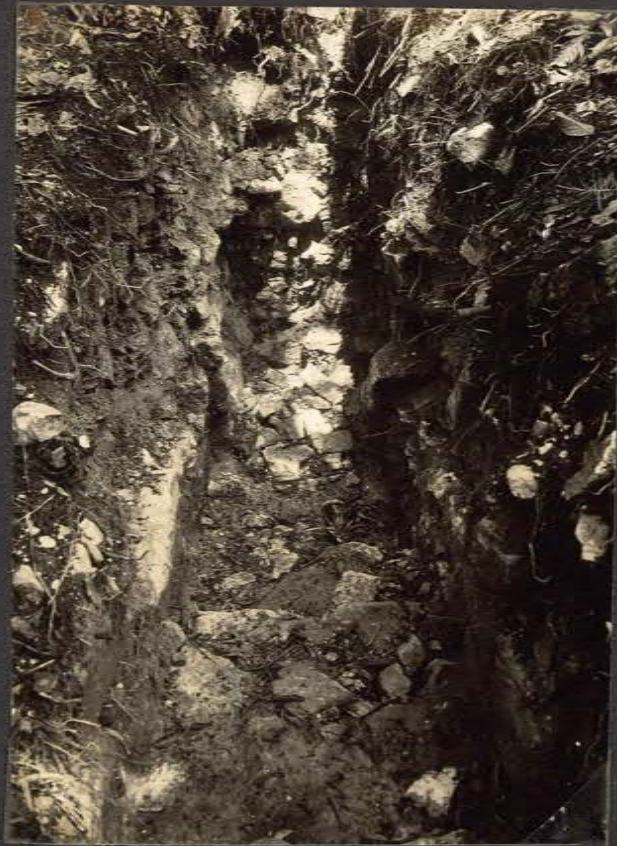
33-264

- 264 (264) S-2 SE Center trench - after rain, very dirty; & poor lighting; See plan and section; depressed passage in foreground, possible "shrine" in background at end of trench.

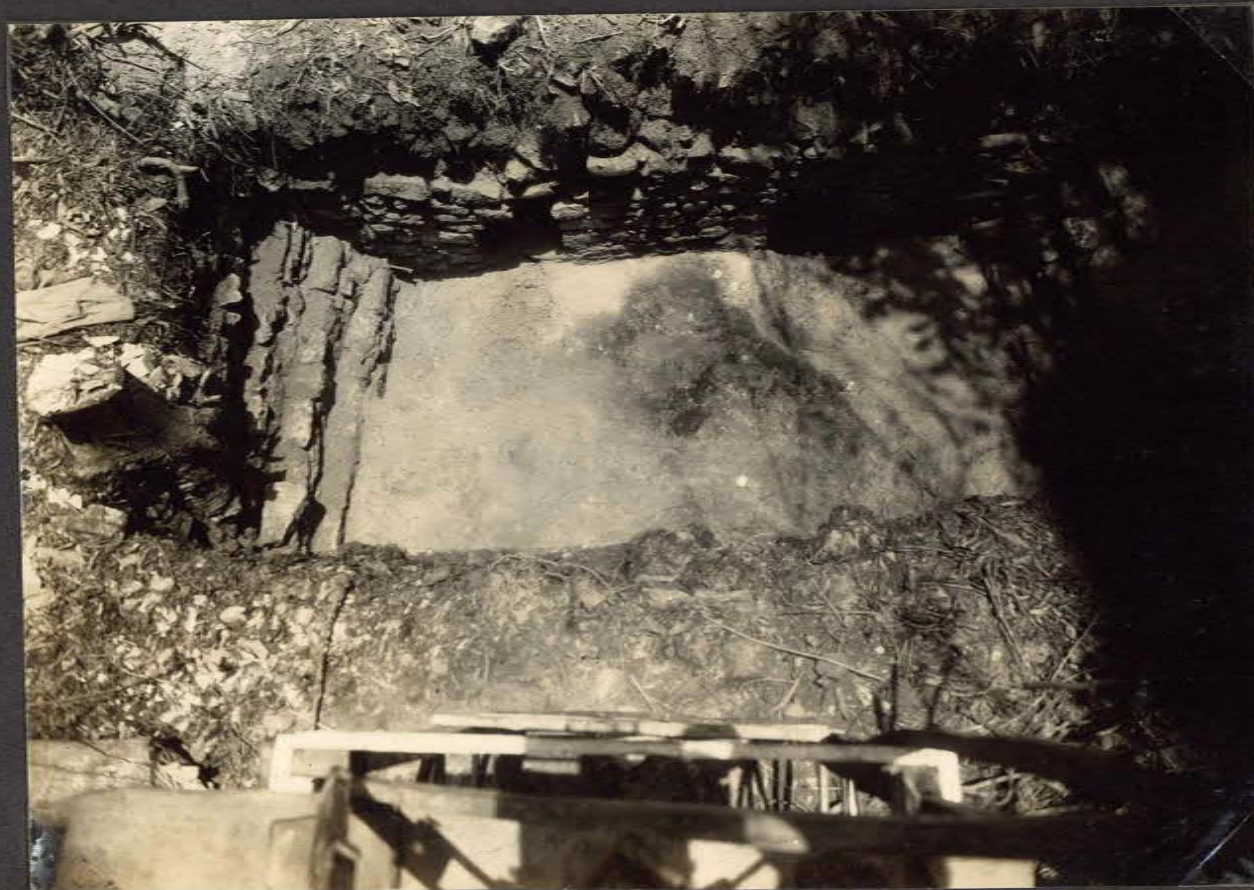
33-266

- 266 Bur. 10 SE The chamber cleared to just under level of first step except at SWly corner, where it is cleared to bed rock. Notice the two niches in NWly wall, and stepped SWly wall left; and the black discoloration at center.

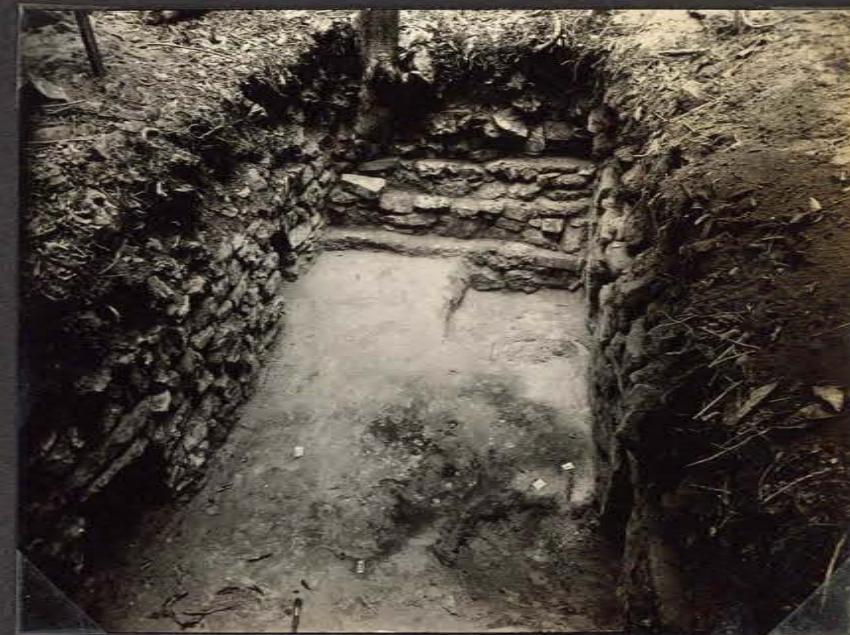
- 267 Bur. 10 NE View at same time as 33-266, from NEly end, showing niches -s of SEly wall, SWly stepped wall (background) and the lowest level of white fill cut to bed rock in far corner and in front of niche at lower right. The numbers here and in 33-267 marks points where objects were found. This is the level of the objects not in niches.

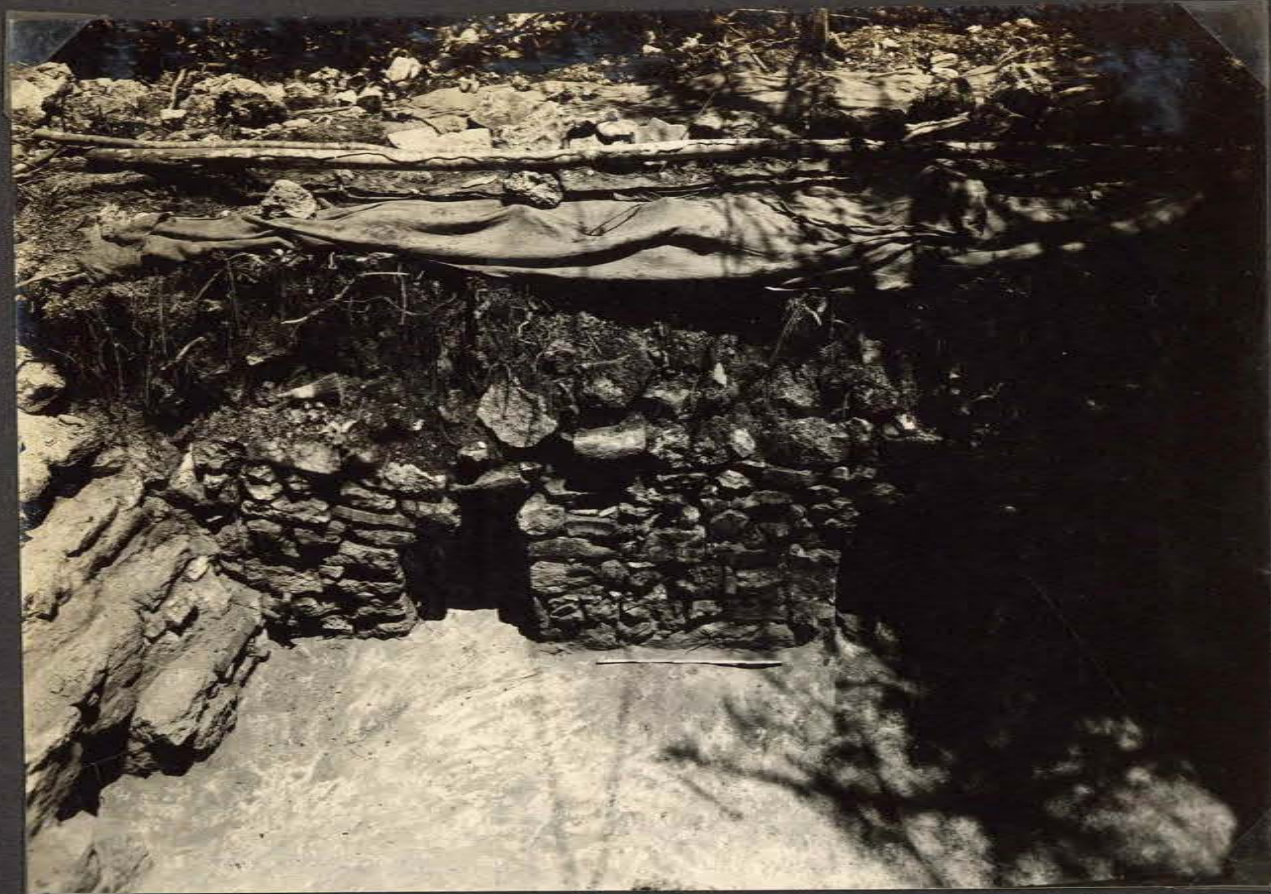
33-268

- 268 Bur. SE Same view as 33-266, but from surface instead of tower,
10 and after removal of fill, showing bedrock floor.
The burlap (at left) lies on surface of plaza.

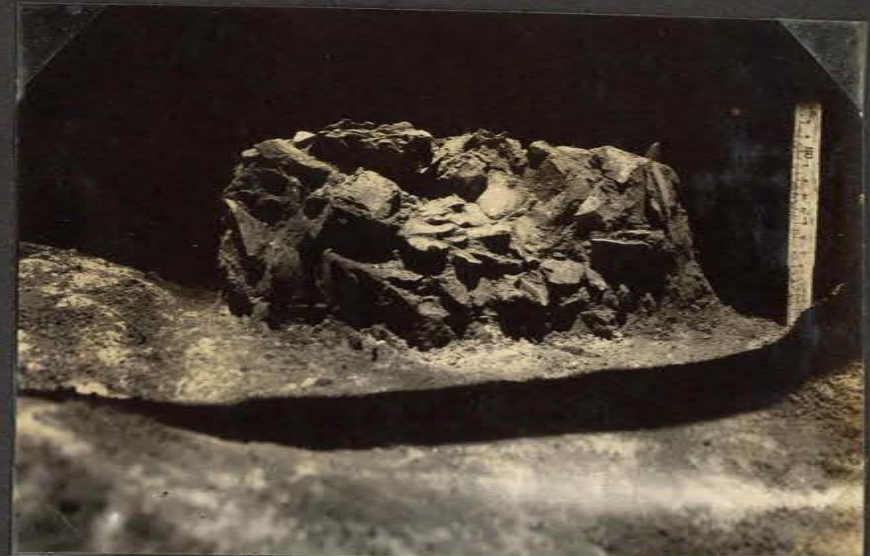
33-270

- 270 Bur. NW A horizontal view of cut section through above cache
10 of flint chips (in niche 1).
- 271 Bur. NW Similar view to 33-269, after removal of front half of
10 the cache, showing flint knife at bottom, left side
(facing the niche - that is to the NE). To the right of
this was a flint piece, probably a blank from which
a knife was to be made. No. of the knife is L-39-248
(S-15-11; of the blank, not showing here, L-39-249
(S-15-12).

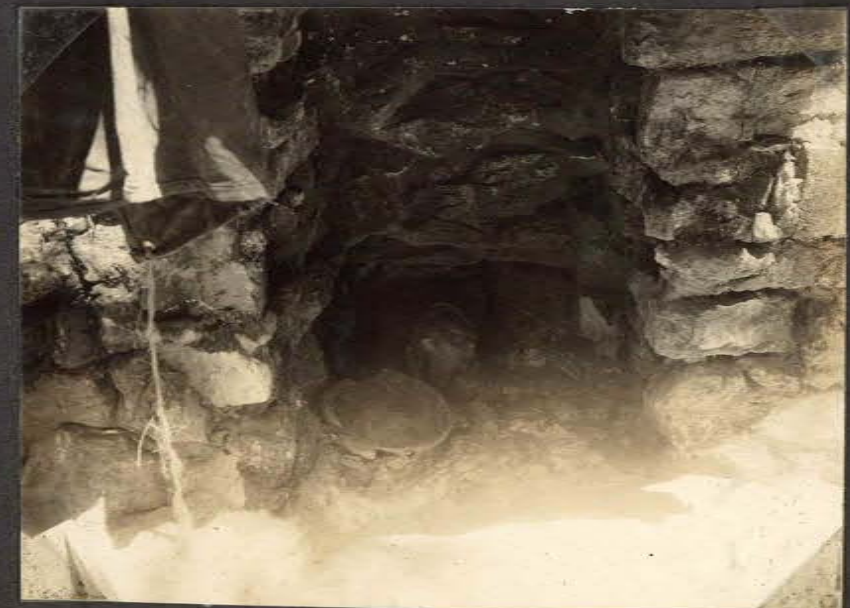
33-272

- 272 Bur. SE Niche 2: pottery footed bowl (L-39-44, field No. S-15-18)
10 against left (SWly wall of niche, in the soft fill
a few cms above bedrock floor; skull behind it, face
down, but turned slightly to left (SW). Some of the fill
has been left in the inner right corner.
