1933

P.N. 1933 P.3

Photographs

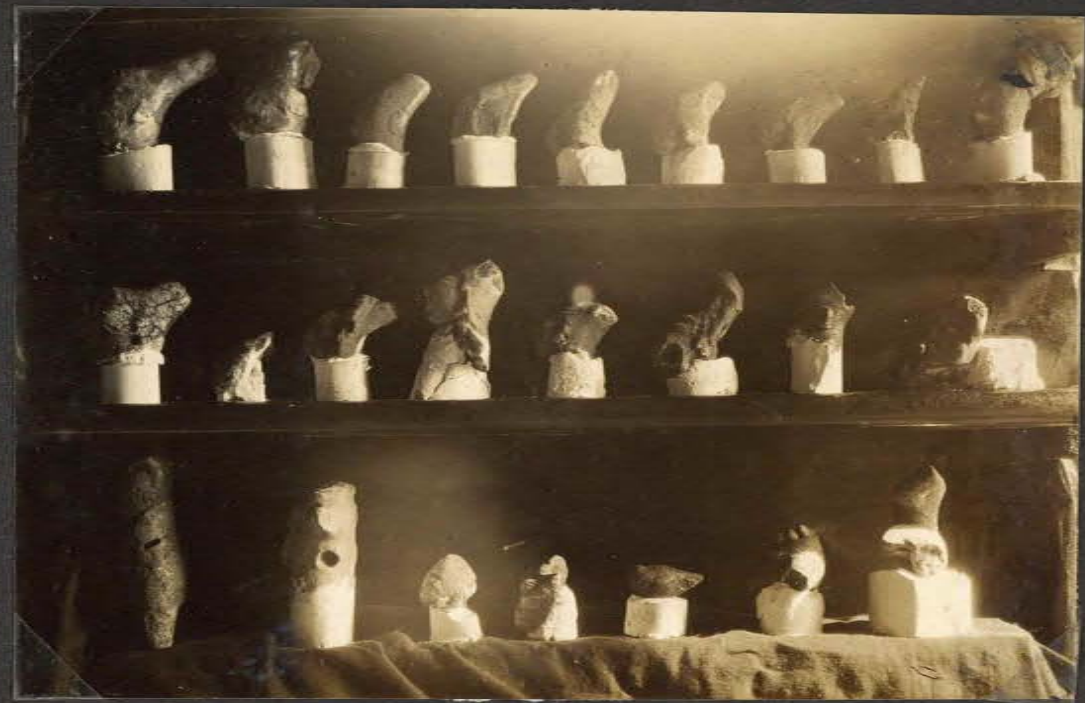
33-279

Same as 33-277 and 278, left profile views.
