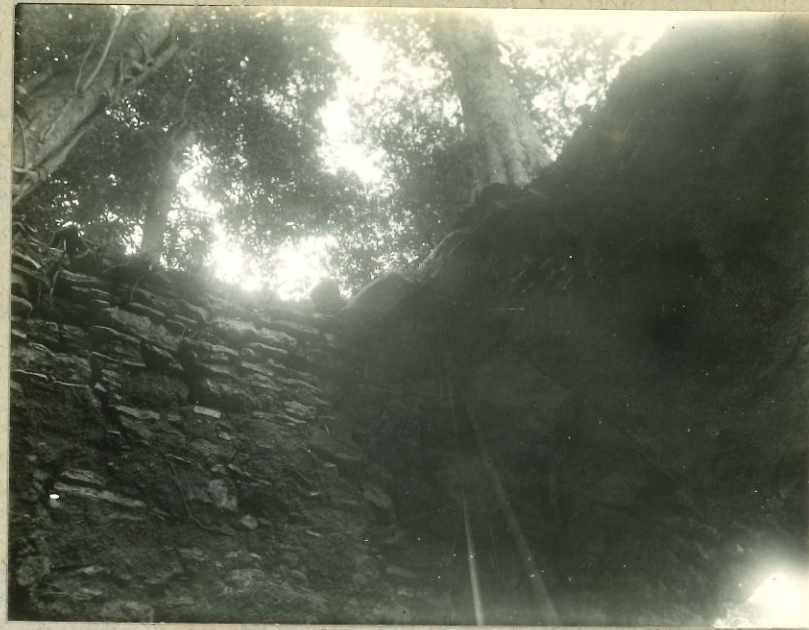
34-121

121 P-7 N Vaulting at juncture of medial wall vaulting with that of right side of Sanctuary. Note stone projecting from Sanctuary vaulting at top - see cross section sketch for its inner end - is at same level as cap-stone-like stone projecting from medial wall vaulting, which is in deep shadow. Tape hangs from corner under slabs projecting from both vault systems.

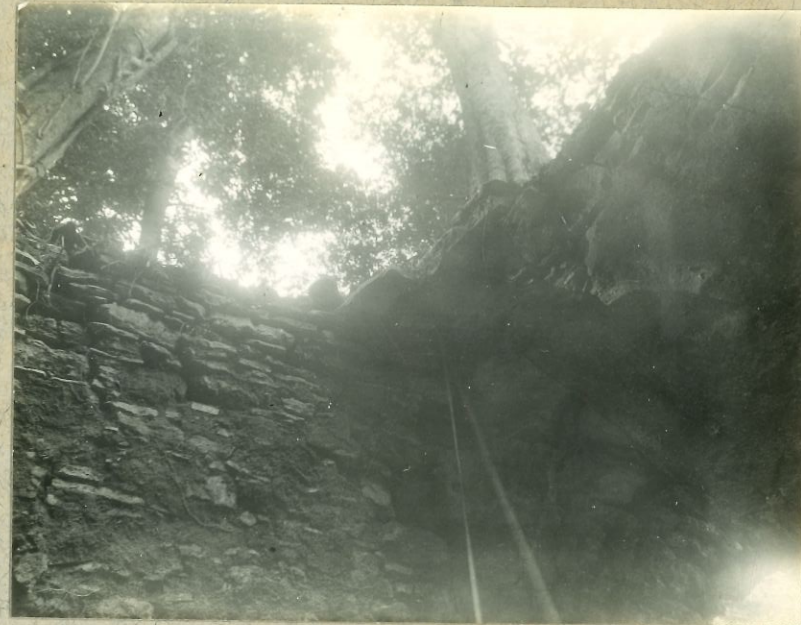
34-122

122 P-7 Same view, another negative - no better.

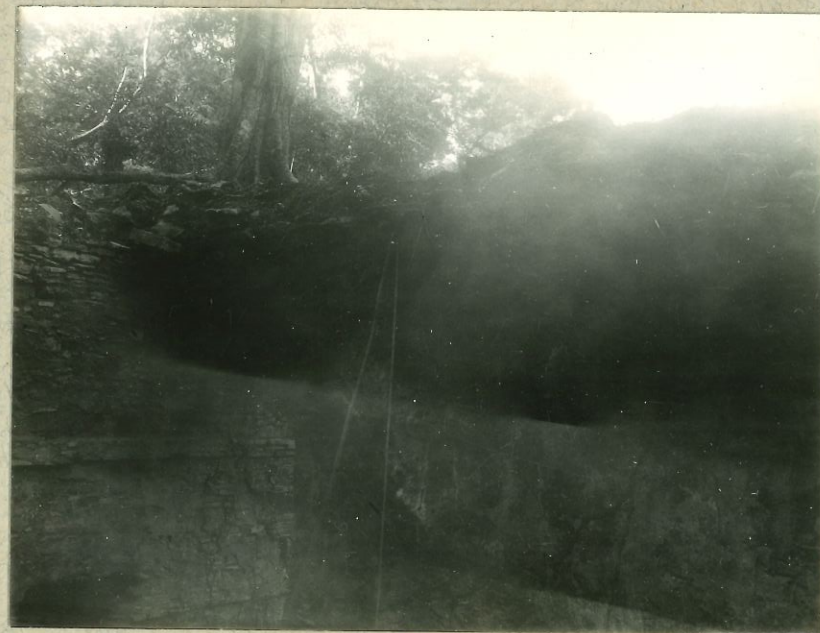
34-123

123 P-7 S Vaulting, rear right room; tape hangs from under side of projecting slab at point where it passes horizontally outside the plane of the soffit slope (medial wall vaulting). See sketch. Poor negative.

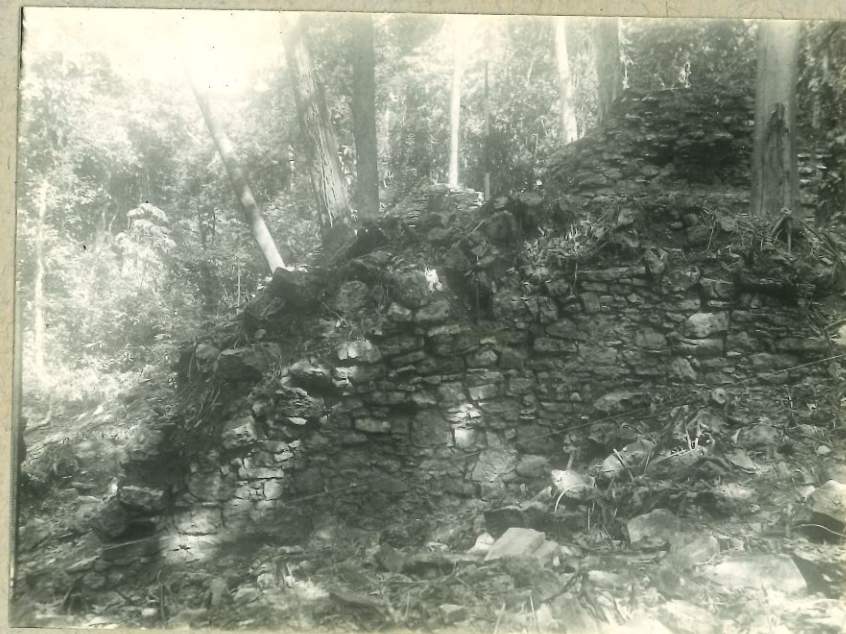
34-124

124 P-7 SE Left end wall; rod on point No. 51 of sketch notes. Note liberal use of small thick slabs, but of irregular blocks also. For other end see 34-125. (Cp. with 34-127, inside).

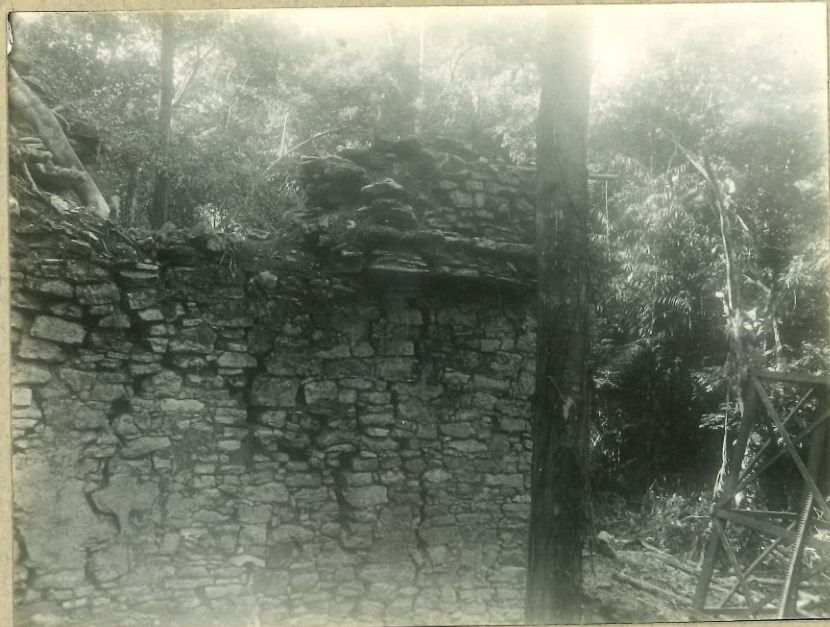
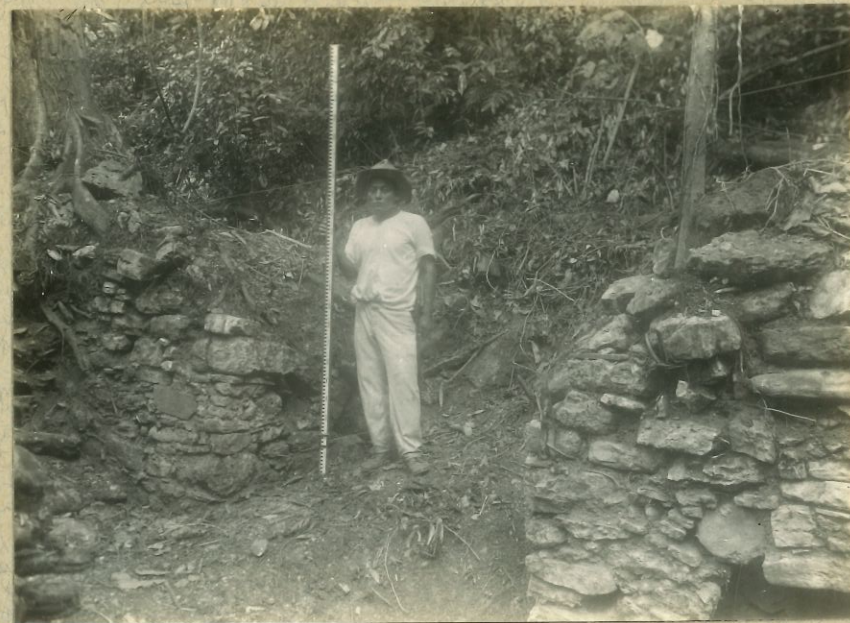
- 125 P-7 NW Right end wall including cornice and upper zone. Note generally thick slabs in upper course of cornice. The two flat stones of upper zone are on same level, giving slight indication of total height of entablature. Other data points to this as a reasonable height.
- 126 P-7 S Left (SEly) doorway of rear wall, from left rear room, camera just SE of bench-altar. Meter stick is about .70 m (? - stated as 1.70 in original note) above surface of lower course of "flue" or "drain" stones.
- 127 P-7 NW Left end wall, inside view (Cp. with 34-124). Note irregular blocks.
- 128 P-7 NE Rear wall, from outside, rod at point 75 of sketch notes. Note free use of irregular blocks, together with small slabs. Absence of large stones.

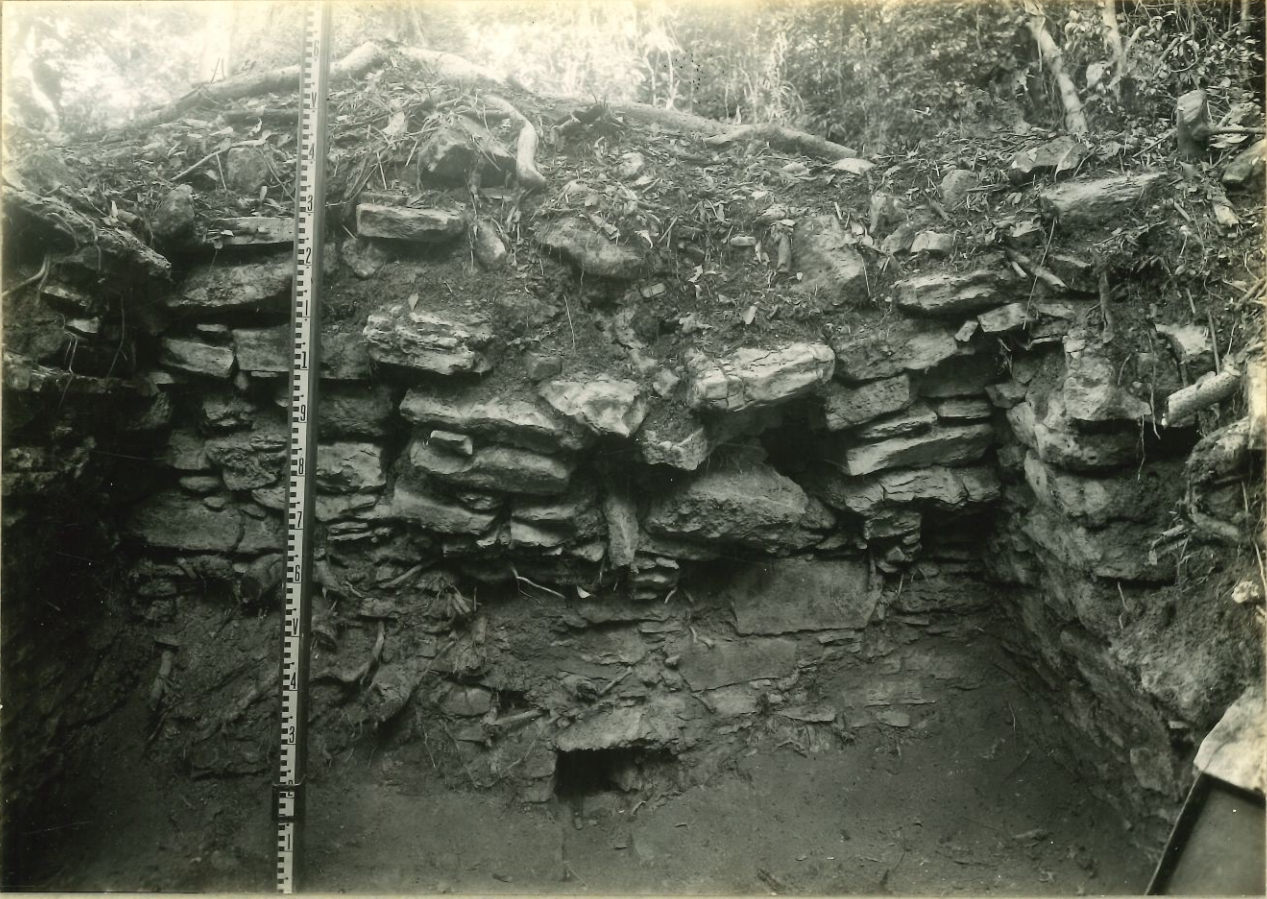
34 - 131

131 P-7 SE Upper Chamber of Sanctuary, right (NWly) end wall and vaulting, from inside. Note drain at bottom (meter stick projects from it; Tendency to block vaulting and chinking. Cp. with the other end (34-132) where the chinking persists, but blocks appear only toward the top. Why are the inner sides of this vault system in such poor condition? the other side of this balanced vault is in good condition.

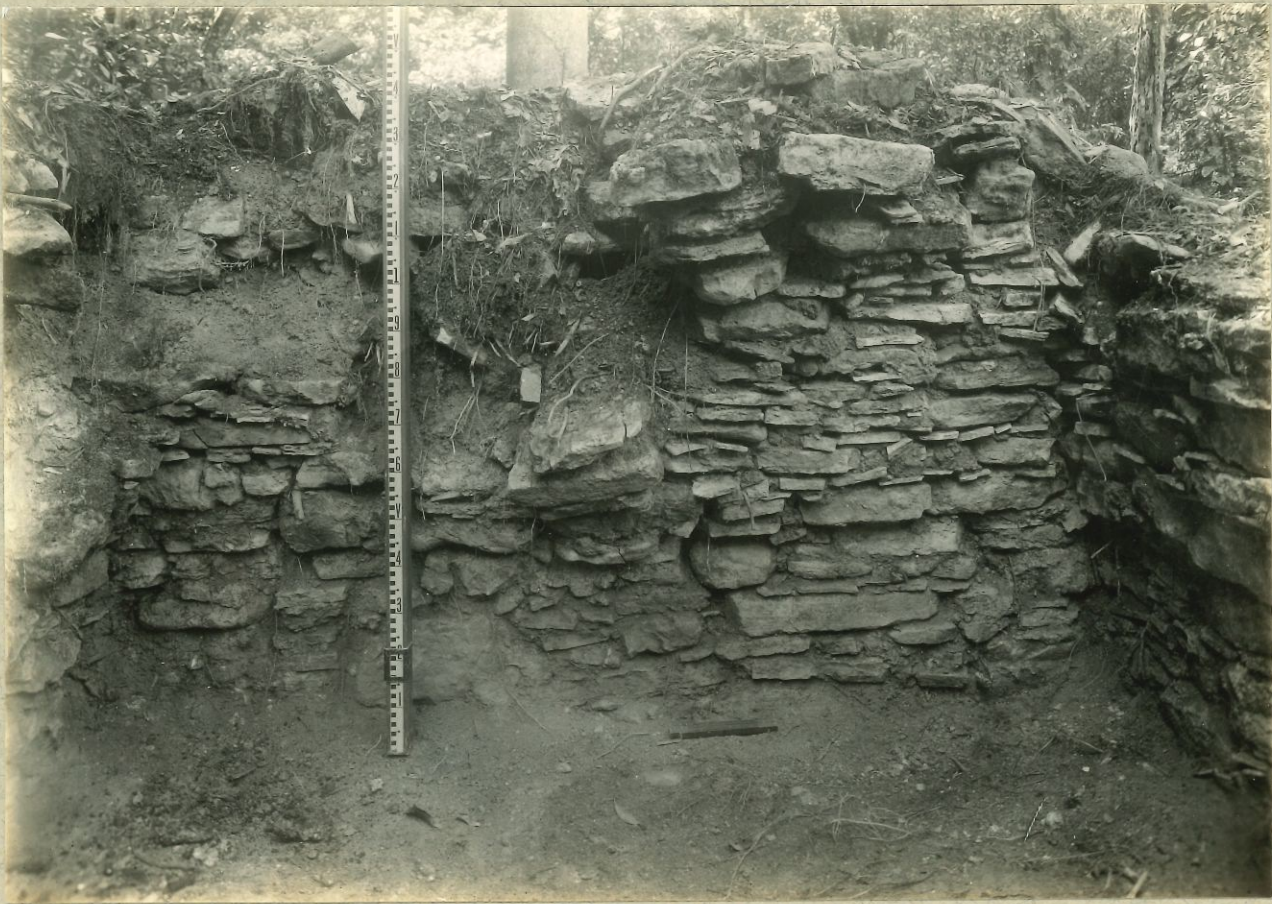
34 - 132

132 P-7 NW Upper chamber of Sanctuary, left (SEly) end wall and vaulting from inside. Cp. with 34-131 and 34-133.

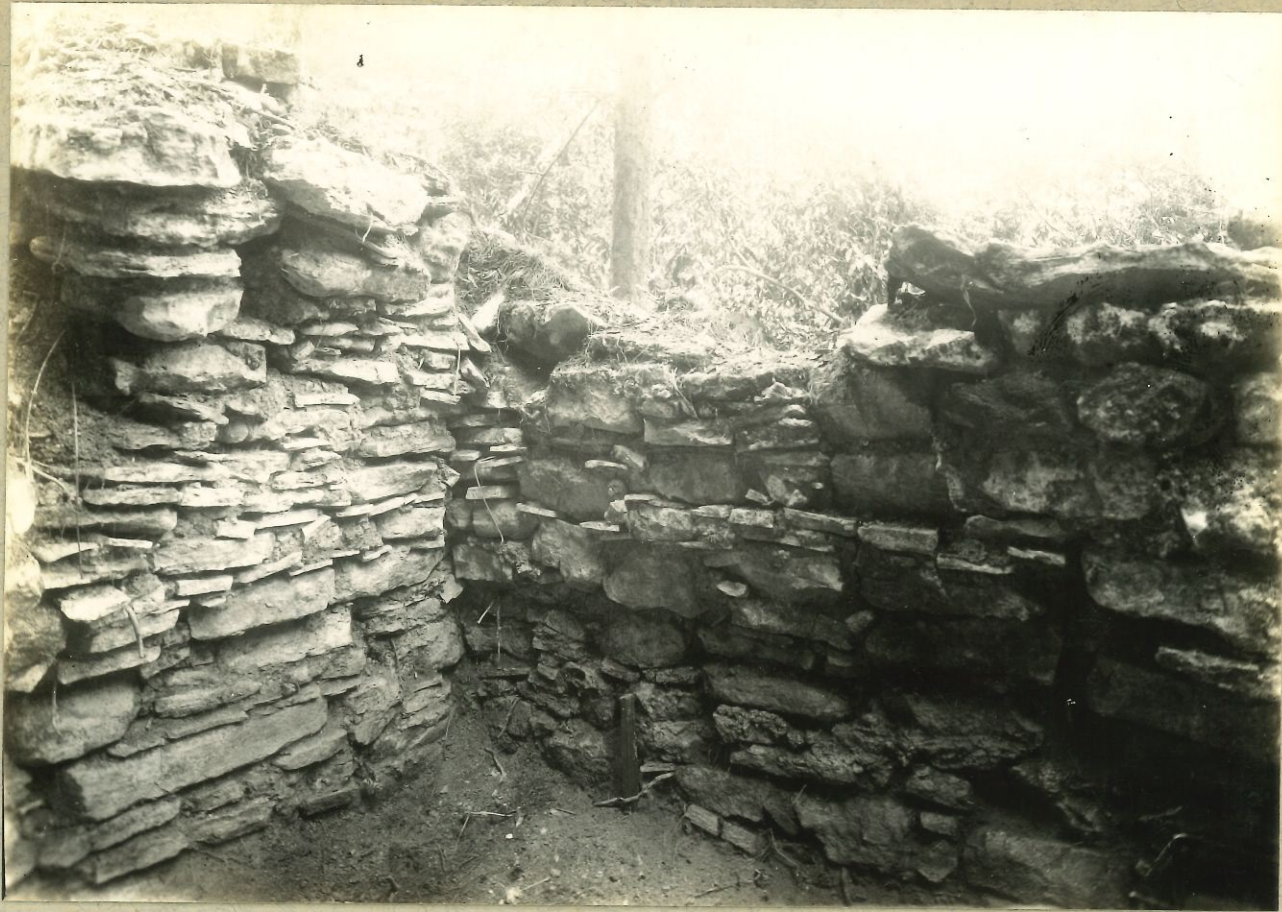
34 - 133

133 P-7 N

Upper Sanctuary Chamber, inner sides of front and left end walls and vaulting. Note difference in masonry in front and left end walls; while front and right end walls (see 54-131) are of same general character. (The rear is fallen, except at corners, to height of vault spring. There is here a xx rough vault-spring 45 cms above floor. Note that the vaulting looks more like vertical wall masonry - heavy slabs or blocks, with chinking - on the front; more like usual vaulting on left end, except toward the top.

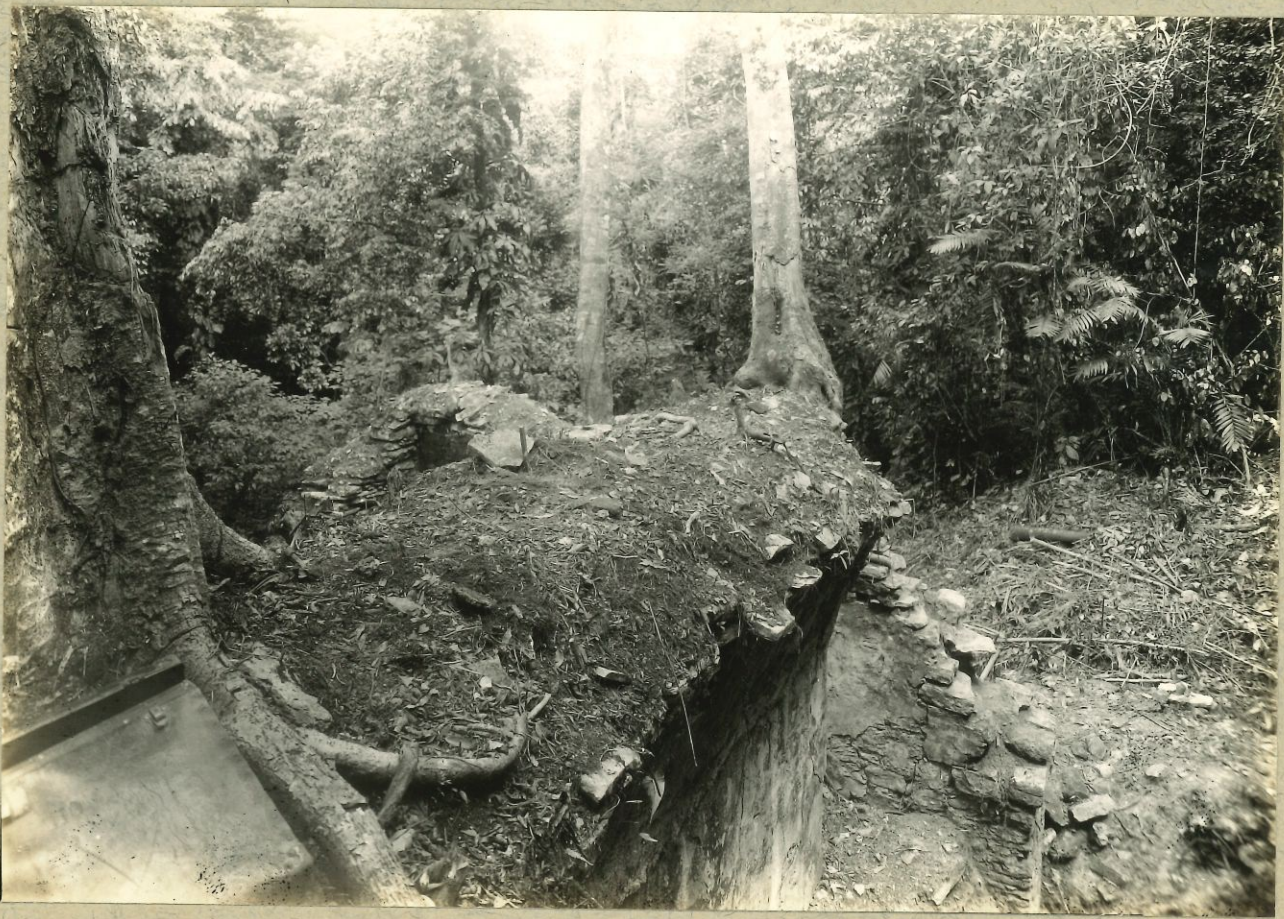
34 - 134

134 P-7 E

Probable (disturbed) roof surface of vaulting over medial wall ~~right~~ between front and right rear rooms. From right corner of Sanctuary vaulting, Meter stick rests on a slab in position; the slab to left of it has been turned revealing hard pieces of river-pebble concrete. Note other small slabs and spalls lying on surface. They were all more or less loose.

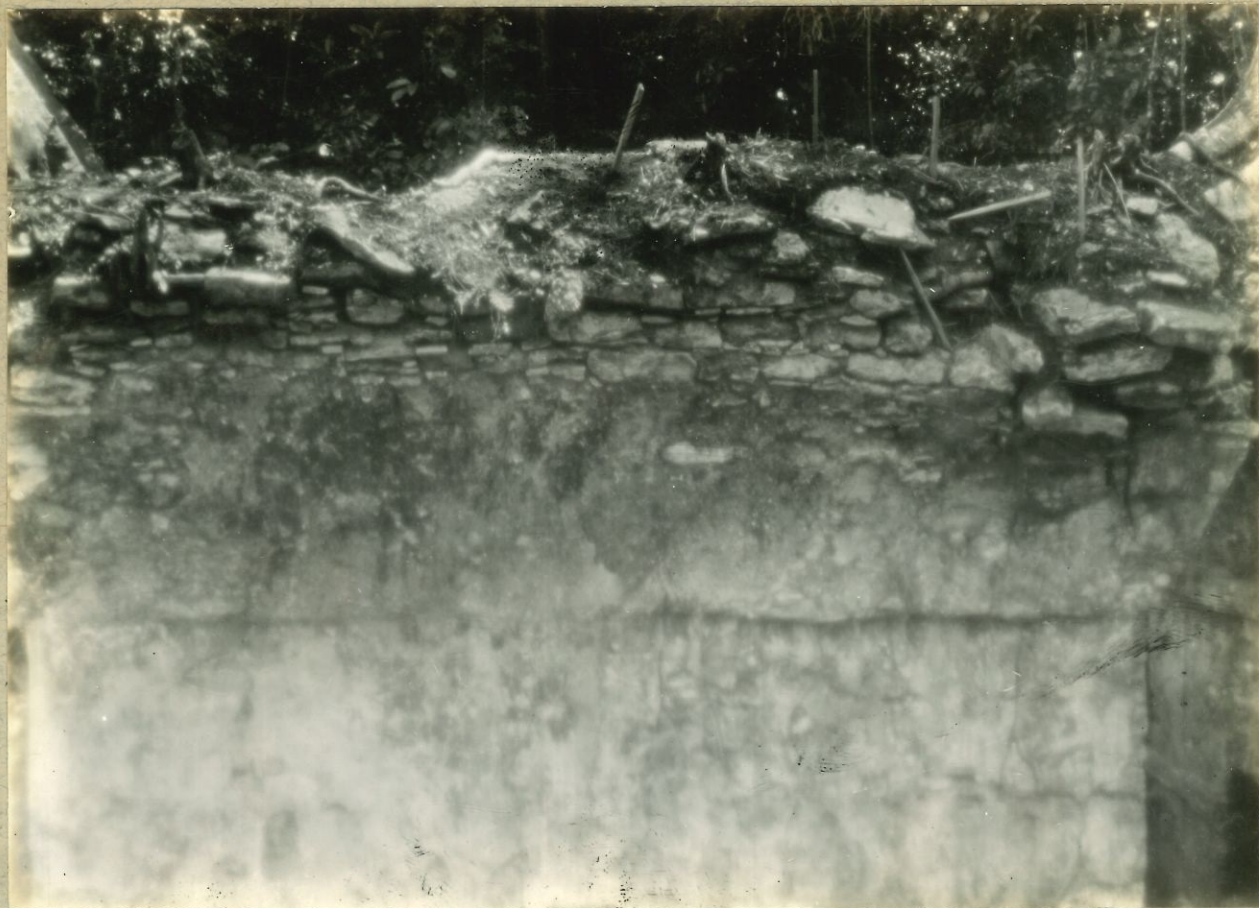
34-135

Medial wall vaulting from the front, from tower in front room. Meter stick extended to 22 cms stands on slab in position at center (same position as in 34-134), on which lay river-pebble concrete. The sticks point to pieces of this concrete, loose but not moved by us. The lowest one rests in a cut into the vault, its upper end pointing to the concrete at one side. The slabs in the cut were laid in ordinary (no gravel) mortar. The lower level of the center surface at left, which seemed to have been cleared off a bit in course of excavations, is strewn with river pebbles, ~~xxxx~~ though loose. Note use of heavy ~~xxxx~~ block-like slabs at top of remaining soffit slope. A satisfactory picture of the lower part of this slope could not be had without stripping off the plaster.

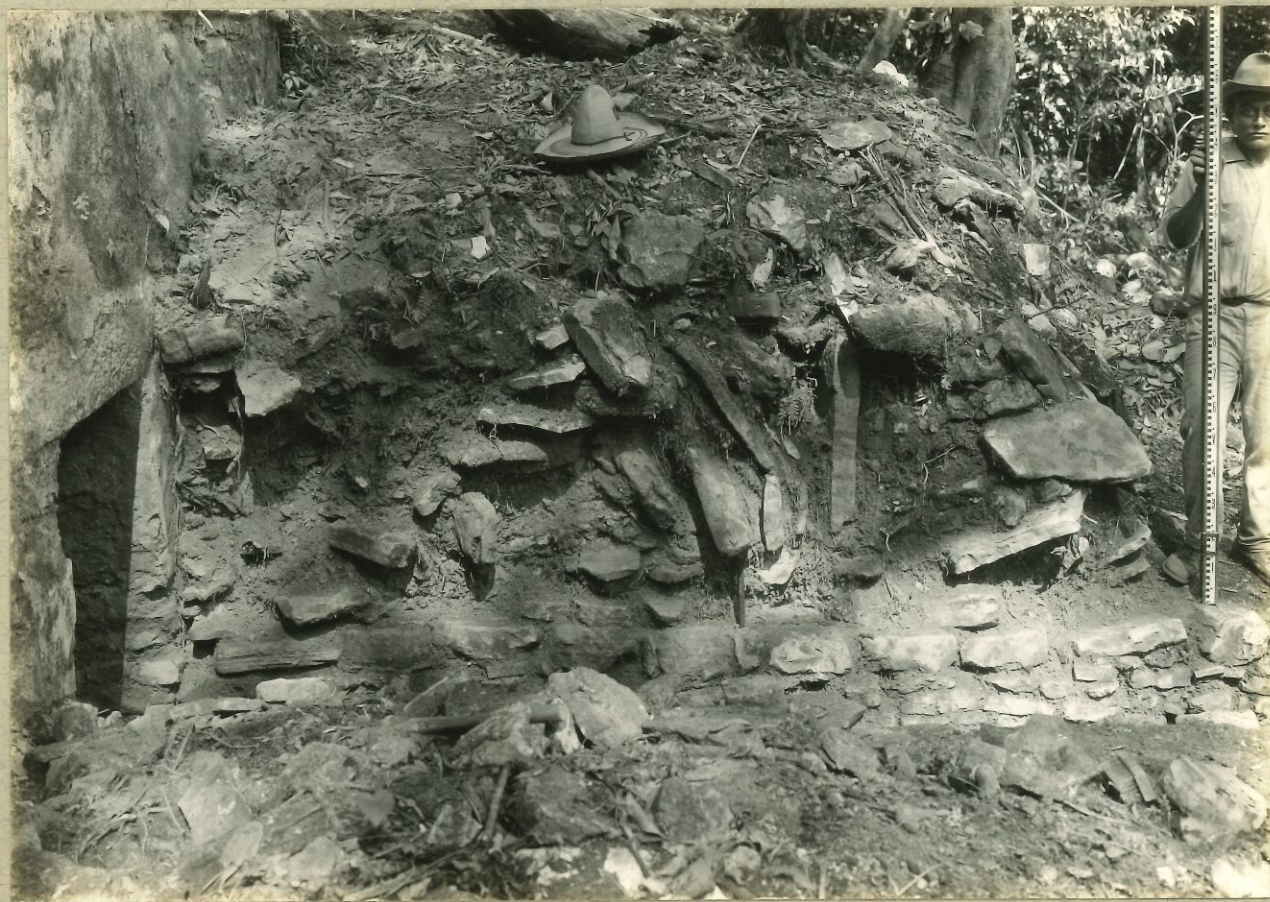
34-136

Cut section of debris just left of left wall of depressed passage. Rod rests on this wall, near front. Note large slabs do not reach floor level, though small ones (such as seen on surface of medial wall vaulting (33-134) do. Gravel-concrete on floor, and a little above - note large mass about 50 cms. left of meter stick, over a small slab and below large ones. See 34-137 for close-up of this, with the surface (up) cleaned off.

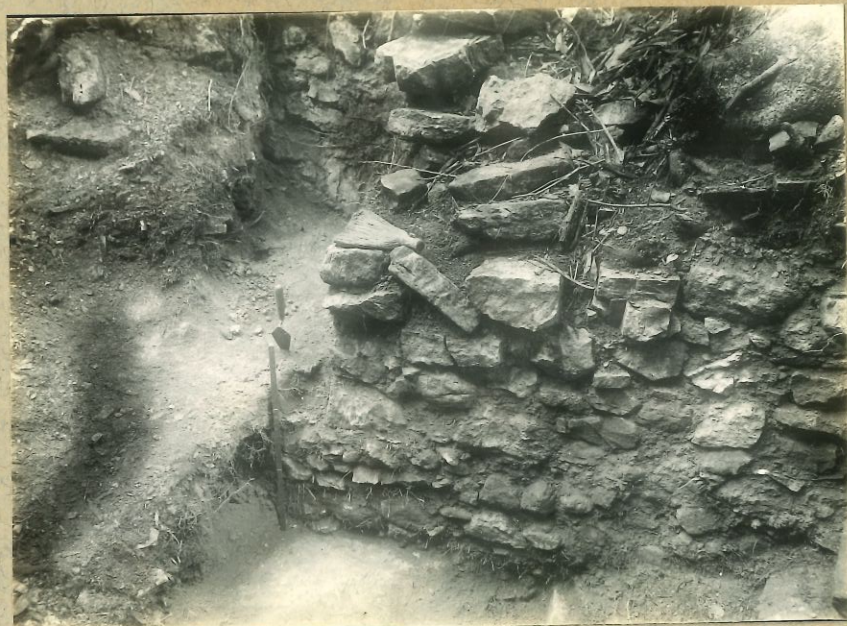
34-129

129 P-7 S Bench altar, etc. in left rear room, looking forward from SEly jamb of left rear doorway. Meter stick stands on lower floor and rests against upper floor, which is here 37 cms above it; Trowel sticks in mortar-like deposit on upper floor. This includes river pebbles and mortar, so that we thought it was the floor, at first. Note that originally the lower floor ran under a wall or bench which runs to left (in pictures of meter stick, beyond the SEly end of the ~~XXXX~~ altar, and runs in other direction an unknown distance. This same lower floor runs over "flue stones at right, though a little higher, and under the wall there also. If this was a flue, it was below the lower floor. There is no trace of the other side of a "flue" now. The bench and altar appear to be a unit (check notes for later opinion?). Marks of upper floor on its face, at base of altar, could result from later bringing floor to level of bench. Was not able to follow these marks inside and under the bench, as we should be able to do if bench-altar is later than the lower bench. Note: the question of relative age of this lower bench and the altar should not be decided without careful attention to all available evidence, and considering all implications

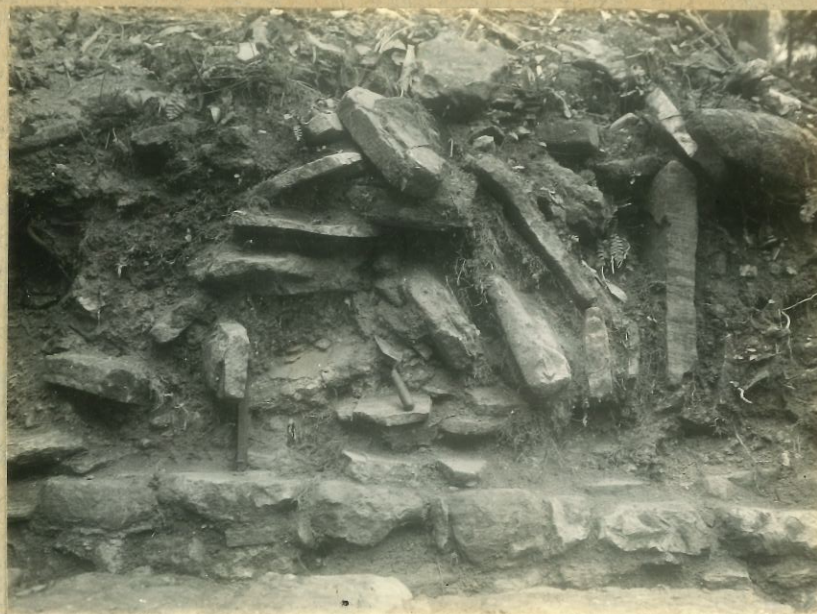
34-137

137 P-7 NW Close of part of cut-section of 34-136, with better cleaning. Meter stick extended to 22 cms, rests on room floor level (i.e. on top of left wall of depressed passage. From its top a large slab of river-pebble concrete, with smooth surface upper-most, runs to point behind trowel to right, over-riding small slab on which handle of trowel rests. This concrete slab is obviously fallen, sloping slightly ~~XXXXXXXX~~ up to right (in picture) and away from camera. But it is below vaulting slabs which must have fallen from sanctuary front vaulting. See drawing of this section for other masses of pebble-concrete. Cp. with 34-136.

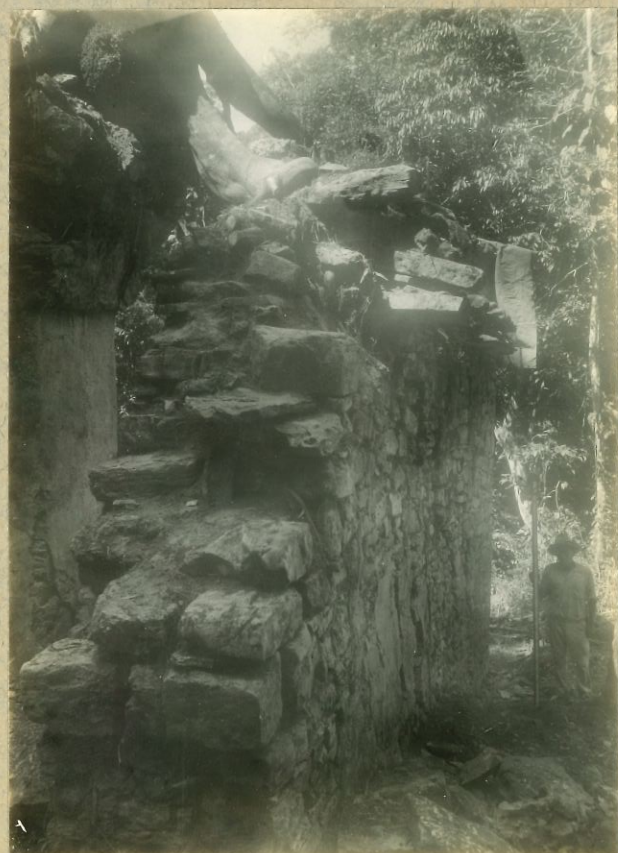
34-115

115 P-7 N Right end wall looking forward at sharp angle. This was intended to give section view of cornice for which purpose a piece of canvass is hung out on a stick, like a flag. In foreground, receding crosssection of wall above lower intact portion of doorway jamb. The two white slabs projecting at top of wall (right center) are the lowest and highest courses of cornice. Here the lower is heavy, but upper is heavier, and still tied under an interior slab (see notes.)

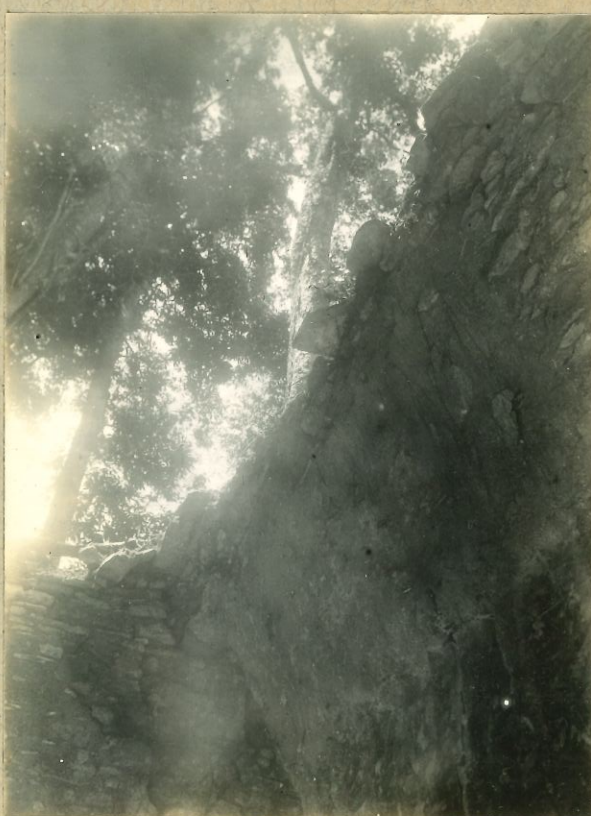
34-130

130 P-7 N Vaulting of rear room, medial wall, showing two projecting slabs; also projecting slabs at junction with Sanctuary vaulting. See 34-121 to 123.

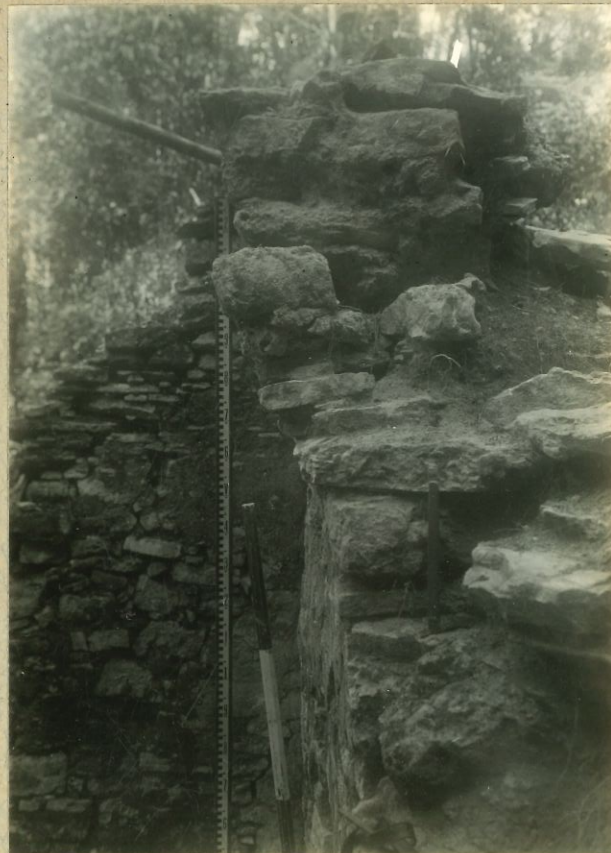
34-141

141 P-7 NE Fallen section of vaulting on right end wall of front room, and of supporting wall. Note slab construction at base of vault only, giving way to blocks and block-like slabs. The steep angle of the soffit slope (see drawings). Rod rests on debris at this end.

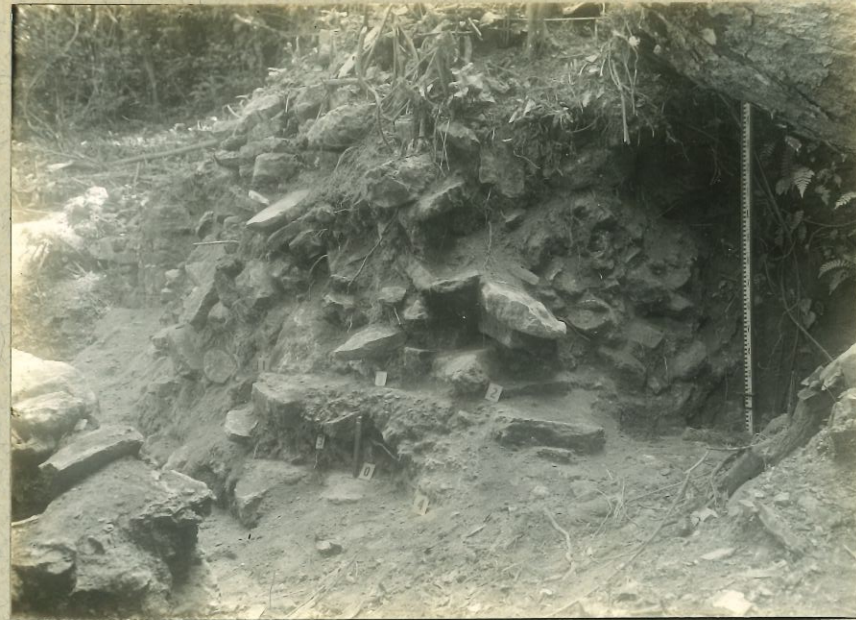
34-139

Cut section of debris, right rear room, taken from doorway leading to front room. We look at the corner of a cut out from rear wall to the No. 2 and thence (to left in picture) roughly parallel with rear wall. The rod, at the back of the front-rear cut, has its base at the level of the bottom of the rear wall, which is hidden in shadow. This is more or less the floor level here, about 39 cms. above zero (which is the floor level at the rear of the front room). The No. 2 is 1.30 from rear wall, and 1.60 from the No. 1, which marks the other end of the longitudinal face of the deposit.

Note the deposit of gravel and mortar which runs from No. 1 to No. 2 (1.60m). The number 8 rests on the surface of this deposit near the center. Finish plaster could not be found (as in the front room - see 34-136 to 138) but this is a much longer and nearly level deposit. It over-ruled a couple of blocks and a small slab. The block under the No. 1 rests on a fallen slab. No 0 is at about the floor level here, though plaster finish of this floor is not found here. Below this level are building blocks and broken stone, a fill. We have checks on this floor level along the nearby altar, the corner of which appears at left.

The left half of this deposit, from No. 1 to 8 runs from 2 to 4 cms to 15 cms. in thickness. There is no gravel below, the deposit being crushed down on fallen stone below. To the right of No. 8 the thickness of gravel increases until a little to right of the No. 4 it is present to about 10 cms above the floor, but here there is also stone, and light yellow to white mortar.

Note that the gravel deposit brushed out quite level, despite the lack of the (probably) former finishing plaster surface.

Gravel does not appear in the cut from rear No. 2 to the rear. But the failure of the other cut to be truly parallel to rear wall, indicates the No. 1 - 2 deposit was above 40 cms in front-rear width - i.e. began about 30 cms in front of rear wall, and extended an unknown distance to front.

There is no gravel directly on the floor; and none above the surface of the Nos. 1 - 2 deposit. Above this level are slabs and wall blocks, ordinary mortar.

For the height of the gravel deposit see meter stick extended to 22 cms., the bottom on approximate floor level - i.e. the surface is about 30 cms above floor, the bottom of the deposit running from about 25 cms to only 10 cms above this level.

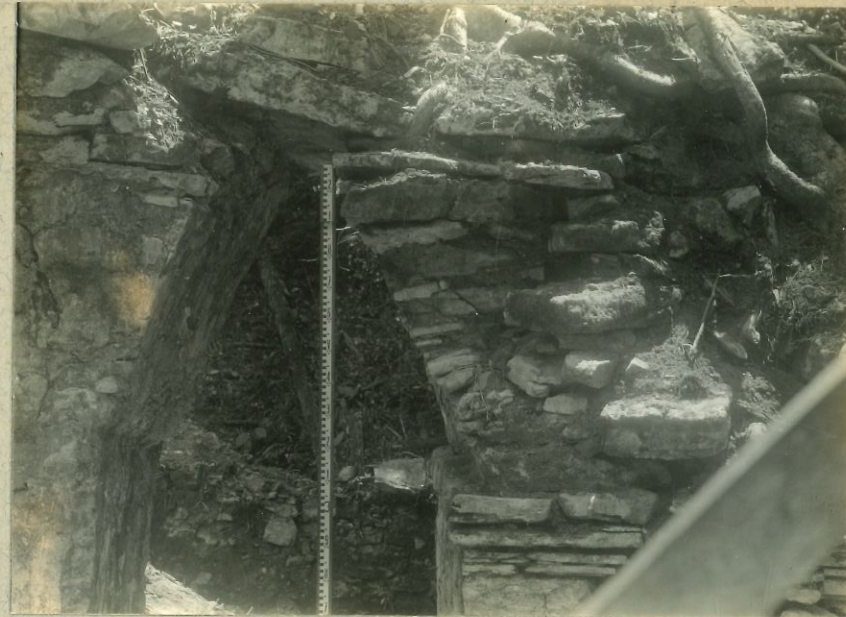
34-140

Fallen section of Sanctuary vaulting, cap stone to right medial wall, from the front. Red is on floor, extends to 2.28 m.

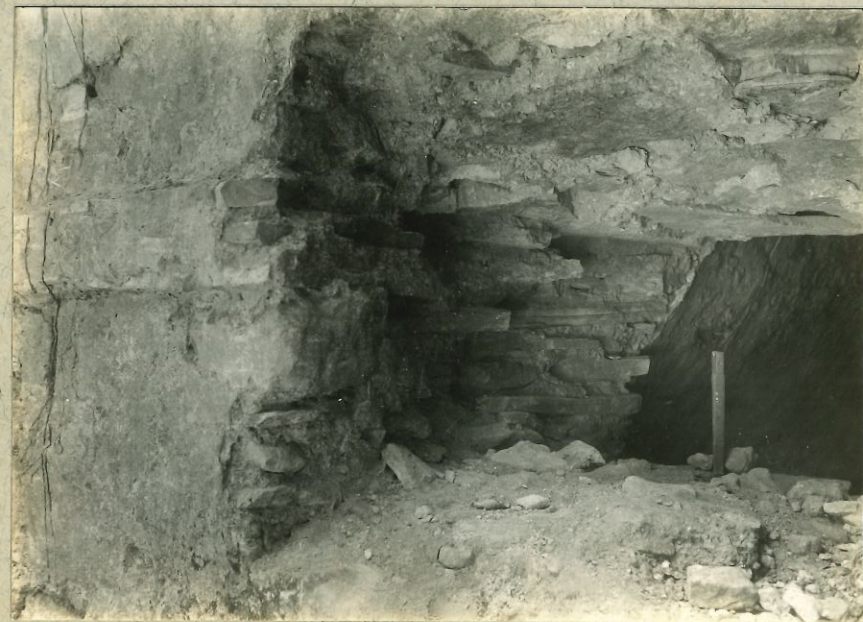
34-142

Cut section of lower chamber vaulting, right (NWly) side of Sanctuary, at an angle. This is the rear side of the breach made in this wall before "aler's" time. The lower band shows at left. The meter stick, extended to 22 cms., is about 1.12 above the floor level of the rear right room skight. Note thin slabs running far in from the vault surface (and see sketch). At the outer wall surface, a big block and small slabs. Slabs used to building out the band or moulding.

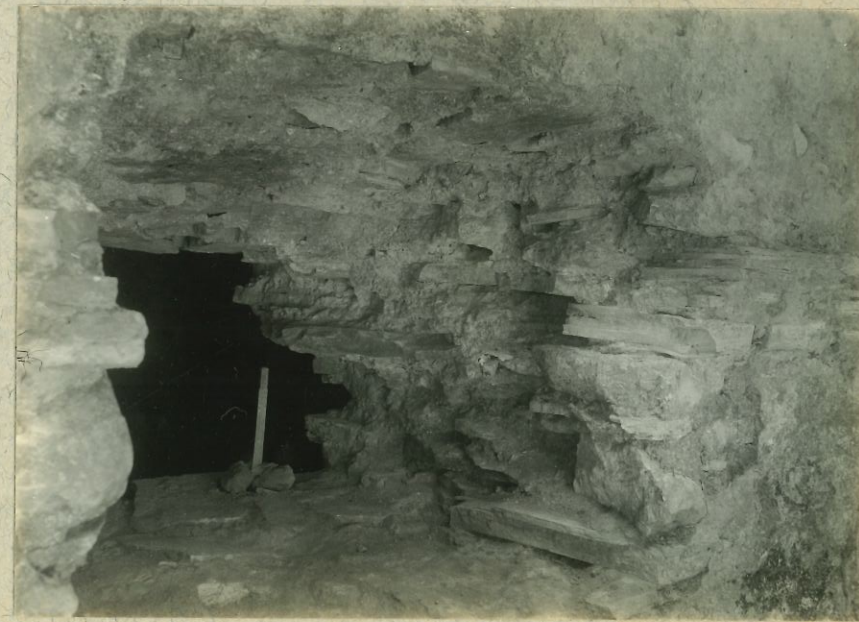
34-143

Cut section, the other side of the breach through right wall of Sanctuary. Same remarks as under 34-142, which see. This is a better picture. See sketches.

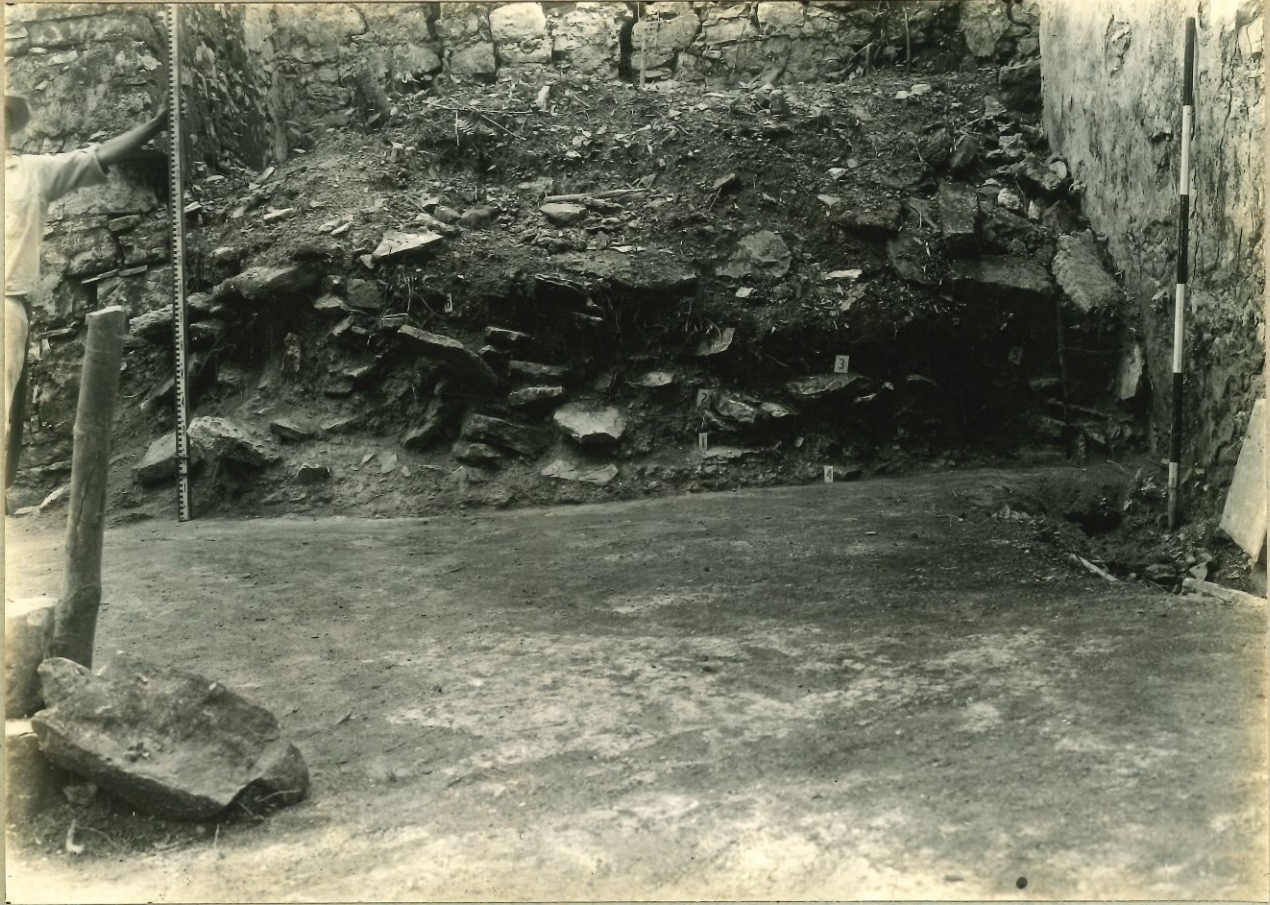
34-138

Cut section through debris of front chamber, 20 cms right of the cross-section drawing (i.e. of lines passing through center of right doorway). This debris was left in place during 1931 excavation, though a small amount was thrown over it. The numbers on cards indicate location of river-pebble (gravel) mortar as follows: On the floor it runs from No. 4 to left (in picture) to low stone left of No. 4 (also left of No. 1?); This deposit is about 7 cms thick. The No. 1 rests on a surviving remnant of the white plaster smooth finish, confirming belief that this whole deposit is from a roof surface, although 1 mediately on floor. The plaster finish is hard and rests directly on gravel-concrete. 34-147 shows close-ups of this concrete, the surfaced fragments coming from this piece. The gravel concrete seems to be integral with a layer of lime and broken limestone lying directly on the well-finished floor. The total thickness here (where we have the surface) is about 12 cms. Cp. this surfaced piece with similar one in the cut section of 34-137, which is a bit higher up. This finished piece is 50 cms long and probably as wide. The integration of gravel-concrete with the lime mortar and broken stone directly on floor is confirmed by a stray green river pebble only 2 cms from floor.

The indication is a roof surface consisting of usual broken lime-stone and mortar concrete with a cap of gravel concrete between it and the usual pure lime finishing plaster. Immediately above this surfaced piece is another running down to the right (in picture) from the No. 2. The gravel concrete under this surfaced piece is about 7 cms thick, and below this also is crushed limestone and mortar. There is a sherd imbedded below the surface of the other and lower piece, and these occur on roof surfaces over medial wall and sanctuary.

Loose gravel and sherds extend 40 cms left and 20 cms right of the No. 3.

A small deposit of gravel extends 20 cms left from the No. 20 (a mistake in this number), the top at the level, thickness about 5 cms. The only deposit to right (rear) of No. 4 is a small one at the No. 5, well above floor. The material on floor to right of No. 4 is small slabs & plaster without other stone. This is probably from ceiling, as medial wall and probably most of its vaulting is still in place.

Gravel (loose) noted either side and below the No. 6. Apart from this there is no gravel left of the No. 1 deposit,

but isolated pebbles occur now more or less in a line from No. 2 to 6, thus passing above small slabs, as was noted in the cross-section of 34-136&137.

The positions of the numbers in this picture can be located from the following components, bearing in mind that heights are above floor, which descends slightly toward the front (left in picture):

No.	Distance from medial wall.	Height above floor.
1	1.68 m	.14
2	1.68	.30
3	1.15	.40
4	1.23	.00
5	.45	.42
6	2.60	.50

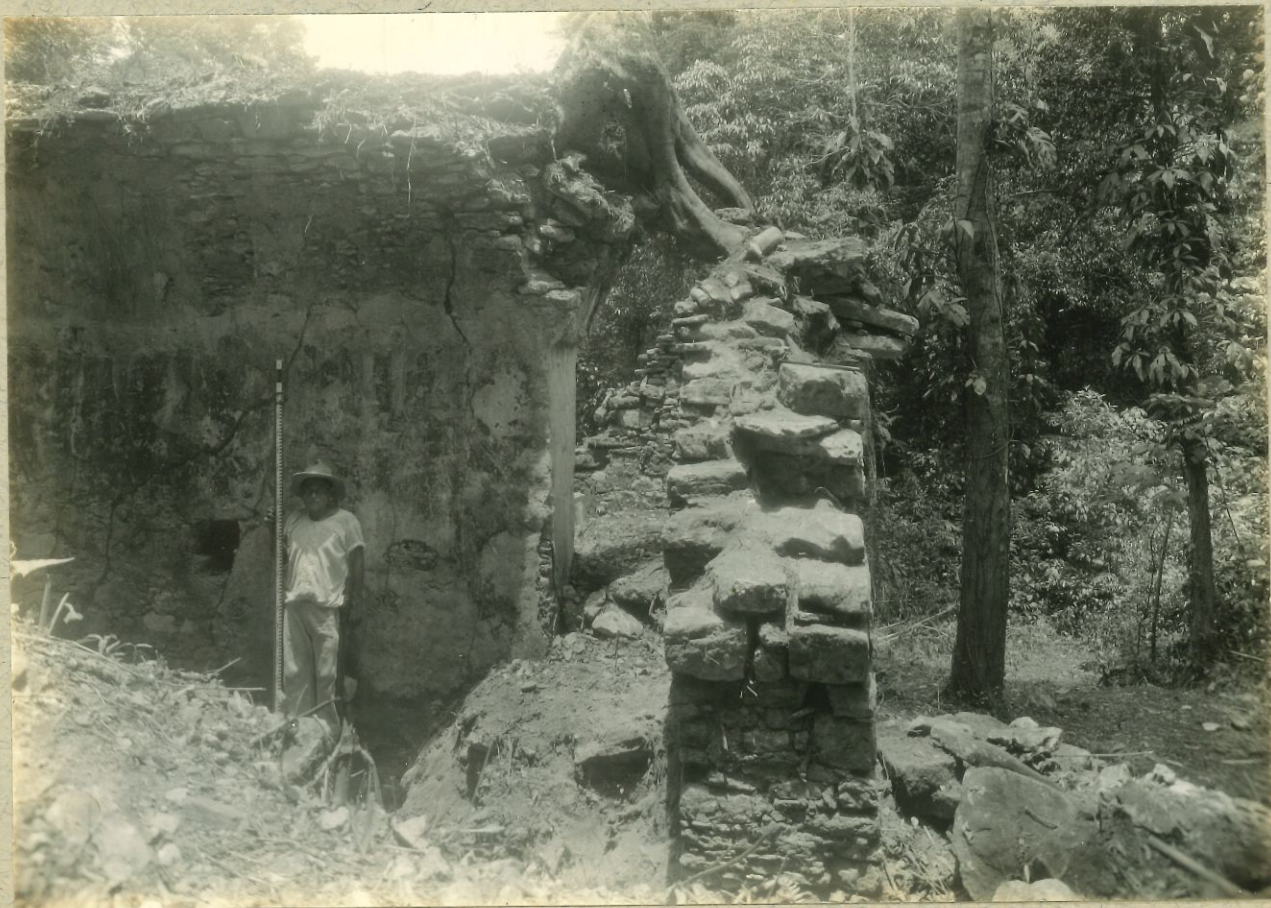
34-144.

Jamb of right wall doorway; medial wall and vaulting from rear; and receding fallen cross-section of right wall. Note use of blocks in combination with slabs - that many extend in from surface to point beyond center. There is nothing like a separate core - and no observable tendency of the stones from one face to fall away from those of the other - some bonding, though probably accidental. The two projecting slabs at right are lowest and highest courses of the medial cornice, shown close-up elsewhere. And see sketch notes. Big slabs such as appear in this cut section (cornice apart) appear but rarely in surface examination.

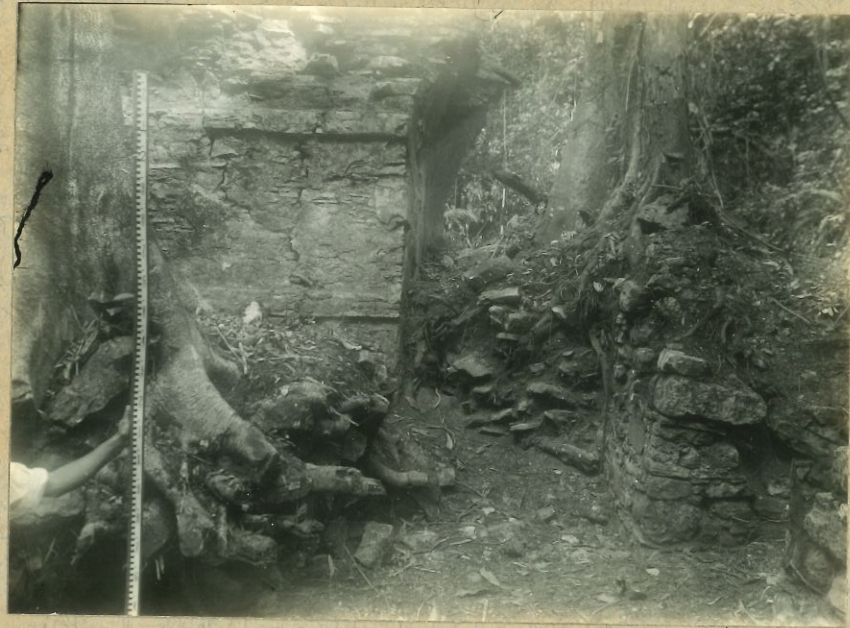
34-145

Rear right room, with cut-section through debris at end of rear passage. Sanctuary at left, left rear doorway at right. Meter stick against rear wall stands at level of point 79 in notes - i.e. only about 34 cms above floor level (latest) here. The rod in left foreground is at approx. this floor level. Note that here, in the middle of the room, the original surface is preserved by the tree, and that it is only about 80 cms above the floor.

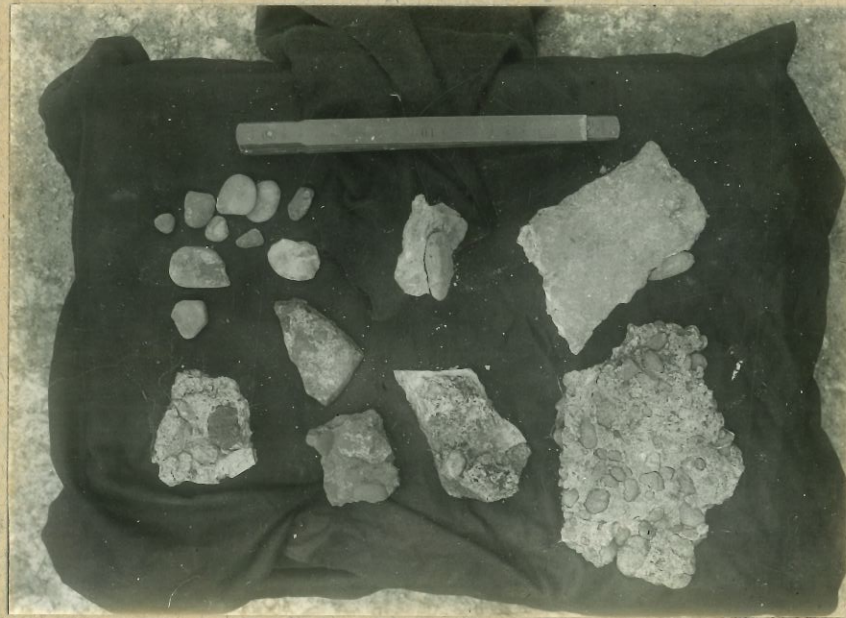
34-146

Same as 147.
