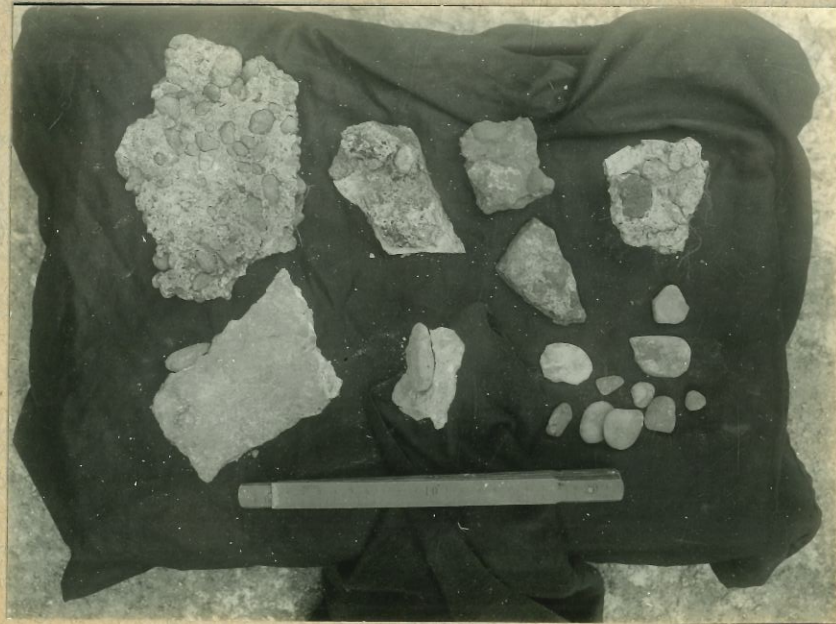
34-147

Samples of supposed roofing concrete:

Upper row, left to right:

1. weathered slab of surfacing gravel concrete, bottom up to show gravel. The other side is weathered to uneven surface, but no gravel shows. Possibly this is the top, with the finishing plaster weathered off. Thickness 2 to 2½ cms.
2. a flat limestone spall with bit of hard gravel-concrete adhering, showing some association of the concrete with at least very small slabs (spalls). Meter stick is at 22 cms. Thickness of spall, 1.7 cms, pebbles in white mortar (vault mortar runs to yellow), in this building as elsewhere). From "roof" of medial v't.
3. bit of gravel concrete.  
Crushed limestone concrete,
4. Sherd with a brick-red paste sherd. These are characteristic, though not plentiful, in this gravel-concrete. Thickness, 4 cms. No gravel.

Lower Row, left to right:

5. Smooth upper surface of piece of gravel concrete, taken from the larger one in the cross-section of 34-138, which see. This is from the lower finished-surface piece of that plate. Pebbles 2 to 3 cms below the surface of finishing plaster.
6. Piece of same, on edge. The finishing plaster, white, is about 1½ cm thick.
7. Sherd, with white mortar adhering, from "roof" of right medial wall.
8. Loose pebbles from deposits of this concrete (taken from the pieces numbered 5 and 6 above). Max. diameters here run from .013 to .04 m, but larger (not much larger) ones occur.
