2036:

Debris filled with rubble facing and with mud brick outer facing which runs round entire structure including south addition. The original stone core, however, includes A and B, the upper parts are 36 X 18 X 12 and in the lower part 28 X 13 X ~~19~~.

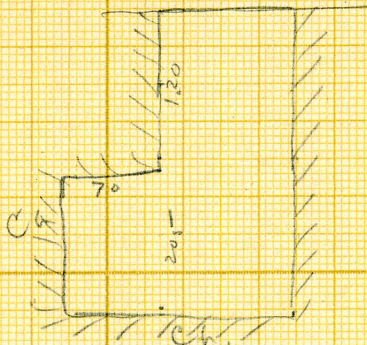
G 2081
B

Shaft -
ch at W
E & W. sides, shaft
in c.b. at W
broken away,
with prov. ca 1.

Burial young
adult ♀ on
l side, head
N, rest up on
a large c.b.
(39 x 18 x 12)
knees drawn up,
hands up before
breast -
skull fallen
back -

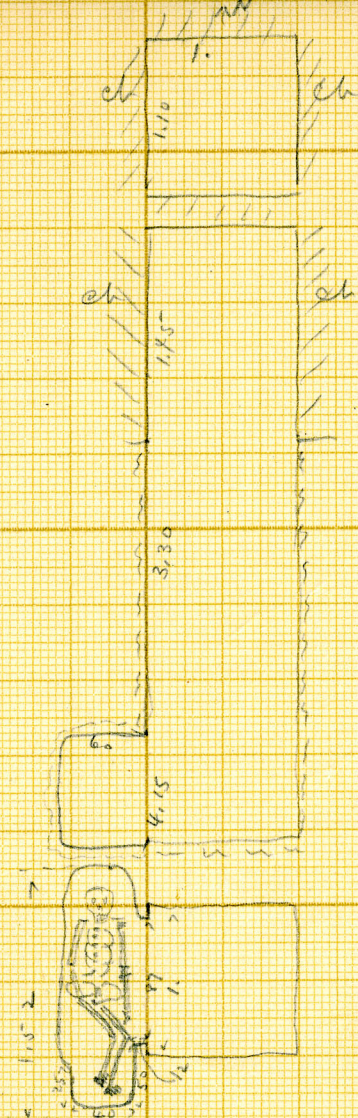
G 2081
E
as in plan

Small Ch at W

Burial -
young adult ♀
upper part of body
on back, head
N, face up -
lower part of
body, from hips
down, on l side
knees up, upper
legs not quite
up to rt E with
body -
l. arm straight
rt hand on
pelvis

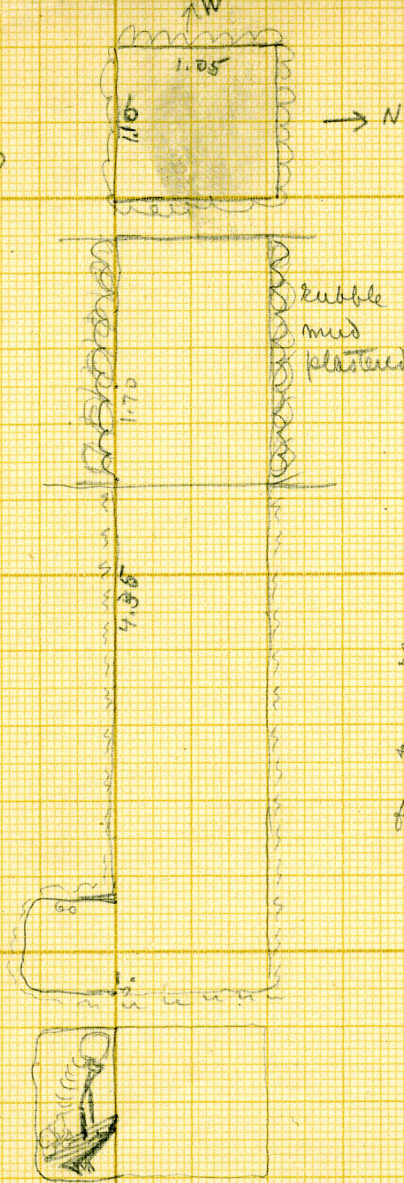
G 2085
A

regias
at 5

Burial
adult female
on l side

head W
(Skull fallen
forward on
face) face
orig. N.

In bottom of shaft
2 large c. b.
39 x 20 x 13
+ 1 smaller c. b.
26 x 13.5 x 7
fallen from
above (?)

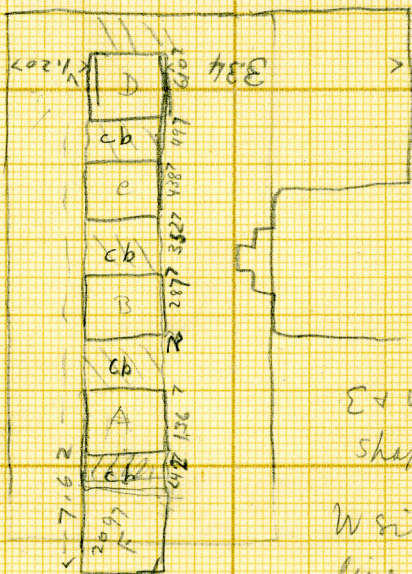
Location of shafts A to D

E & W sides of shafts in line

W sides also in line with C D E F 2097

Division walls c. p. feet plastered rubble

G. 2088. D. Shaft is built against the western half of 2098 with rubble filling mud brick facing while the B. shaft of 2028 is built against 2088. The lower courses of the east face have a different orientation than those above, the indirection of the face of the wall having been changed after the destruction began or the lower courses may be the remains of an early mastaba. The mud brick wall built against this face ran across shaft X the rib vaulting of 2098 is 5 ribs in the distance of 98 cent. It is earlier than 2097 at least the brick facings of shaft A. are continuous around A. The brick facing on the west face has a joint which is not in line with the face along the south of A. The batter of the south face is so slight that it would appear that 2097 was practically built in conjunction with 2088 although the A. shaft of the latter was completed before the structure of F. was begun. The rubble and filling runs through the west face between the brick facing wall. The face on the east most probably runs through the 2098 in a straight line. The mass of brick work at the northern end being a later addition. The bricks in the addition are dark grey 42 X 20 X 15 while in the main structure they are yellower. The offering room walls opposite the large niche were built before the walls enclosing the X Room of 2097.

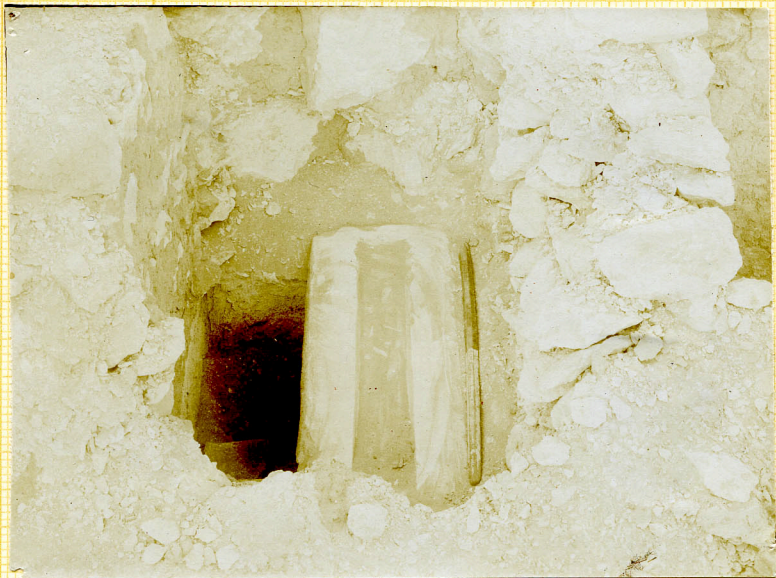
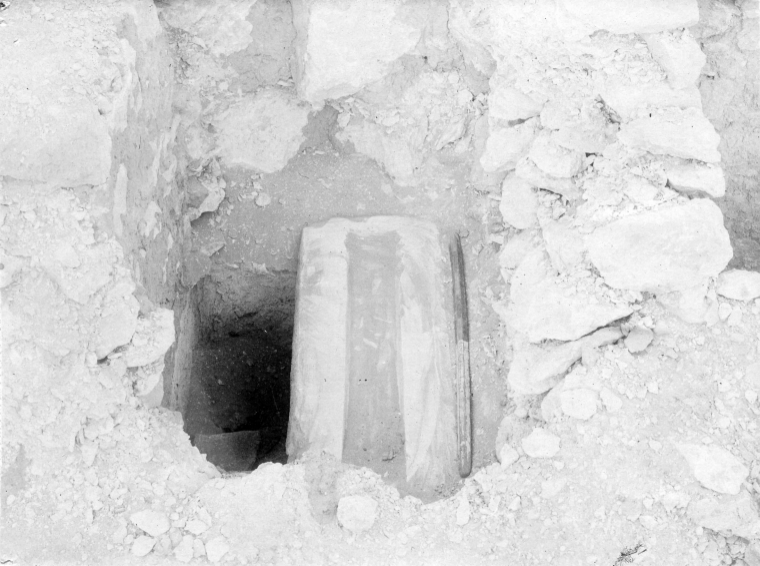
G
2090
A

Sheets A'
inside
plaster
with greyish
stucco
~~at~~ door at
S end into
A, blocked
with slab.
In A', 1 pelin
bone + a broken
leg bone of
adult.
A Supt
