1931

Mason Book 5

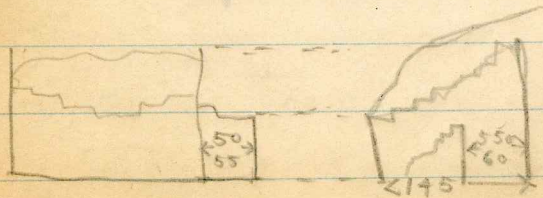
side, + 3 diggys around rear walls  
 on W. side + S.W. corner. See  
 diggy p. 24. The wall of the  
 middle south section is 14.5 thick, +  
 straight on rear side. South edge  
 at S. But a smaller wall of  
 uncertain height + thickness is built  
 against it. S. edge + rear wall in  
 good condition, front wall + top  
 destroyed. ~~27~~ Rear wall is 55-60  
 W. of rear wall of main <sup>well</sup> ~~the~~ s edge  
 50-55 on south of S. edge of main  
 wall of well section b.

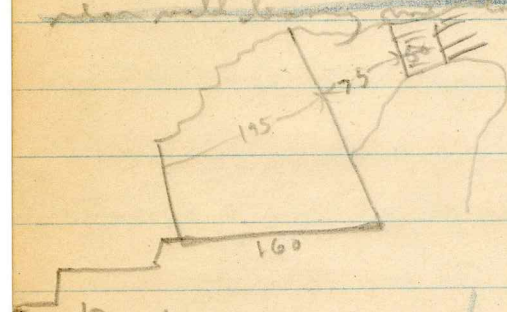
above terrace B. ~~The latter wall~~  
~~continues across corner 2 and forms~~  
~~ledge under to form floor of between~~  
~~section 2, will form a step for~~  
~~terrace C to floor of room. Section~~  
~~of wall a is 160 wide at floor~~  
~~but 145 at light structure section,~~  
~~near wall being <sup>more than</sup> feet.~~

Behind this is fill of 75 cm, & then  
another section of very slopy filling up  
at high level, goes into. ~~Fill can't~~  
~~be dug out or new wall would fall~~

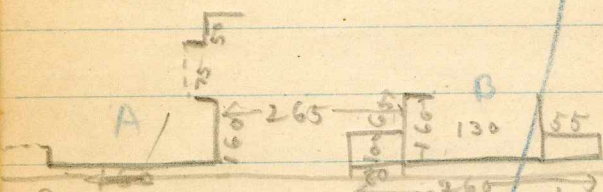
S. line of this fragment, high slope  
 wall is parallel with S. edge of wall of  
 section a. 50 cm. behind this, a  
 the for 125 behind, an wall of section a  
 is another fragment of a sloping wall,  
 falling and visible only at height of  
 5 ft, which probably represents rear wall  
 of room. But it cannot be seen  
 as it is on part of falling. Original  
 features probably so:-

of last was, all connected in features.

Room was probably 125 wide; may be  
 excavated later.

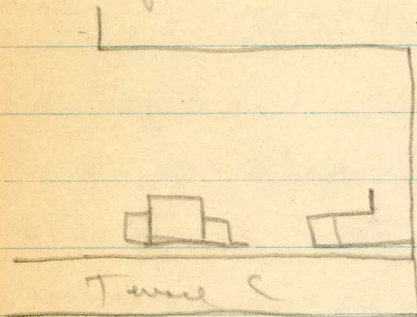
Terrace B

Terrace A of 12-15

S. W. corner of latter well behind terrace  
A (12-15) seen to be about 120 m  
south of main S. wall of the above.

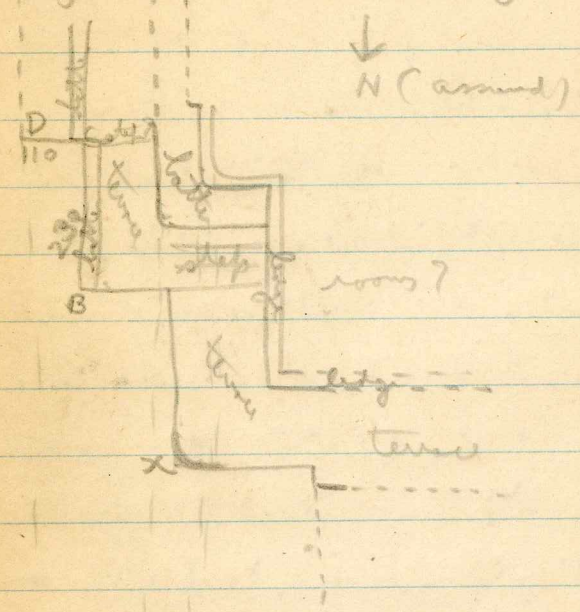
~~end. Clutch and wall B-C is 220 cm~~~~long. C-D 70 cm long~~

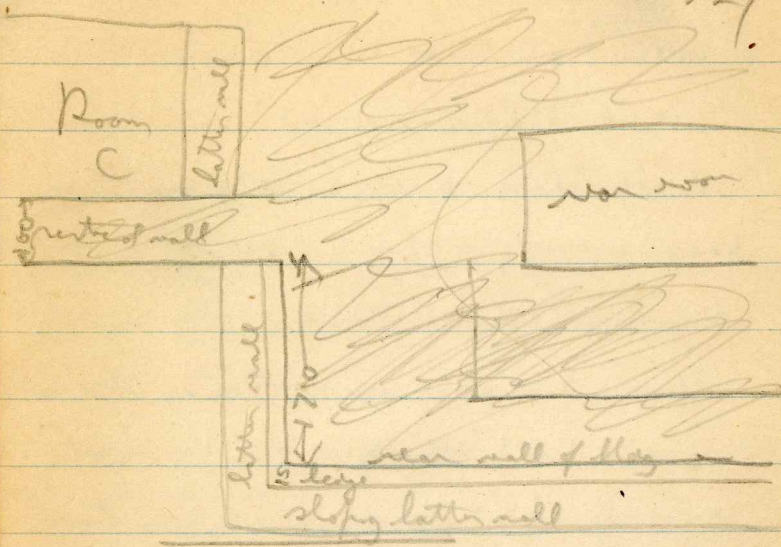
has been 55 more or 220 to edge of  
 covered wall to W. Width quite  
 regularly 35 cm and height above  
 slabs 15-18 cm. In places a good  
 floor at bottom, <sup>of</sup> unexcavated. Further  
 end is about 50 cm. for E. wall  
 No definite wall at end and side walls  
 not so good near end. Nothing but soft  
 dirt found in floor, no dark earth over  
 elsewhere. I have no explanation for  
 this feature. ~~A little further excavation~~  
~~was done along near wall of~~  
~~triple in corner with near wall~~  
~~of room # C. See plan next page.~~  
~~Near wall of room C is noticed. There~~  
~~is some appearance as if it was originally~~

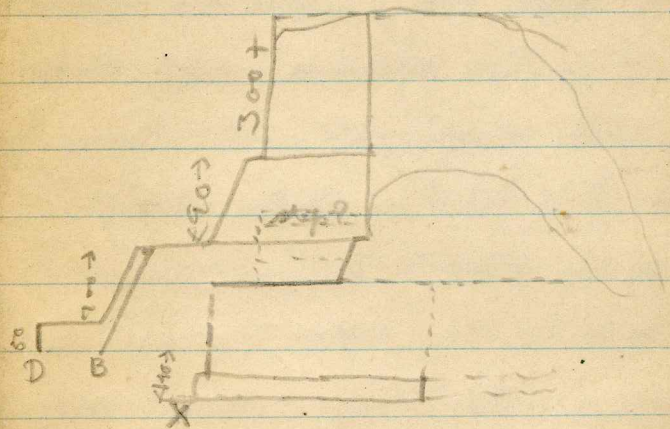
~~low terrace platform on east side.  
Presumably this terrace platform was  
for entire the rear length of ledge.  
Width of terrace floor at east from  
low edge of upper latter wall to upper  
edge of low latter wall is~~

~~Point D is apparently about 140 cm higher  
than point X (lowest n.d. corner), both at~~
