Mason
Piedras Negras, 1932 ✓
Book #4 1

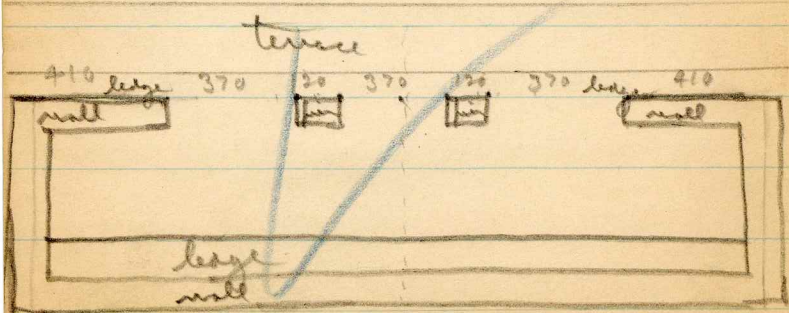
~~no small. This W. end of this
piece is about 2 m. from central
line N-S of upper temple, & since
east entrance is about 370 wide,
it may be presumed that central
entrance was of like width and
that 3d lower temple was fairly
well centered with upper end & of
construction somewhat as below:~~

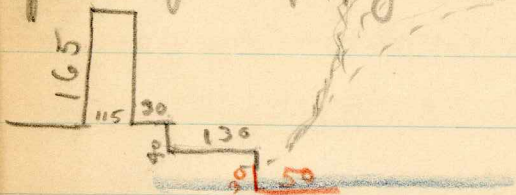
~~This is very long & wide room &
could have been roofed only by
timber. No capitals found in all
excavation. Older rooms, apparently
larger than ~~the~~ more recent ones.
^{2d} floor at south beyond ledge
wall is very uncertain, not built
in most places & soft. Ledge
wall probably continues to east end
of S. boundary wall & being lower
& looks east wall, but should be
proved. Going towards west, ledge
wall seems to disintegrate about
150 east of east end of platform, &~~

~~is a continuation beyond this. Must
be investigated further. At 130
S. of ledge wall is south edge
of wall, indicating first terrace of
front face of pyramid.~~
