1932

K-5 3rd.

Summary Mr. Mason's notes.

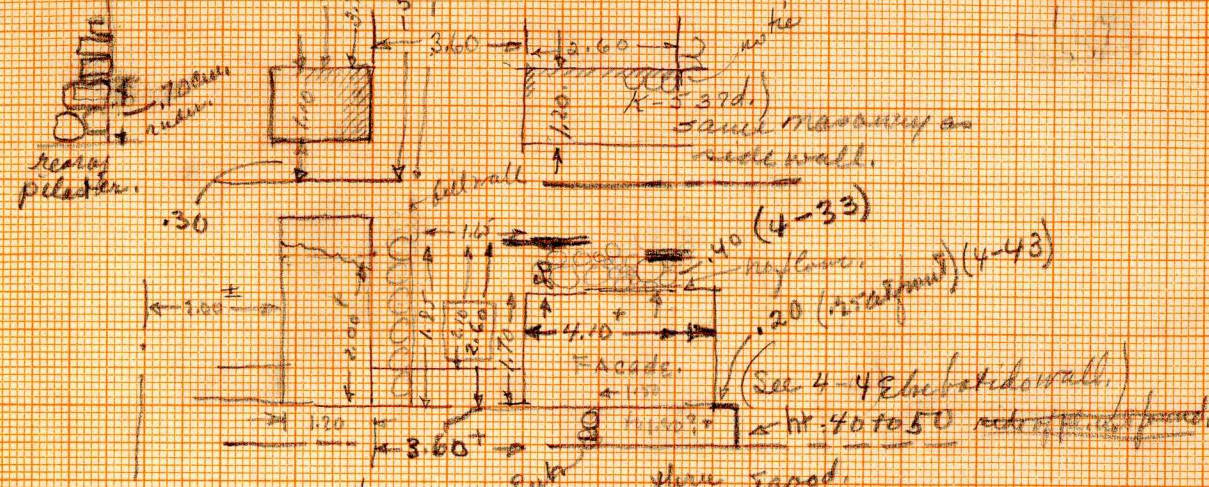
4-15 - masonry
change in plan.
different from
(rudder) no rest. from

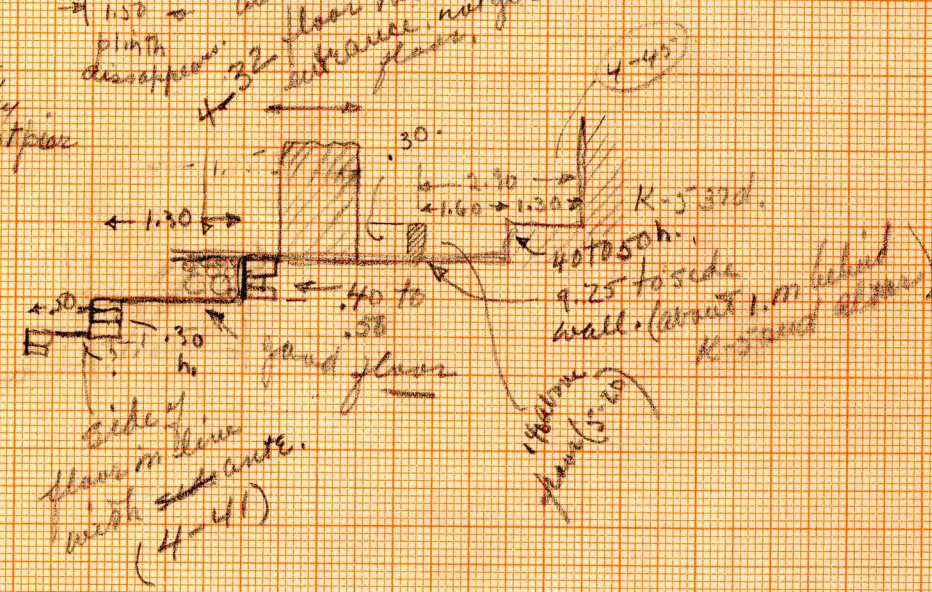
4-12 K-53rd. pier
destroyed by
falling K-51st pier

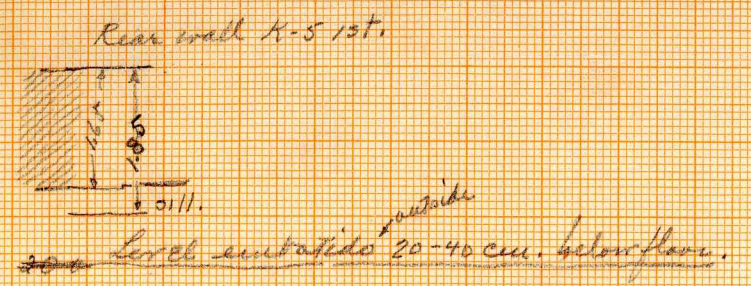
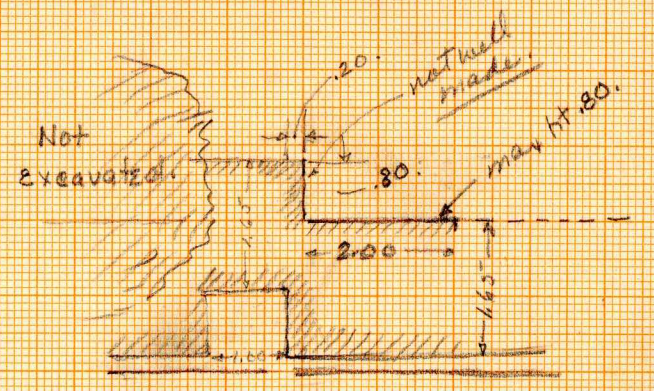
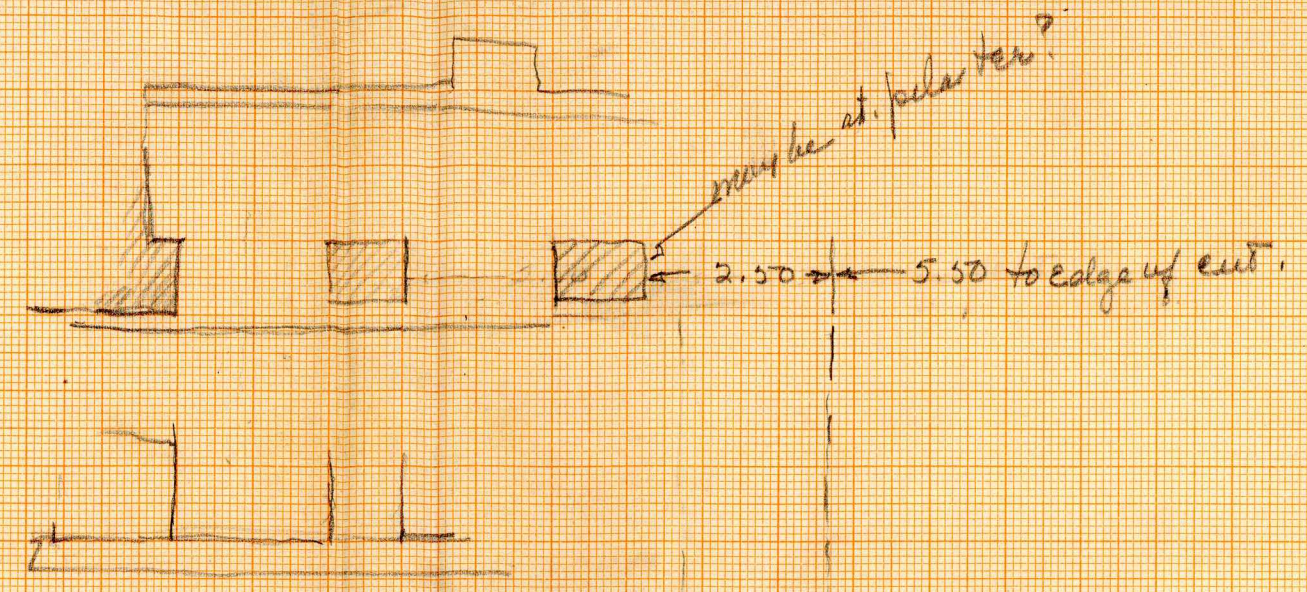
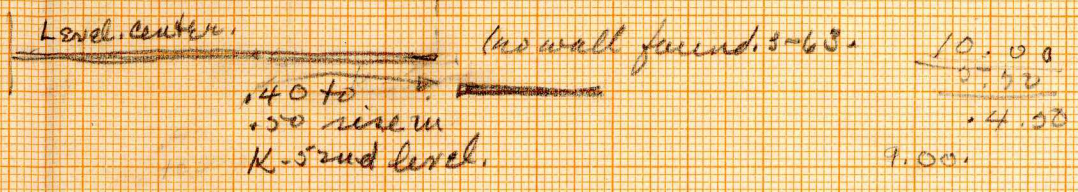
Section 90-90 wide

Left near Corner -

Wall continues down
behind plinth - 4-60
ledge 25 wall 1.50 above pl.

near 1.45 wide at corner

source from 1.20 higher than terrace at ft. of 5 ft. pier (3)
from 1.80 above terrace. at side

entrance corner - 3rd floor
Remains
pt. in l. entrance K-5-1st

4.10
2.60
1.50

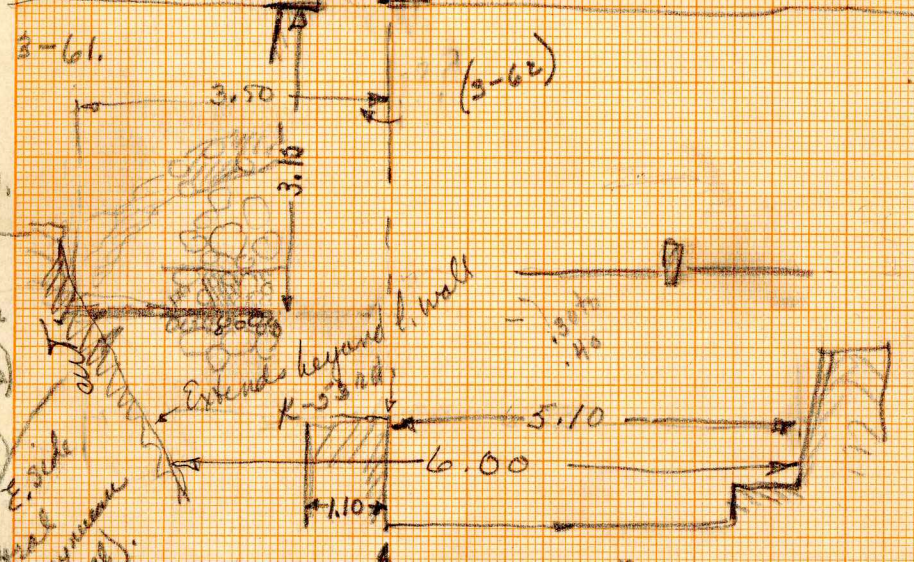
floor
no surface
mud
hemispherical
to base.
(S)
(S)
2m. E. of E. side
of 2. central
pier (symmetrical
upper level).

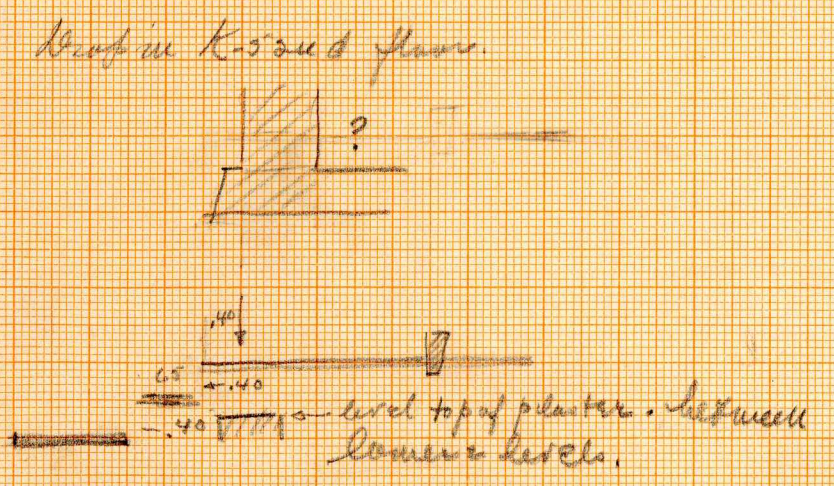
Pier exactly in
line with K-5 1st.
Side about 1.1m. to
left of left side of
K-5 1st pier. (3-71) & about
6.25 from inner side of
side wall K-53rd (3-72)

Plaster surface on top, about level
with rubble. Smooth top for .35. Near
rubble below surface of top. (?) top =
.70 below level of floor (?) top =
center which is .30 above "same"
floor near rear wall. (?) (3-73)
